**THE BOARD OF CHOSEN FREEHOLDERS  
OF THE  
COUNTY OF MONMOUTH**

Re: **OPRA REQUEST RECEIVED – MAY 4, 2018**

Your request seeks "Any/all reports and findings to the air quality in the Monmouth County Courthouse from the closing June 18, 2012. Also any on going mold and asbestos surveys, treatment."

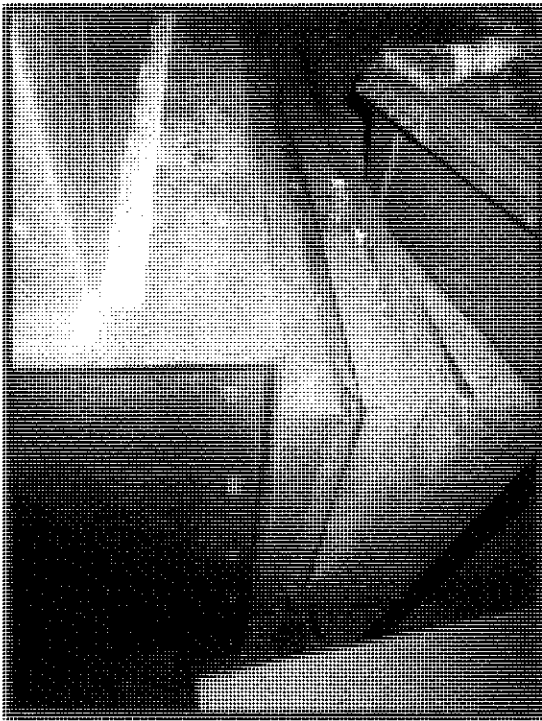
*HVAC Duct Joint Vibration Cloth  
Determined to be ACM during previous  
inspection activities per  
County of Manmouth Records*

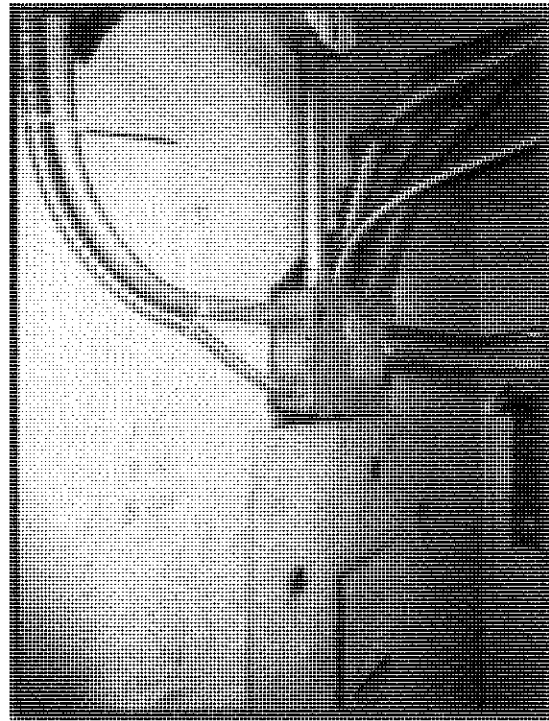
*Two Coat Plaster  
Determined to be Non ACM  
[REDACTED] Material Code 02  
10/21/16*

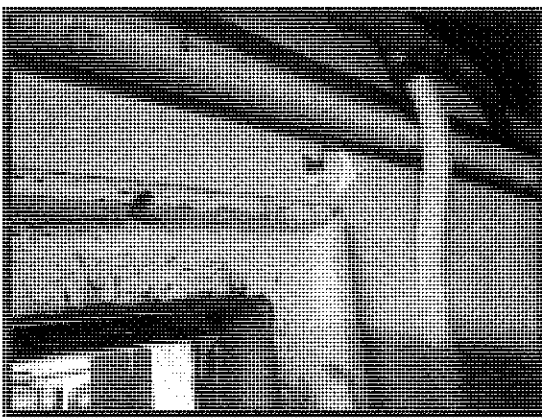
*Two Coat Plaster  
Determined to be Non ACM  
[REDACTED] Material Code 02  
10/21/16*

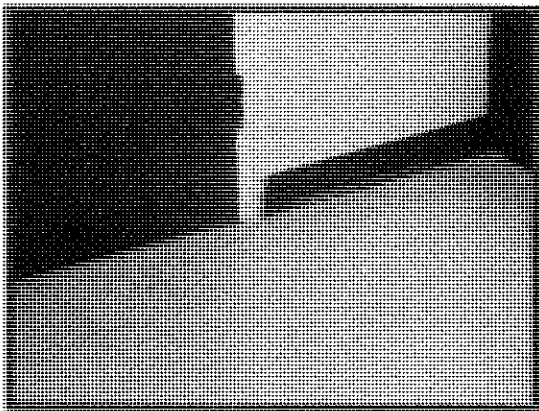
Cove Base

Determined to be Non ACM

[REDACTED] Material Code 03

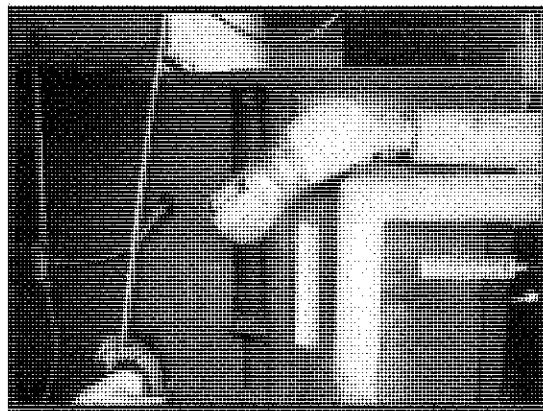
ACM Pipe Fitting Insulation and Non ACM

Fiberglass Pipe Insulation determined

activities per County of Monmouth Records

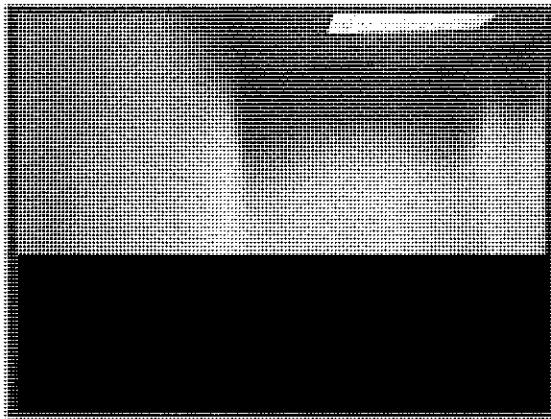
*Drywall, Ceiling Tile, Floor Tile and Cove Base  
Systems determined to be Non ACM*

[REDACTED] Material Codes 05, 06, 07, 08, 09 and 10.
