BUREAU OF FIRE PREVENTION  
OFFICE OF THE FIRE OFFICIAL

**BOROUGH OF TETERBORO**  
250 HOLLISTER ROAD • TETERBORO, NEW JERSEY 07608

June 2, 2025

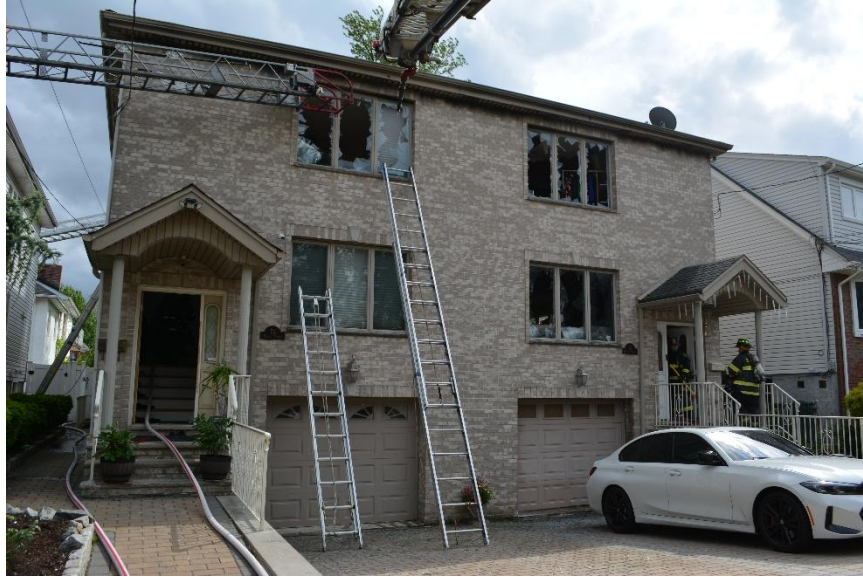
The subject structure is a 2-story duplex residential occupancy constructed of wood and masonry materials. The building is located on the south side of 4<sup>th</sup> Avenue with the front of the structure facing north. The exterior of the structure is covered with vinyl siding and the front of the structure is covered with a brick veneer. The roof is hip shaped and covered with asphalt shingles, the west side of the roof is covered with solar panels. The structure was built in 2005. 7A 4<sup>th</sup> Ave is located on the east side of the structure and 7B 4<sup>th</sup> Ave is located on the west side of the structure.

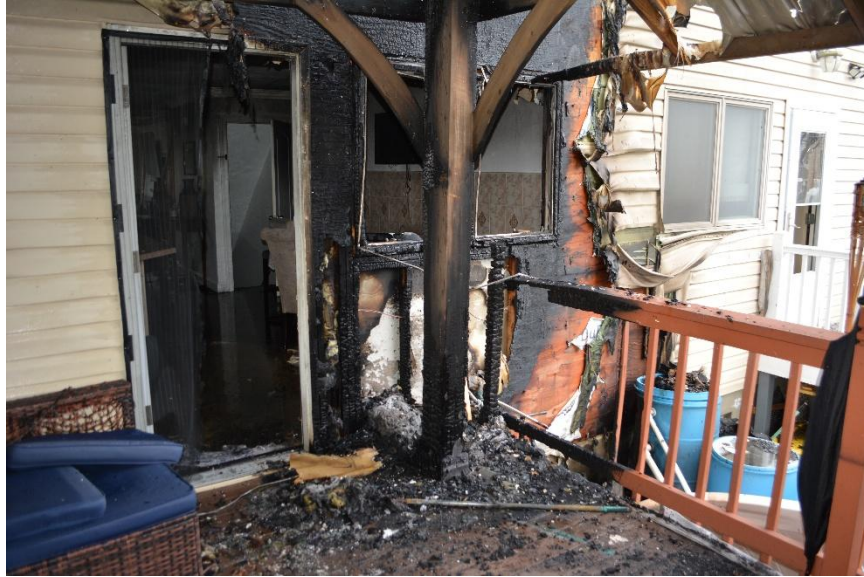
A systematic interior examination was conducted utilizing the scientific methodology as outlined in NFPA921 2024 Edition. Examination of the structure revealed smoke damage throughout the interior of the structure. Tracing the heat and smoke damage, from least to most severe, found that the most severe damage was noted on the rear deck of 7B 4<sup>th</sup> avenue. The examination of this area found heat and fire damage to the right rear side of the deck between the railing and the column.

Right rear side of the deck

The fire originated from the right side of the rear deck. The fire migrates up and outward from this general area, igniting a combustible cardboard box and communicating to the deck and structure.

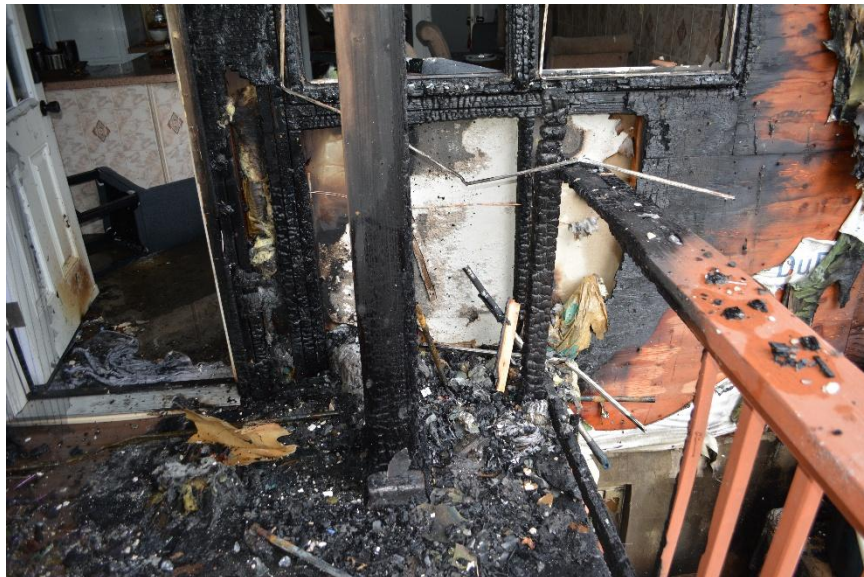
Close up view of the right rear side of the deck

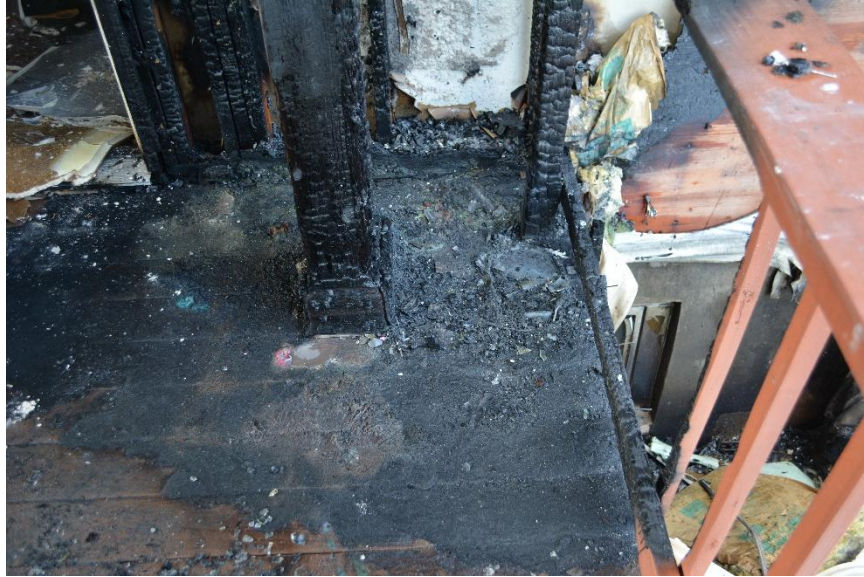
Area cleared of debris

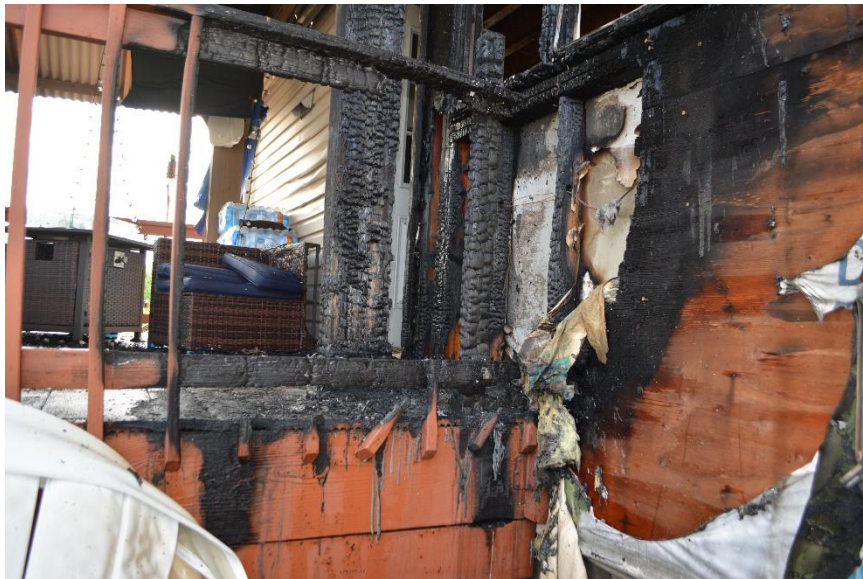
Side view of the deck

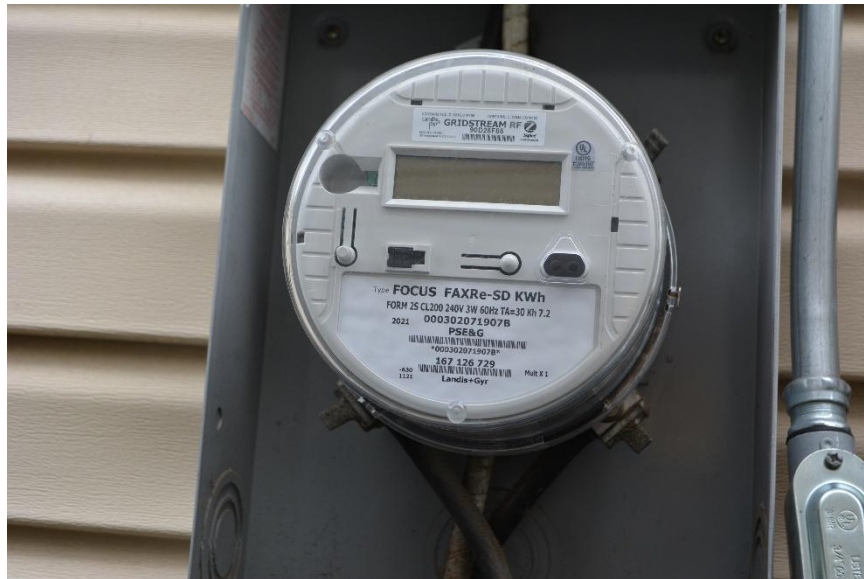
The electrical service is supplied to the structure via overhead wiring from PSE&G pole # 60484 to a Landis & Gyr watt meter PSE&G tag #000302071907b. There are no signs of damage or tampering to the weather head, meter pan or conduit. A Siemens electrical panel is in a basement closet under the stairs. Breaker's 11, 12, 24, 28, & 32 are in the tripped position. Breaker 11 is labeled kitchen wall outlet, breaker 12 is labeled 2<sup>nd</sup> floor bathroom, breaker 24 is labeled smoke detectors, breaker 28 is labeled rear bedroom and breaker 32 is labeled middle bedroom.

**Landis & Gyr watt meter**

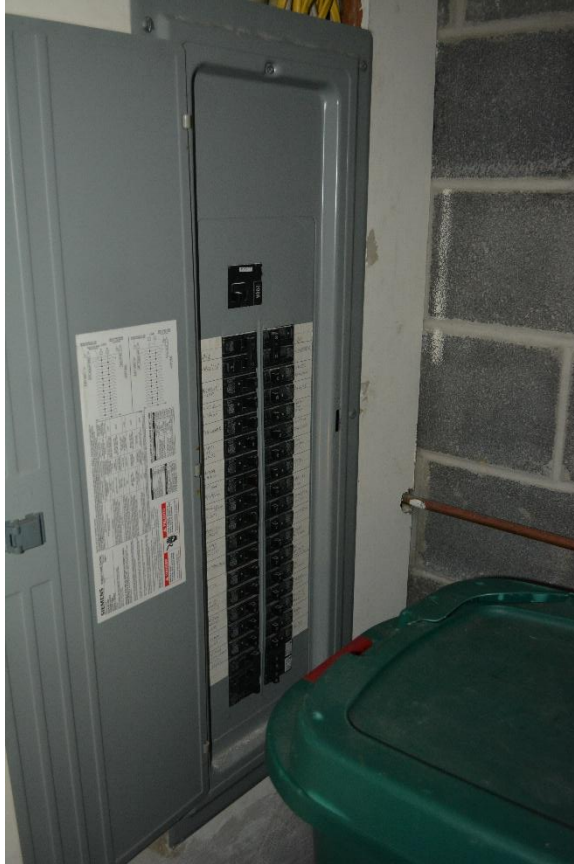
**Siemens electrical panel**

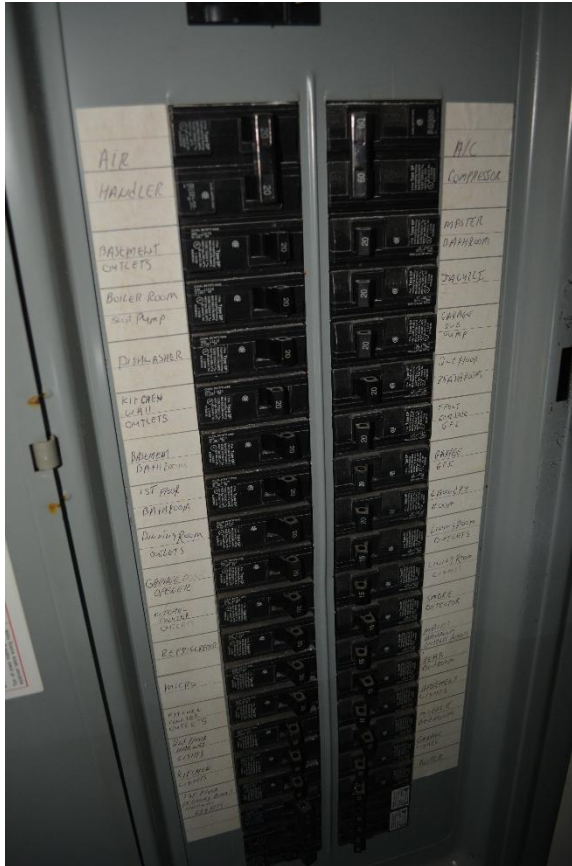
**Breakers 11,12,24,28,32 in the tripped position**

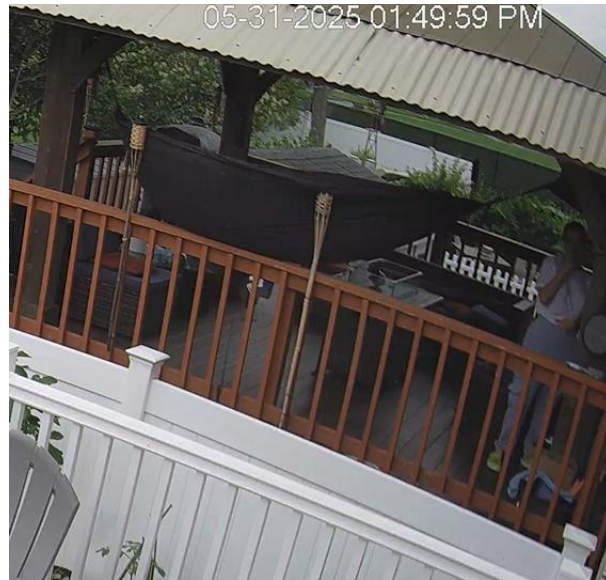
**Eliana Dominguez Smoking**

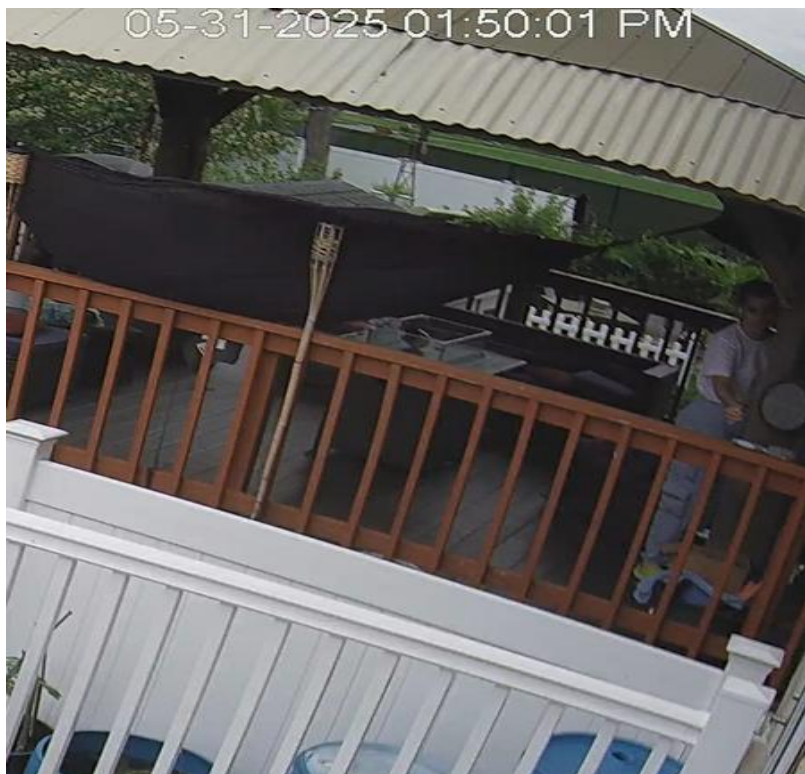
**Eliana Dominguez dropping the cigarette near the cardboard box**

The inappropriate disposal of smoking materials by Mrs. Dominguez is the cause of the fire occurrence.

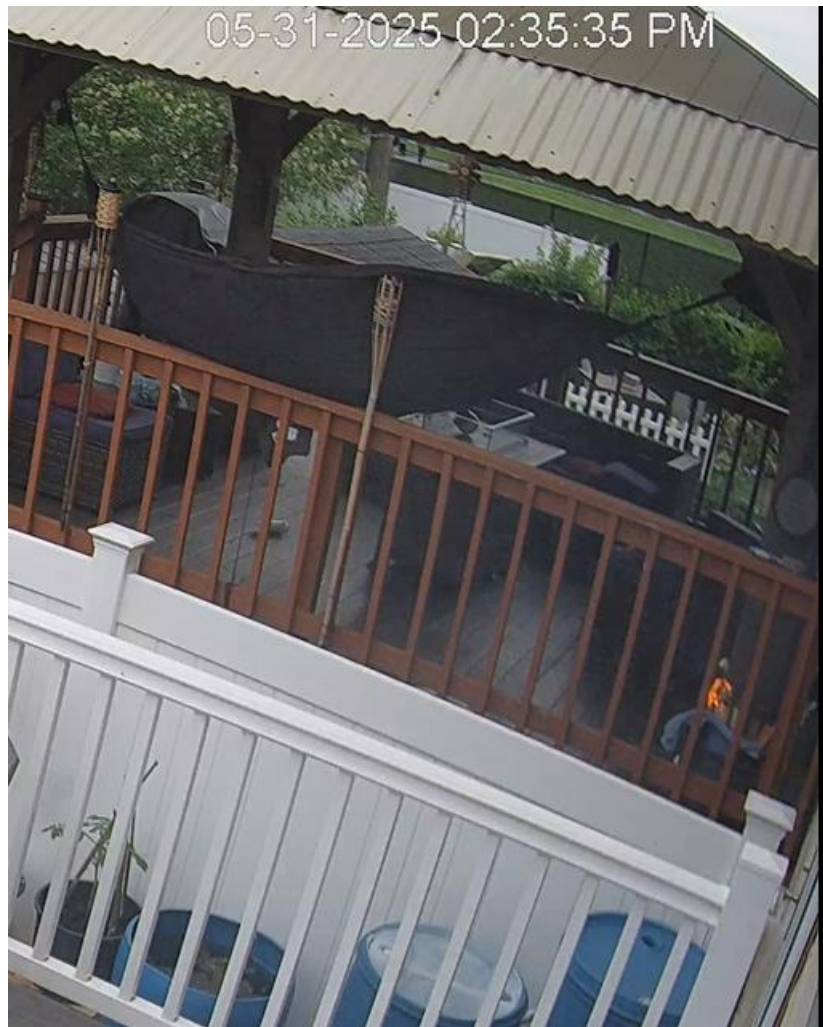
**First sign of flame from the cardboard box**
