| New Jersey Police<br>Crash Investigation Report | | | | | | | | | | | | Case Number<br>2018-00037549 | | | Page 2 of 3 | |

New Jersey Police Crash Investigation Report  
Motor Vehicle Crash Diagram

Police Dept: Brick Police Code: 01  
Station:        Case No: 2018-00037549

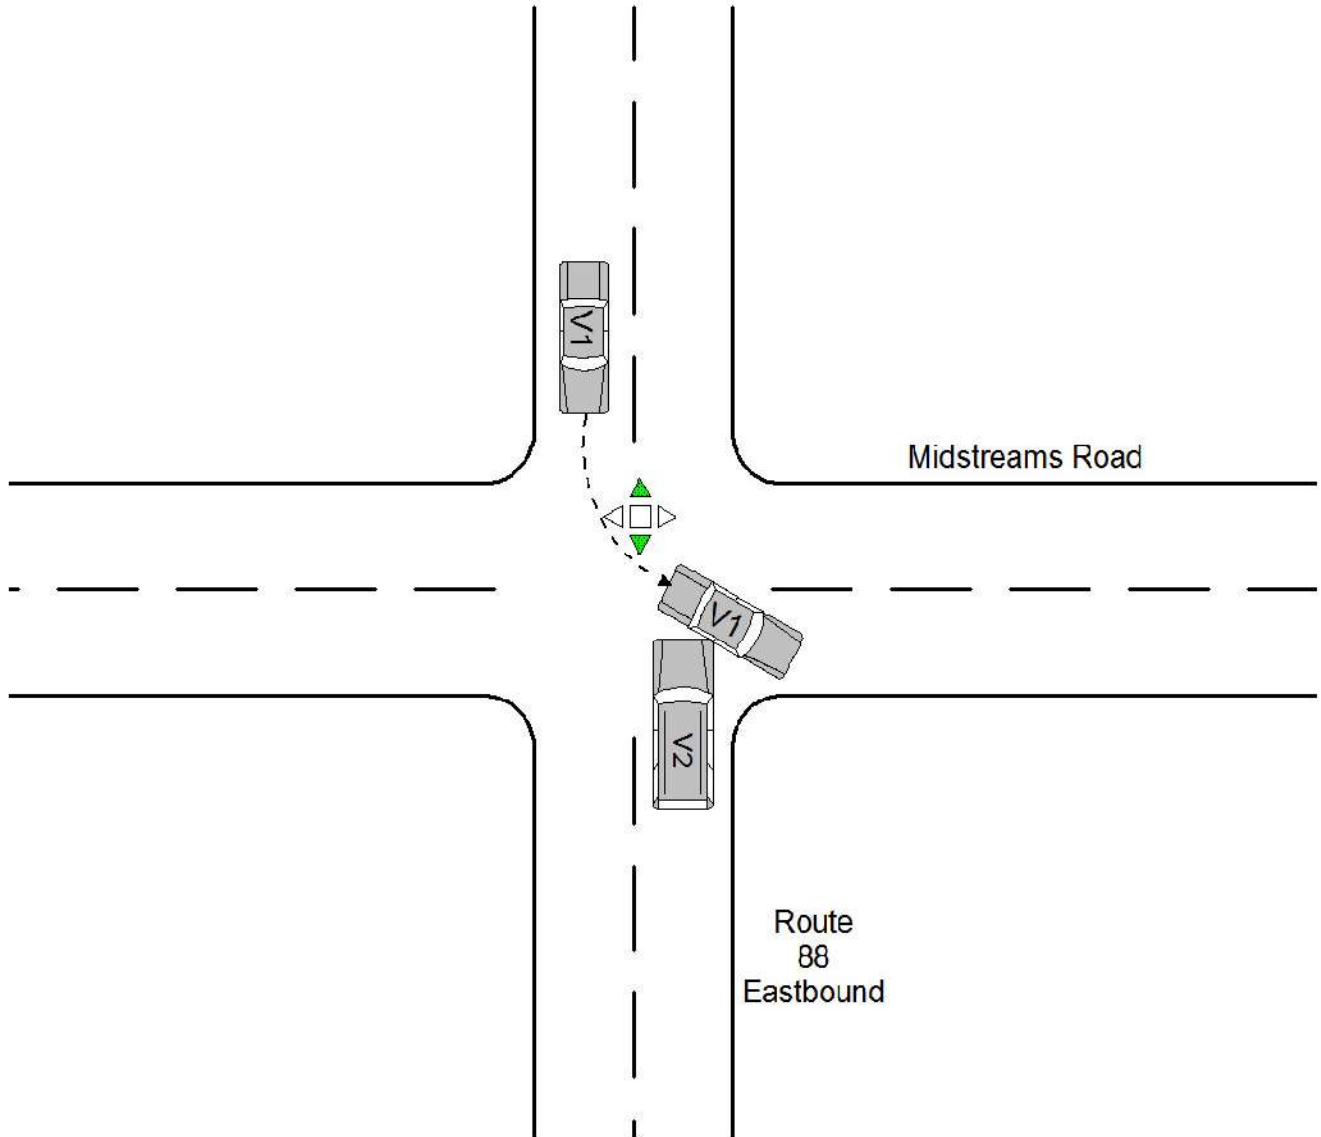
144 Crash Diagram (NOT TO SCALE)

On scene investigation concluded: Vehicle #1 was turning left from Route 88 Westbound to Midstreams Road. When the traffic light turned green vehicle #1 made the left turn when vehicle #2 began to accelerate to go Eastbound on Route 88. Vehicle #1 made the left turn failing to yield to traffic causing vehicle #2 to crash into the right rear of vehicle #1.

During my investigation, I find vehicle #1 at fault for the crash for not yielding to traffic.
