| New Jersey Police<br>Crash Investigation Report | | | | | | | | | | | | Case Number<br>2018-00019182 | | | Page 2 of 3 | |

New Jersey Police Crash Investigation Report  
Motor Vehicle Crash Diagram

Case No: 2018-00019182

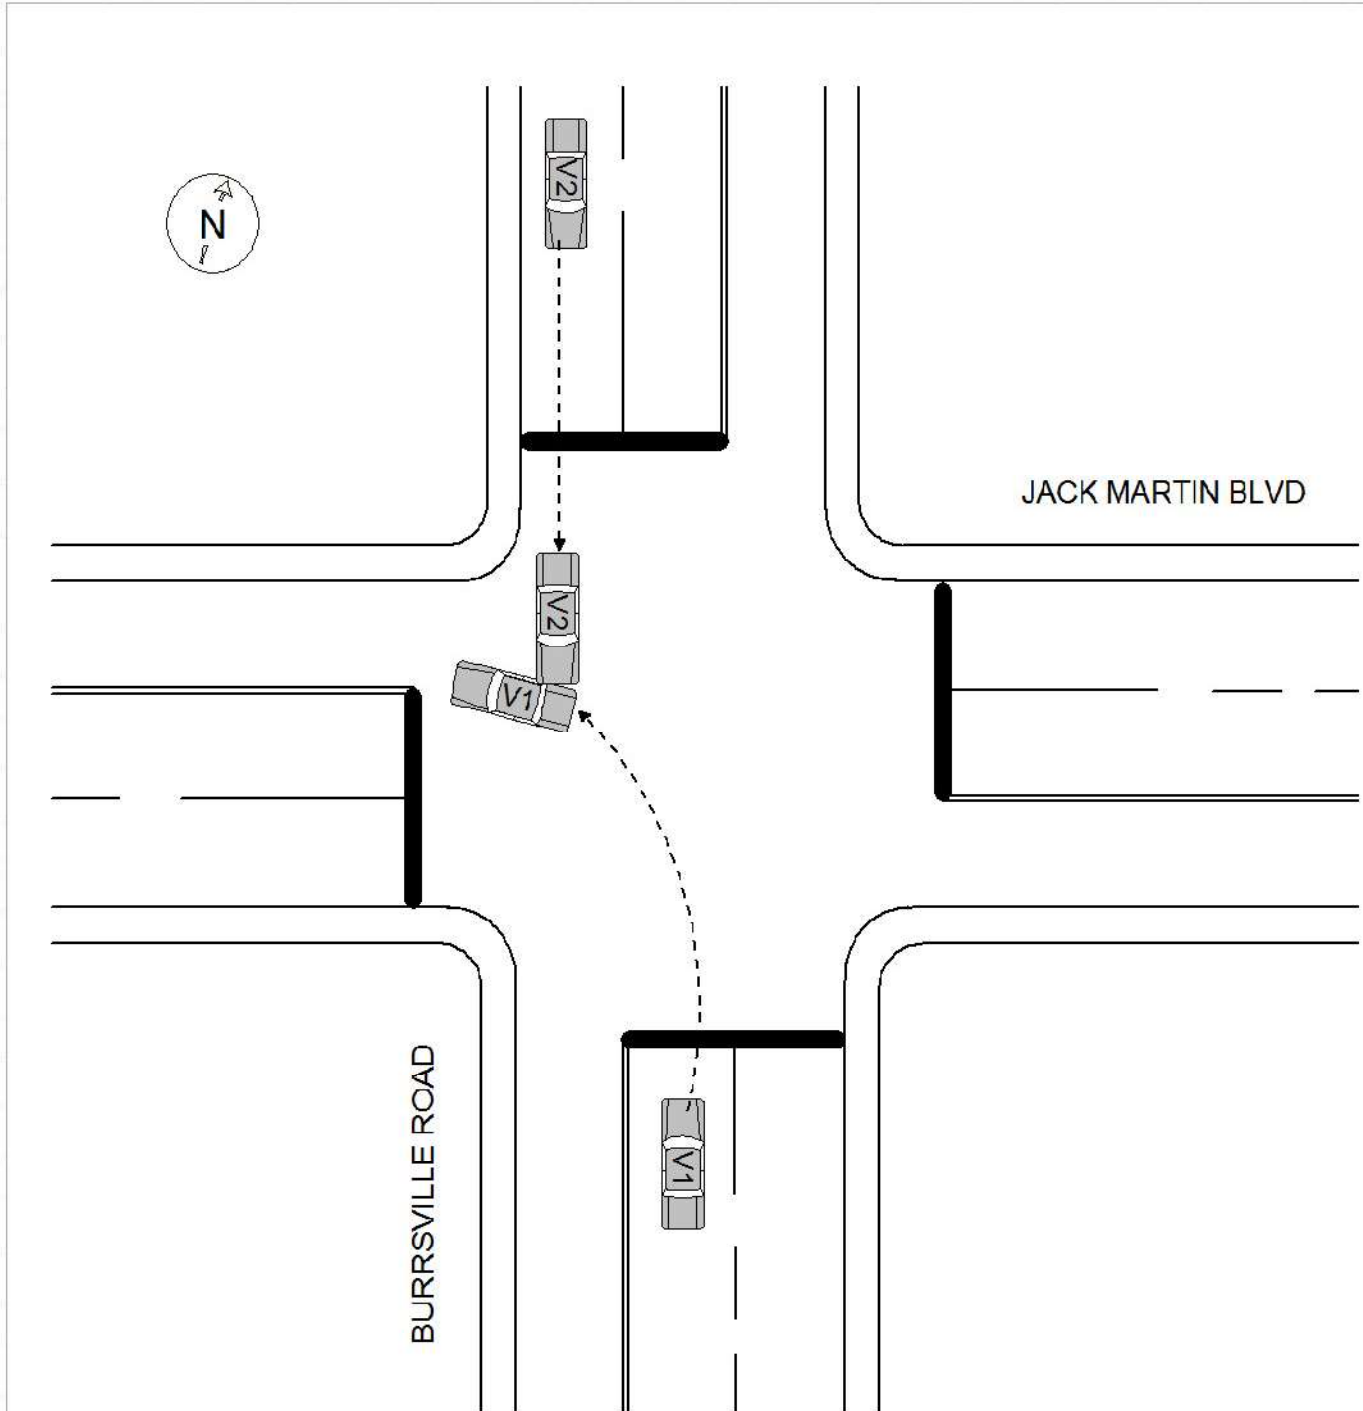
144 Crash Diagram (NOT TO SCALE)

Vehicle #1 was traveling north bound on Burrsville Road, attempting to make a left hand turn onto Jack Martin Blvd. west bound. Vehicle #2 was traveling south bound on Burrsville Road approaching the intersection of Jack Martin Blvd.

Driver #1 stated she was waiting to make her left turn onto Jack Martin Blvd west bound when she proceeded to make her left turn. While turning, the area of the right rear tire was struck causing her side airbag to deploy.

Driver #2 stated she was traveling south bound on Burrsville Road with a green light. She proceeded through the intersection and at that time, Vehicle #1 made a left turn in front of her. She applied her brakes and tried to maneuver around Vehicle #1 but was unsuccessful, causing front end damage to Vehicle #2.

Based on my on scene observations and statements made by both drivers, I determined Vehicle #1 to be at fault for the crash.
