| New Jersey Police<br>Crash Investigation Report | | | | | | | | | | | | Case Number<br>2018-00004507 | | | Page 2 of 4 | |

New Jersey Police Crash Investigation Report  
Motor Vehicle Crash Description

New Jersey Police Crash Investigation Report  
Motor Vehicle Crash Diagram

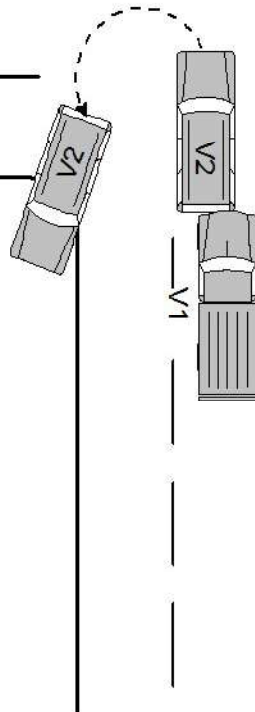
144 Crash Diagram (NOT TO SCALE)

On scene vehicle #1 was in the westbound lane on Route 88 with severe front end damage. Vehicle #2 was facing eastbound on Route 88 with damage to the rear of his vehicle. I observed vehicle #2's rear window blown out in the westbound lane on the roadway.

Driver #2 explained he was making a left turn onto Midstreams Place when he was struck in the rear by vehicle #1.

Driver #1 explained he was attempting to pass vehicle #2 on the right. Driver #1 could not pass vehicle #1, causing him to crash into the rear of vehicle #1.
