| New Jersey Police<br>Crash Investigation Report | | | | | | | | | | | | Case Number<br>2017-00070801 | | | Page 2 of 3 | |

New Jersey Police Crash Investigation Report  
Motor Vehicle Crash Diagram

Case No: 2017-00070801

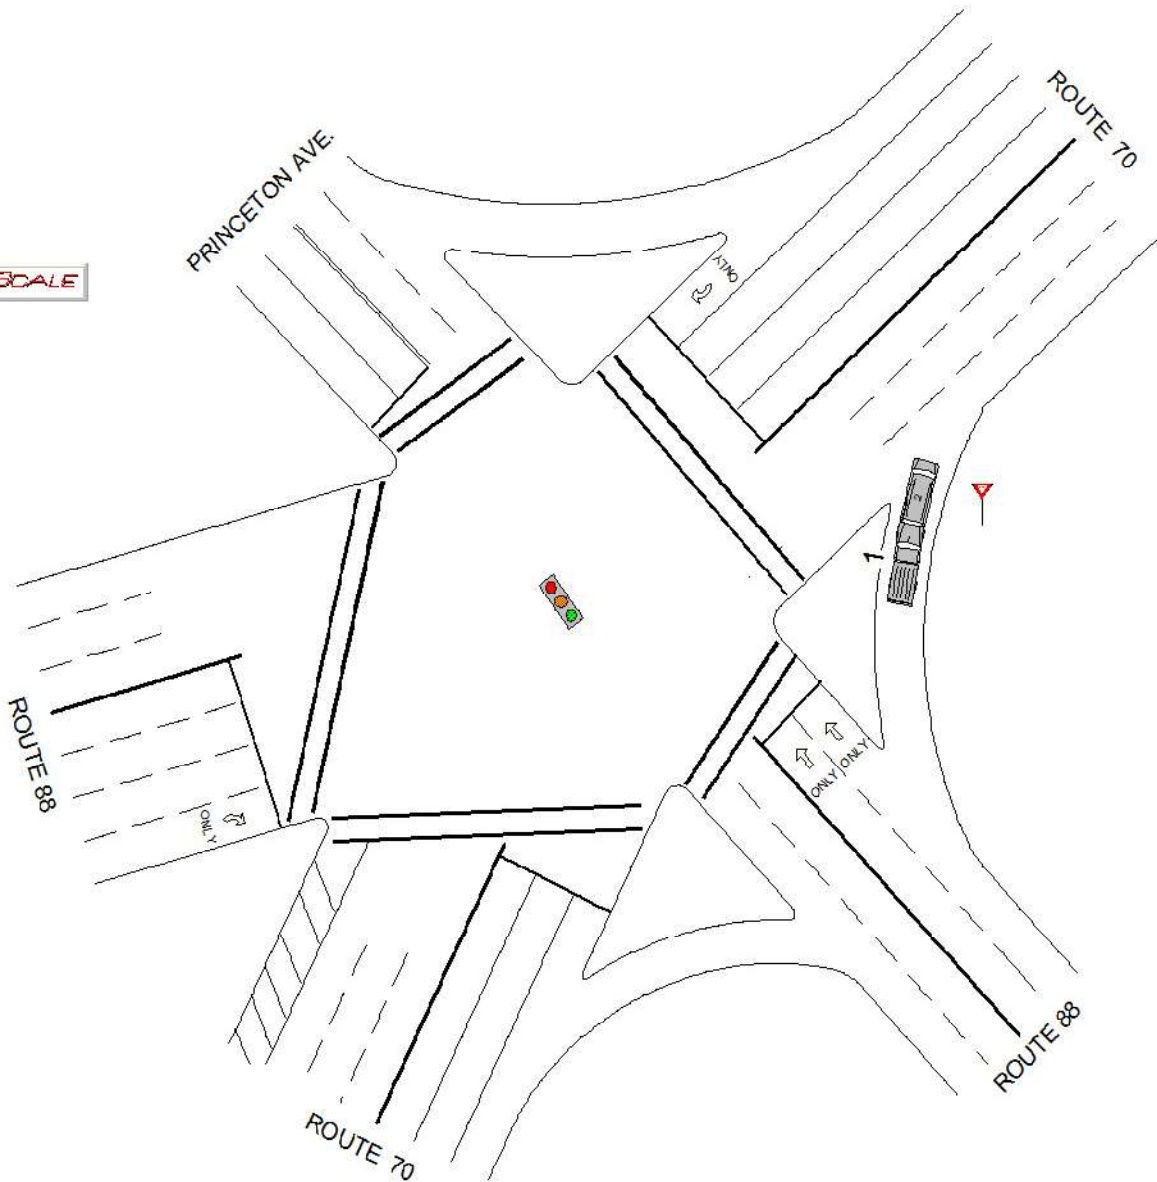
144 Crash Diagram (NOT TO SCALE)

Both vehicles were waiting to merge in traffic onto Route 70 West from the Eastbound Route 88 off ramp. The front end of Vehicle #1 collided with the rear end of Vehicle #2, causing moderate damage to both vehicles.
