## New Jersey Police Crash Investigation Report

## Motor Vehicle Crash Description

Station: **Brick Police** Case No: **2015-00074465**

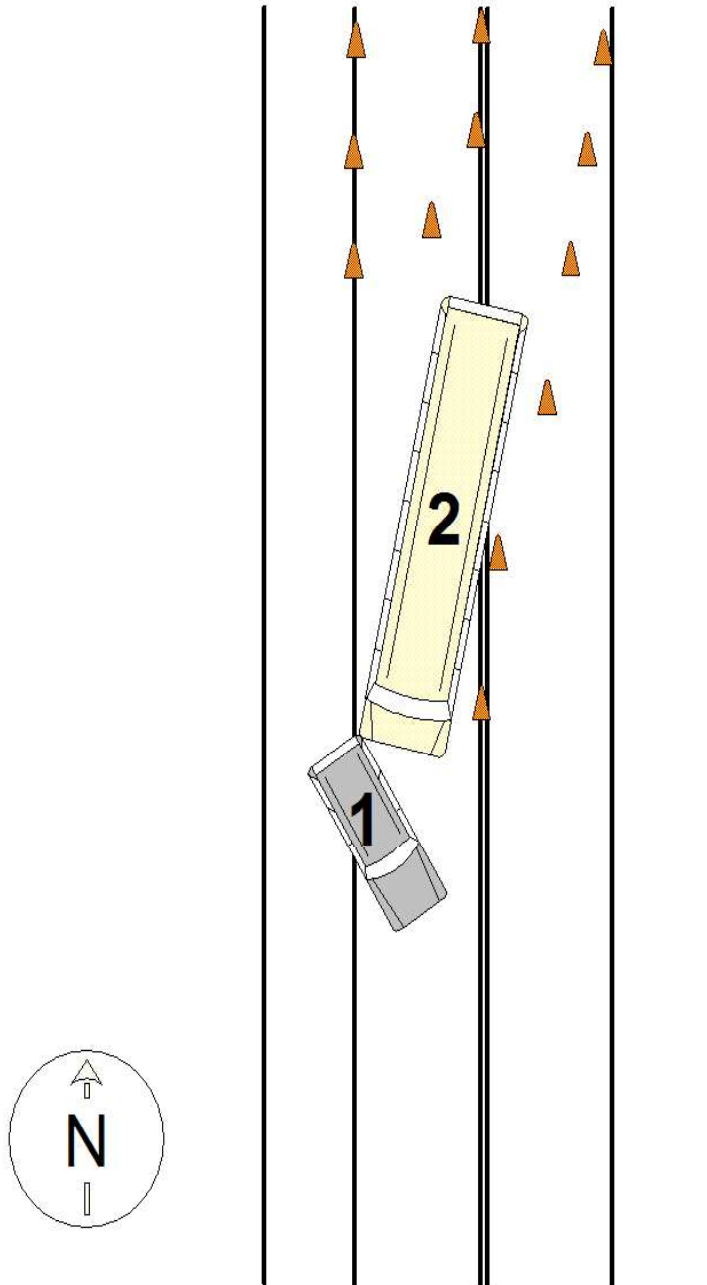
Motor Vehicle Crash Diagram

Vehicle #1 was traveling south through the construction coned right lane on Jack Martin Blvd. Vehicle #2 was also traveling south on Jack Martin Blvd but in the left coned lane. Soon after the two coned lanes merged into one, Vehicle #1 attempted a left U Turn in front of Vehicle #2, causing crash.
