## New Jersey Police Crash Investigation Report

Station: **---** Case No: **2014-00032606**

## 135 Crash Description

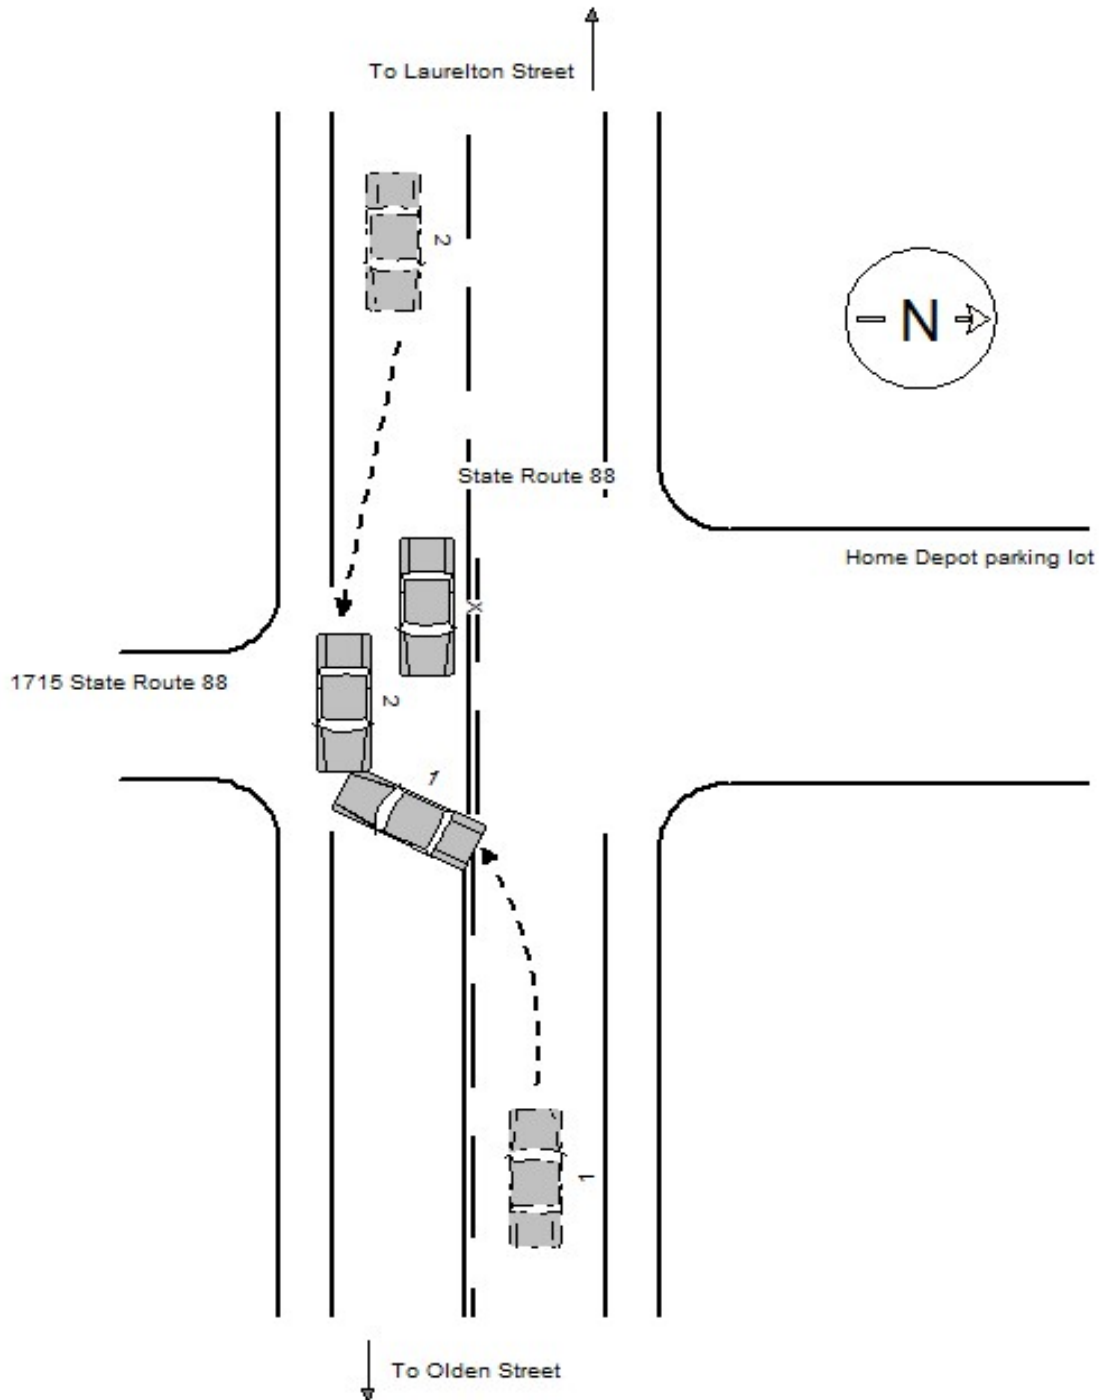
134 Crash Diagram (NOT TO SCALE)

Investigation at the scene indicated the following: Vehicle 1 was traveling west on State Route 88 and had just passed Olden Street. Vehicle 2 was traveling east on State Route 88 approaching Olden Street. Vehicle 1 attempted to turn left from 88 into the parking lot of 1715 State Route 88. Vehicle 1's right front contacted vehicle 2's left front.
