| New Jersey Police<br>Crash Investigation Report | | | | | | | | | | | | Case Number<br>2021-00001021 | | | Page 2 of 3 | |

New Jersey Police Crash Investigation Report  
Motor Vehicle Crash Diagram

Police Dept: Brick Police Code: 01  
Station:        Case No: 2021-00001021

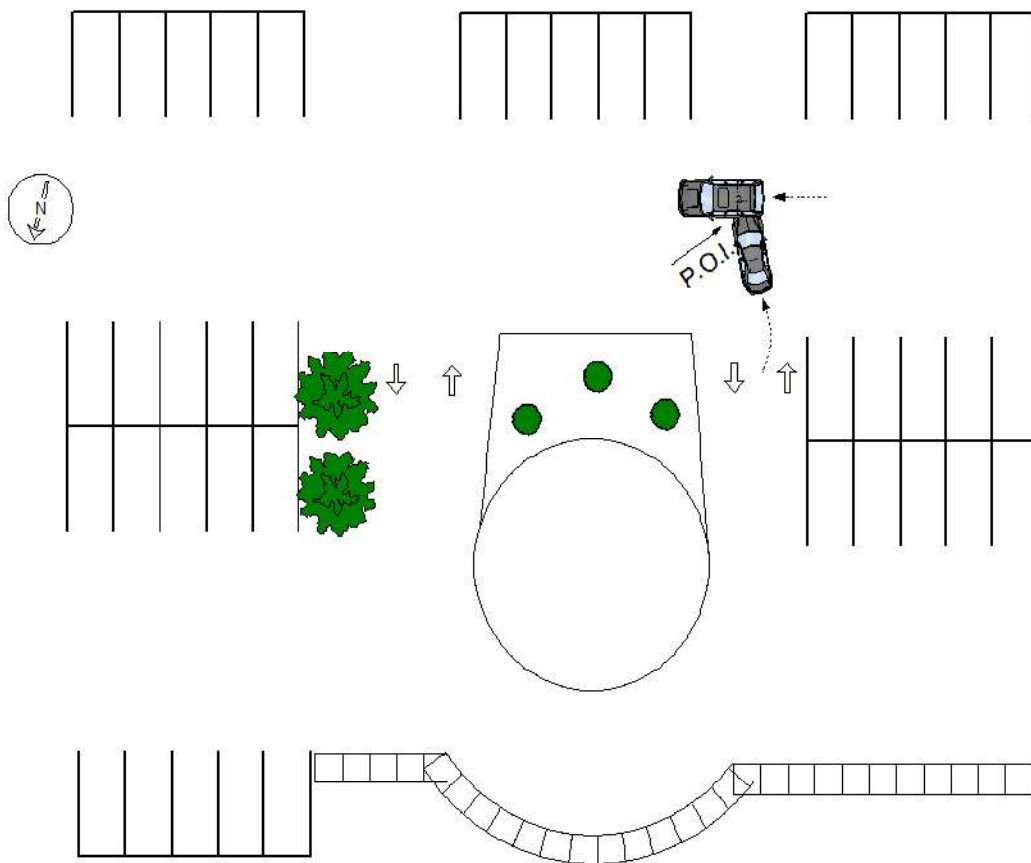
144 Crash Diagram (NOT TO SCALE)

Vehicle 1 was traveling south in the parking lot of 1608 Route 88 after going around a circle in front of the business. Vehicle 2 was traveling east on the main thoroughfare in the parking lot. Vehicle 1 attempted to make a left turn, pulling out as vehicle 2 was passing, and subsequently collided with vehicle 2. There were no stop signs only lane markings in the parking lot where the crash occurred.

Investigation revealed that the cause of the crash was due to driver 1's inattention to traffic and failing to observe vehicle 2 traveling straight past her prior to attempting her left turn.
