| New Jersey Police<br>Crash Investigation Report | | | | | | | | | | | | Case Number<br>2021-00032590 | | | Page 2 of 4 | |

New Jersey Police Crash Investigation Report  
Motor Vehicle Crash Diagram

144 Crash Diagram (NOT TO SCALE)

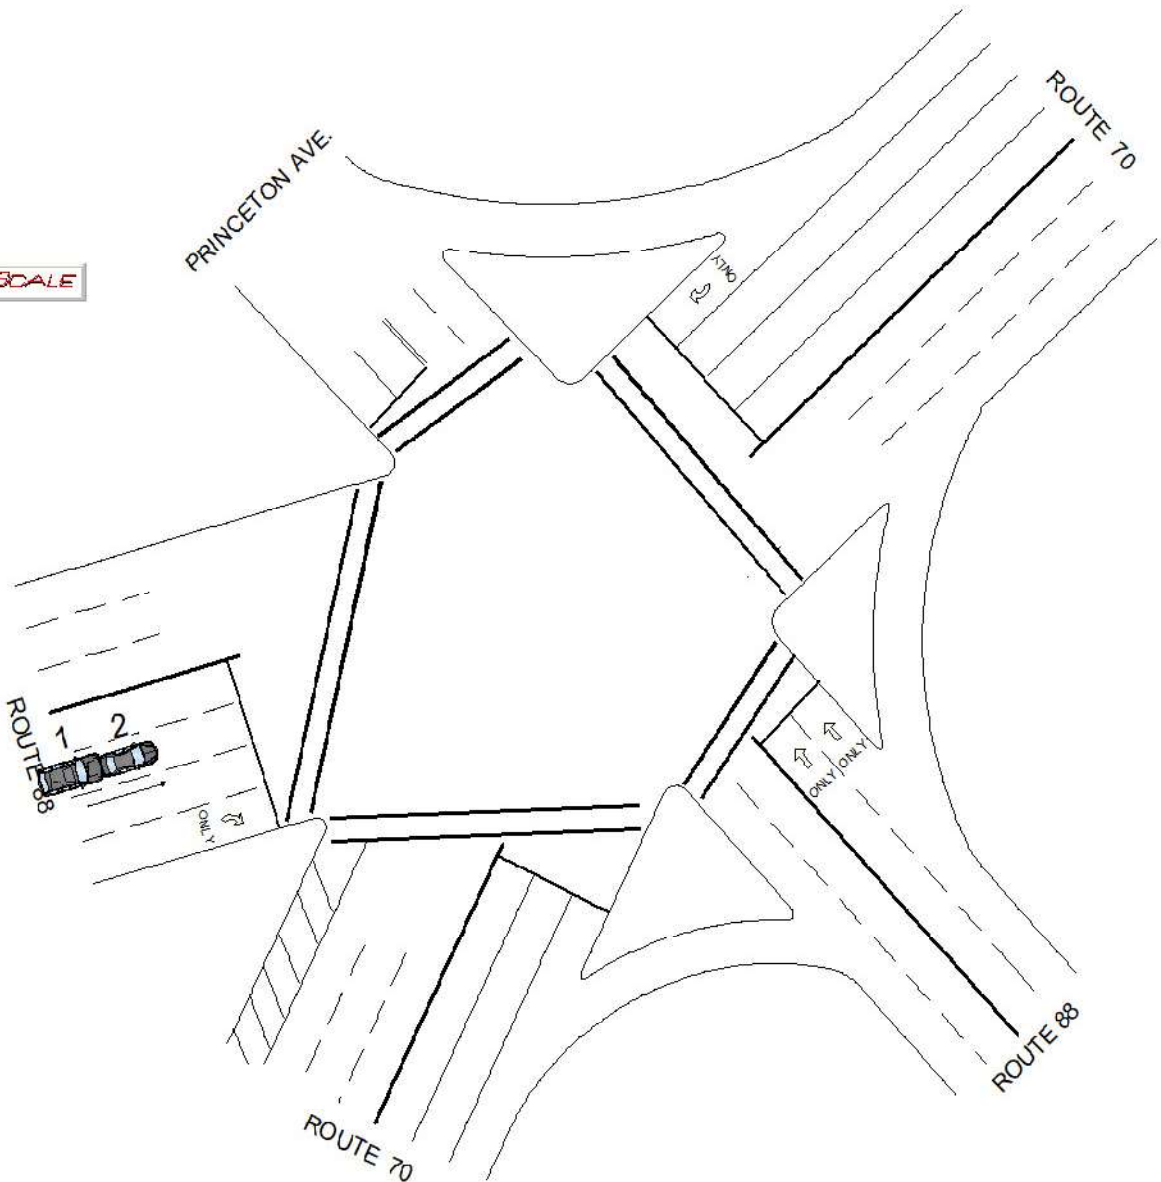
Vehicle 1 was driving west on route 88 in the middle travel lane approximately 25 feet east of Route 70. Vehicle 2 was directly behind Vehicle 1. Vehicle 2 had to stop abruptly prior to the intersection and Vehicle 1 struck the rear bumper of Vehicle 2.

Vehicle 1 had minor damage to the front license plate and Vehicle 2 had a couple of scratches and a puncture hole in the rear bumper. Based on the statements made and the facts of my investigation, The driver of Vehicle 1 is at fault for the accident.
