| New Jersey Police<br>Crash Investigation Report | | | | | | | | | | | | Case Number<br>2021-00051387 | | | Page 2 of 4 | |

New Jersey Police Crash Investigation Report  
Motor Vehicle Crash DescriptionPolice Dept: Brick Police Code: 01Station: — Case No: 2021-00051387

New Jersey Police Crash Investigation Report  
Motor Vehicle Crash Diagram

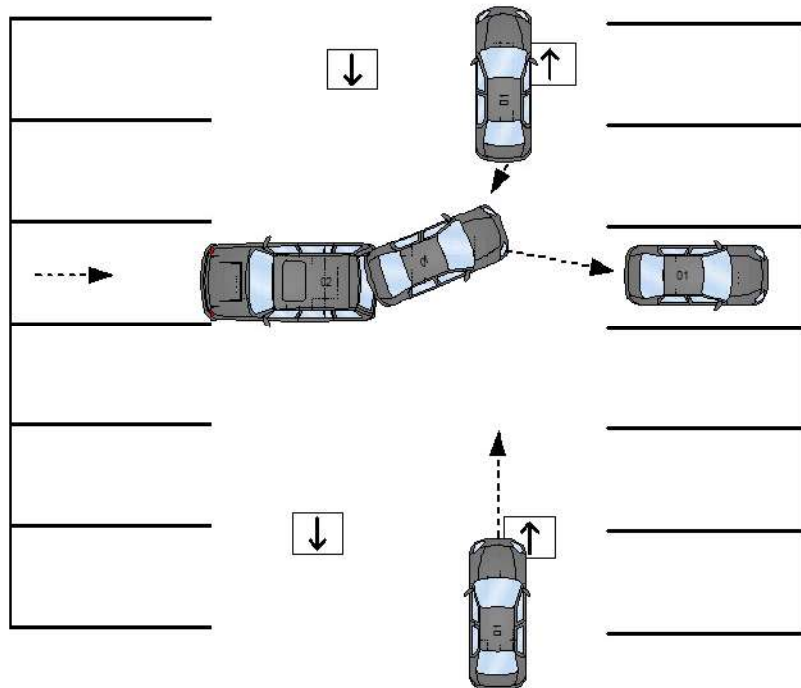
144 Crash Diagram (NOT TO SCALE)

Vehicle #1 was traveling west toward the front of the store and then comes to a sudden stop. It appears driver #1 passed a vacant parking stop on his passengers side and decided to put vehicle #1 in reverse to back up and then pull into the parking spot. As vehicle #1 passed the vacant parking spot, vehicle #1 also passed vehicle #2 that was directly across from that vacant spot. So when driver #2 stated she did not see vehicle #1 behind her vehicle is because vehicle #1 already passed the back of her vehicle. When driver #1 started to back up, driver #2 started to back up, and the left lower bumper of vehicle #1 collided into the rear right bumper area of vehicle #2. After observing the accident on the security camera, it was determined driver #1 to be at fault due to his unsafe backing after he passed the vacant spot he proceeded to reverse his vehicle which ultimately caused the crash.

It is being noted that Driver #1 was asked several times on Body worn camera if he was backing up or parking and he said no.
