| New Jersey Police<br>Crash Investigation Report | | | | | | | | | | | | Case Number<br>2018-00074948 | | | Page 2 of 3 | |

New Jersey Police Crash Investigation Report  
Motor Vehicle Crash Diagram

Case No: 2018-00074948

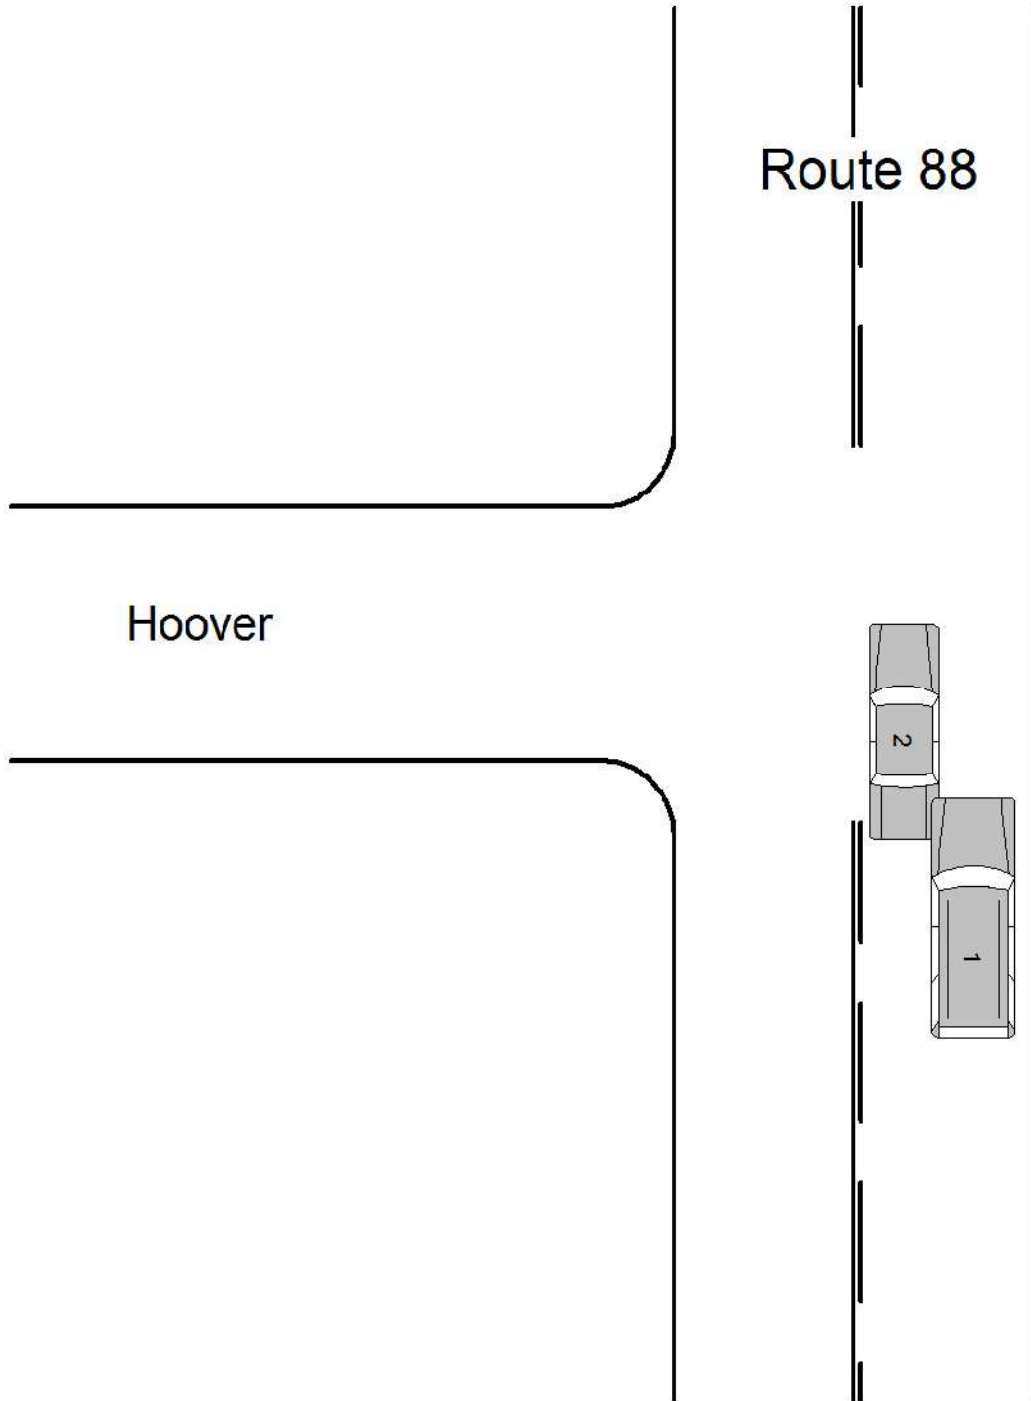
144 Crash Diagram (NOT TO SCALE)

Vehicle #1 was traveling East on Route 88. Vehicle #2 was stopped in traffic waiting to make a left turn onto Hoover Street. The front driver side of Vehicle #1 struck the rear passenger side of Vehicle #2.

Driver #2 stated she was completely stopped in traffic for some time waiting to make the left turn when she was suddenly struck in the rear passenger side by Vehicle #1. Driver #2 further advised that Vehicle #1 continued up the roadway shortly before pulling over and stopping on the shoulder. The damage to both vehicles was consistent with that of Driver #2's account.

Based upon my observations, and statements made by both parties, I find driver #1 at fault for colliding with Vehicle #2.
