# Main Inspections Pipe Run

| <b>10/21/21 KEYPORT 3RD ST STORM</b> | <b>KEYPORT 3RD ST CB T11 TO ST T10</b> | <b>KEYPOT NJ</b> | <b>3RD ST</b> |

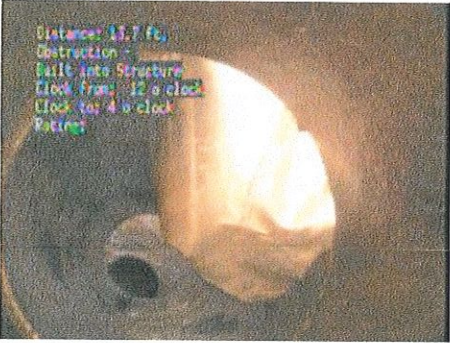
| Distance | Dir. | Length | From/To | Code | Modifier/Severity | Rating | Comments |
|---|---|---|---|---|---|---|---|
| 13.7 ft. | D | 1.9 ft. | 12 / 4 | Obstruction | Built into Structure | | |

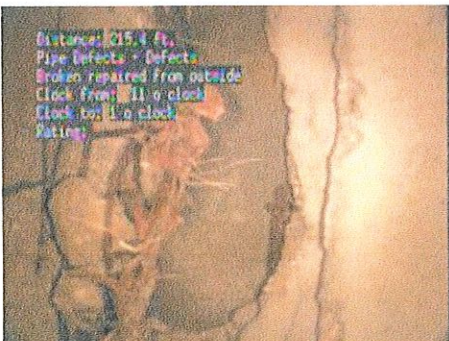
| Distance | Dir. | Length | From/To | Code | Modifier/Severity | Rating | Comments |
|---|---|---|---|---|---|---|---|
| 215.4 ft. | D | | 11 / 1 | Pipe Defects | Broken repaired from<br>outside | | |

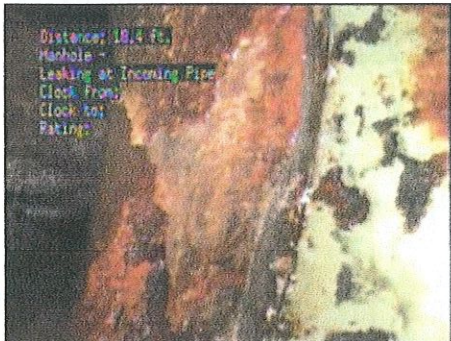
| Distance | Dir. | Length | From/To | Code | Modifier/Severity | Rating | Comments |
|---|---|---|---|---|---|---|---|
| 18.4 ft. | D | | / | Manhole | Leaking at Incoming<br>Pipe | | |
