Proposal for Professional Services  
Township of Toms River Municipal Parking Garage  
Toms River, Ocean County, New Jersey  
Colliers Engineering & Design Proposal No.: TRT0015P

## Structural Report

Township Municipal Parking Garage  
Toms River, NJ 08753

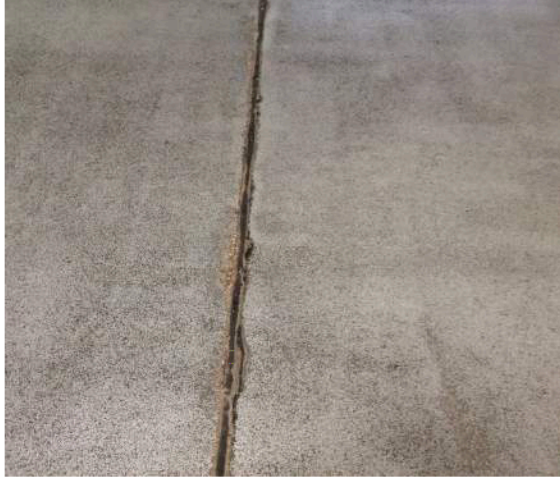
- Compressible filler joints between some edges of the "T" beams are missing or worn thin (see Photo #U1). The deteriorated filler is due to normal wear and tear and aging of the building.

**Photo #U1 – Joint at “T” Beams**

- Deteriorated filler in joints is allowing water infiltration through the levels. The deteriorated compressible fillers between the beam joints should be scraped out and replaced with new compressible filler for the full length of the joint.

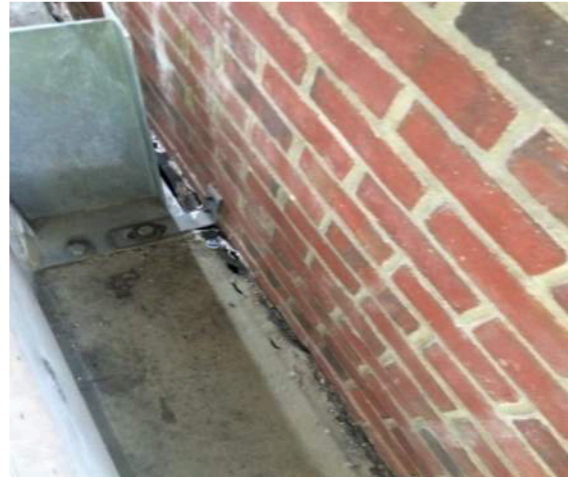
- Compressible filler joints around the perimeter of the slab and the exterior walls are missing or worn thin (see Photo #U2). The deteriorated filler is due to normal wear and tear and aging of the building.

**Photo #U2- Joint at Perimeter Slab & Walls**

- The compressible filler at the joints around the perimeter of the slab and the exterior walls should be scraped out and replaced with new compressible filler for the full length of the joint.

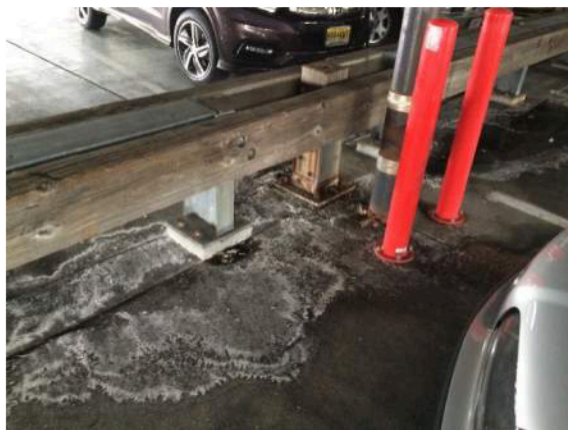
- Compressible filler joints down the center of the slab is missing or worn thin (see Photo #U3). The deteriorated filler is due to normal wear and tear and aging of the building.

**Photo #U3 – Joint at Center**

- The deteriorated compressible fillers down the center of the level at joints on both sides of the guardrails should be scraped out and replaced with new compressible filler for the full length of the joints.

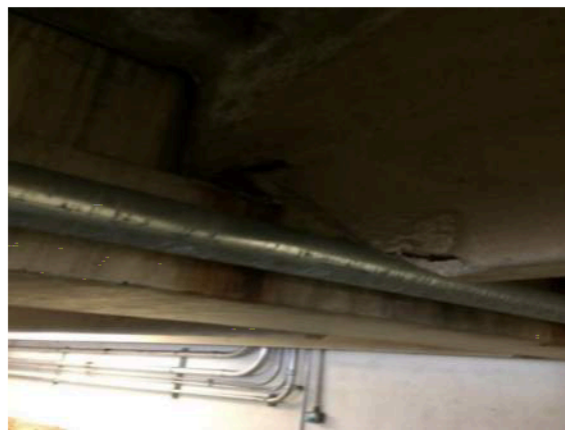
- Spalling concrete was observed at some of the inverted "T" girders, the "T" beams, the columns and corbels. The concrete spalling is due to rusting of the member's rebar which was caused by water infiltration. In addition, at some areas, the bearing plates at the ends of the "T" beams and the "T" girders are also rusting due to water infiltration (see Photo #U4 & #U5).

**Photo #U4- Spall in “T” Girder & Beam**

- The spalling concrete at the girders, beams, columns and corbels should be cleaned out and all loose concrete removed. Any exposed rusted rebar should be scraped clean of rust, reinforced where needed and coated with a protective application. The spalled areas should then be patched with a concrete patching mortar to restore the same profile of the original member. The rusted bearing plates at the ends of the beams and girders should be scraped clean of rust and painted with a protective coating.

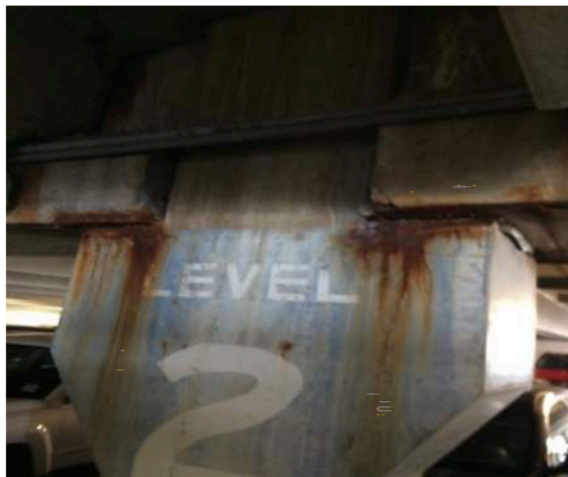
**Photo #U5 – Spall at Col./Corbel**

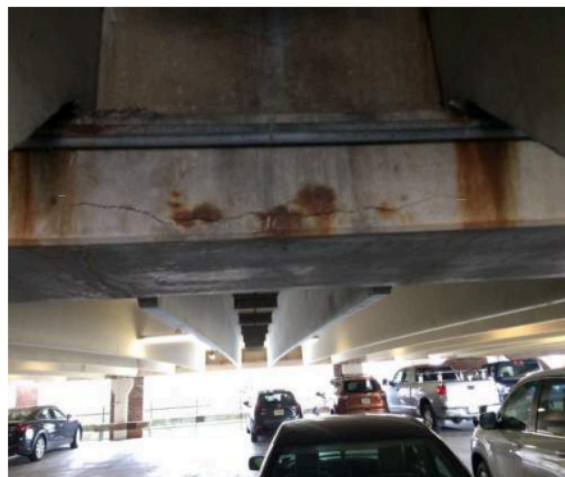
- Cracks in the concrete inverted "T" girders, the "T" beams, the column corbels, and at the top slab stair railing were observed (see photo #U6 - #U8). This is due to rusting of the reinforcement on the interior of the members. The rust is caused by water infiltration.

**Photo #U6- Crack in “T” Girder**

- Cracks in the concrete girders, beams, columns corbels, and at stair rails should be filled solid with an epoxy injection crack repair system and then coated with a surface sealer.

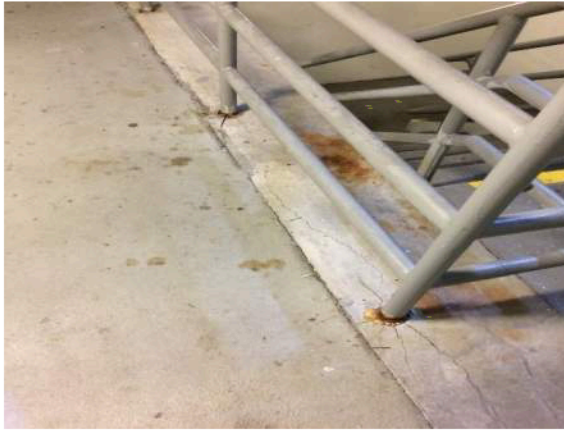
**Photo #U7 – Crack at Stair Railing**

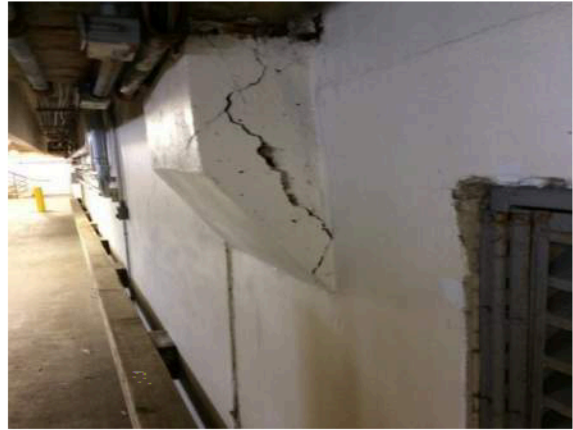
**Photo #U8- Crack at Column Corbel**

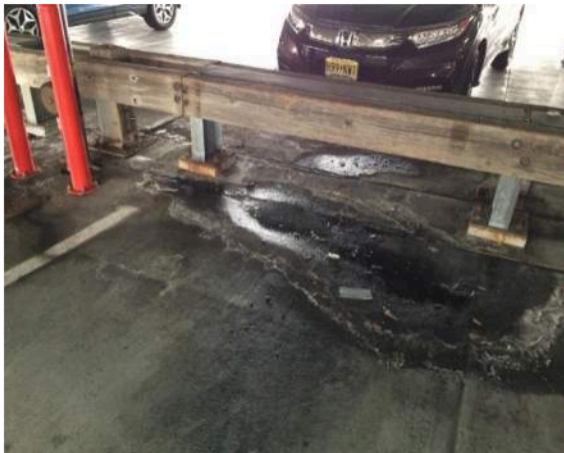
- Water ponding due to poor drainage within the center of the level was observed. This could be due to clogged drains and poor sloping in the topside of the concrete (see Photo #U9 - #U10).

**Photo #U9 – Water Ponding**

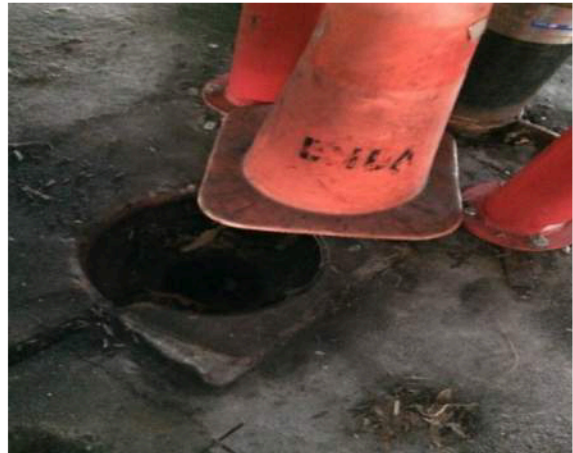
**Photo #U10 – Clogged Drain Pipes**

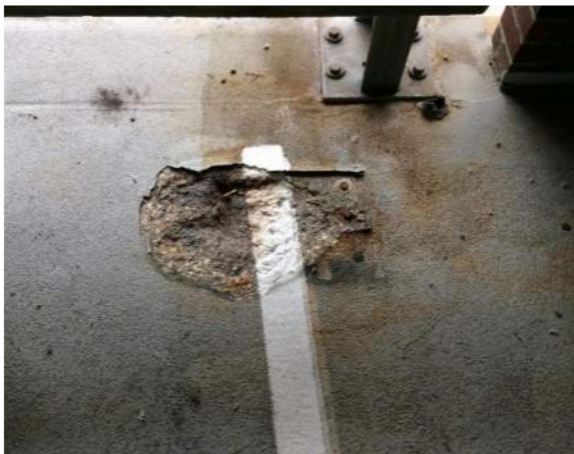
- Bolts remaining from removed lights at the top of the slab were observed. The bolts are starting to rust and could cause future cracking in the concrete (see Photo #U11).

**Photo #U11 – Bolts from Removed lights**

- The abandoned bolts from the removed lights should be removed and the concrete slab at removed bolts area should be patched. The concrete patching procedure should be similar to the concrete spall repair at the girders, beams, columns and corbels.

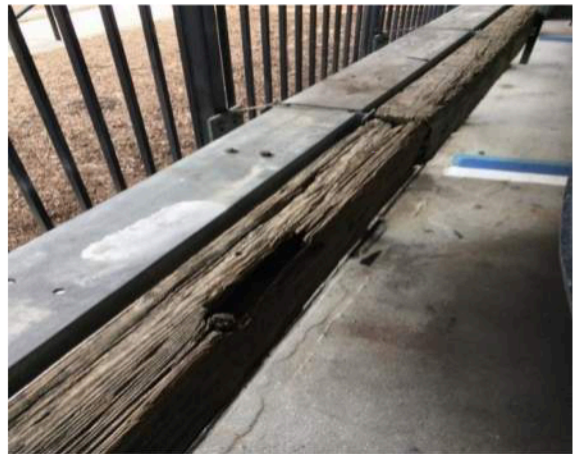
- Some sections of the original timber guardrails around the perimeter and down the center of the level was observed to be rotted or deteriorated (see Photo #U12).

**Photo #U12- Rotted Timber Guardrail**

- The deteriorated timber guardrails sections should be removed and replaced with similar timber ties. The new ties can be bolted back to the existing guardrail posts.

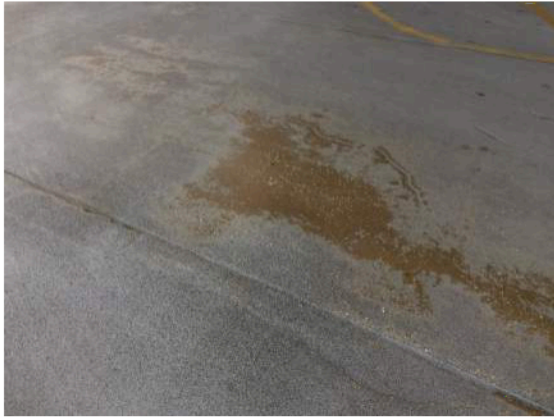
- Traffic surfaces around turn radius were worn down (see Photo #U13).
- Floor drains and drain pipes have signs of rust (see Photo #U14).
- Some areas of the newer steel that were part of the 2011 renovation show signs of minor rust (see Photo #U15).
- Cracks in the brick mortar joints were observed at some of the exterior wall piers (see Photo #U16).
- The material in the building expansion joints at the entrance and middle of the building are deteriorated due to wear and tear (see Photo #U17).

**Photo #U13 – Worn Down Traffic Surface**

- Worn down traffic surfaces should be scraped clean from the top of the slab and a new traffic coating surface should be applied.
- Rust on floor drains and drain pipes should be scraped off and the drains and pipes should be cleaned and repainted with an exterior paint suitable for application to steel.
- The minor rust areas of the new steel columns should be scraped and cleaned. After cleaning the areas should be touched up with zinc rich paint.
- Cracks in the brick mortar joints should be routed out and repointed or patched.
- The expansion material for the building expansion joints at the entrances and middle of the building should be cleaned out and replaced for the full length of the joints.
- After completion of the recommended repairs, the entire floor level should be power washed.

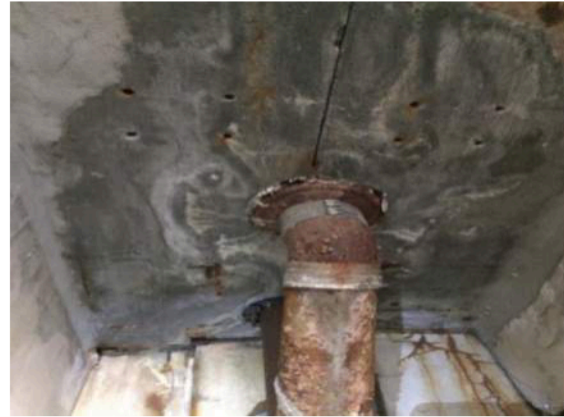
**Photo #U14- Rusted Floor Drain and Pipes**

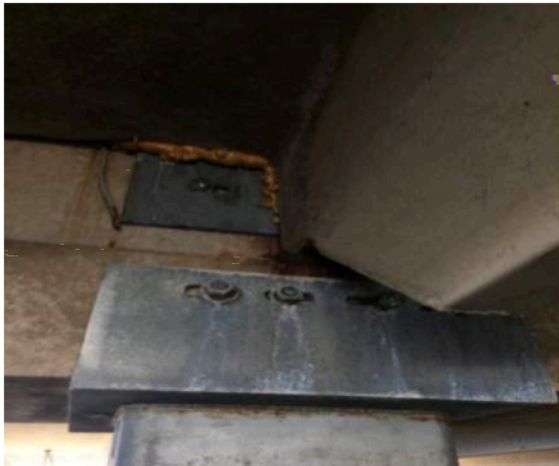
**Photo #U15 – Minor Rust at New Steel**

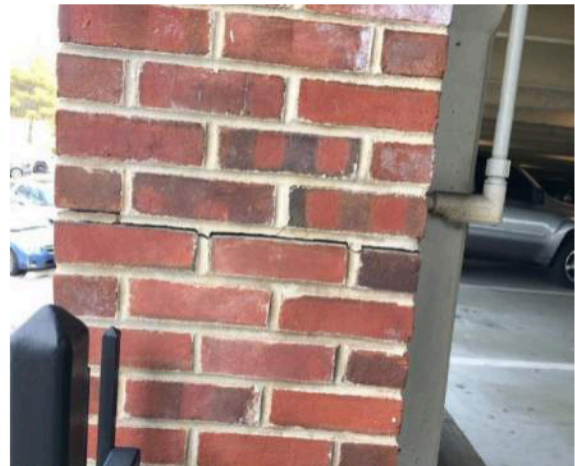
**Photo #U16 – Joint Crack in Exterior Brick**

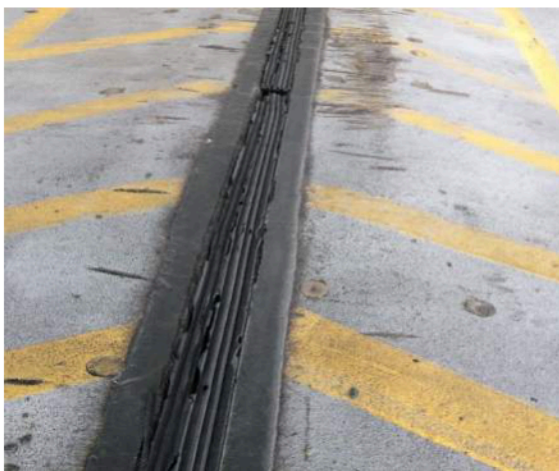
**Photo #U17 – Deteriorated Expansion Joint**

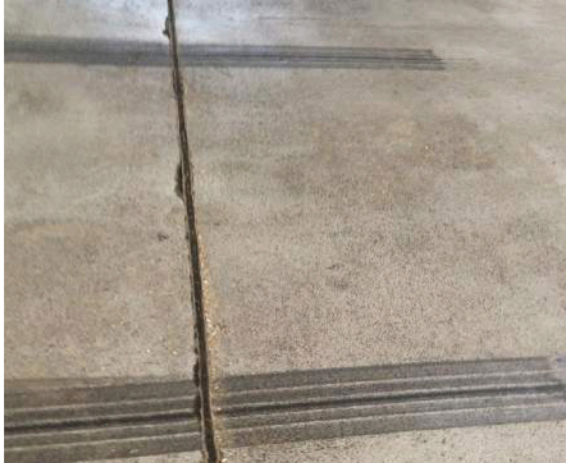
- Compressible filler joints between some edges of the "T" beams are missing or worn thin (see Photo #M1). The deteriorated filler is due to normal wear and tear and aging of the building.

**Photo #M1 – Joint at “T” Beams**

- Deteriorated filler in joints is allowing water infiltration through the levels. The deteriorated compressible fillers between the beam joints should be scraped out and replaced with new compressible filler for the full length of the joint.

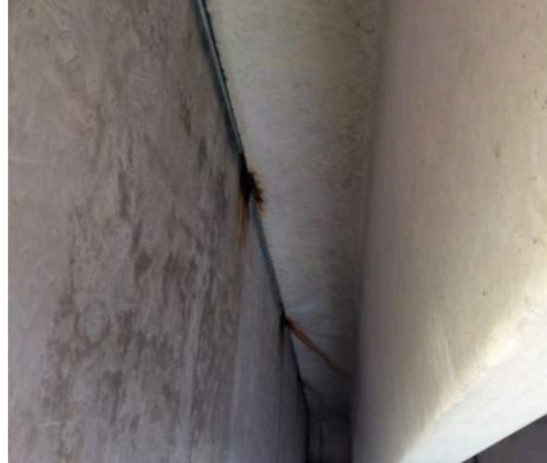
- Compressible filler joints around the perimeter of the slab and the exterior walls are missing or worn thin (see Photo #M2). The deteriorated filler is due to normal wear and tear and aging of the building.

**Photo #M2- Joint at Perimeter Slab & Walls**

- The compressible filler at the joints around the perimeter of the slab and the exterior walls should be scraped out and replaced with new compressible filler for the full length of the joint.

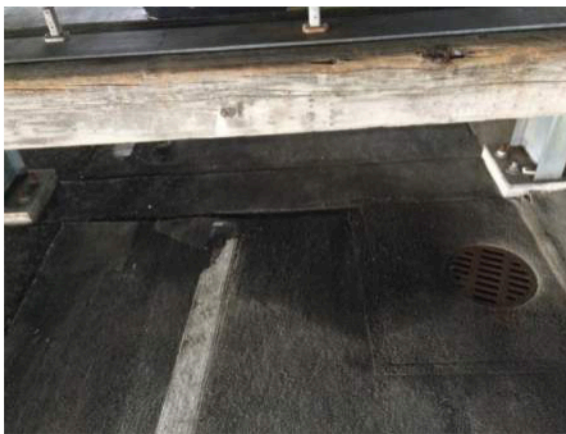
- Compressible filler joints down the center of the slab are missing or worn thin (see Photo #M3). The deteriorated filler is due to normal wear and tear and aging of the building.

**Photo #M3 – Joint at Center**

- The deteriorated compressible fillers down the center of the level at joints on both sides of the guardrails should be scraped out and replaced with new compressible filler for the full length of the joints.

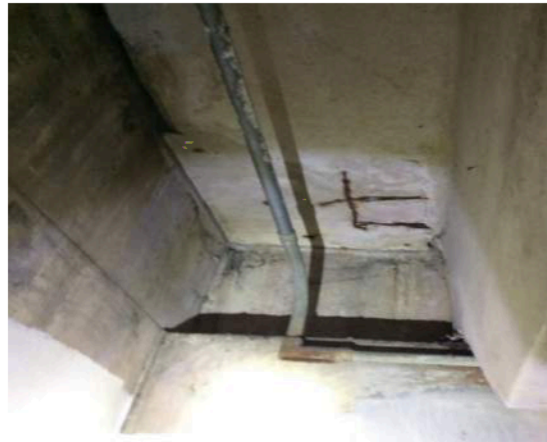
- Spalling concrete was observed at some of the inverted "T" girders, the "T" beams, the columns and corbels. The concrete spalling is due to rusting of the member's rebar which was caused by water infiltration. In addition, at some areas, the bearing plates at the ends of the "T" beams and the "T" girders are also rusting due to water infiltration (see Photo #M4 - #M5).

**Photo #M4- Spall in “T” Beam**

- The spalling concrete at the girders, beams, columns and corbels should be cleaned out and all loose concrete removed. Any exposed rusted rebar should be scraped clean of rust, reinforced where needed and coated with a protective application. The spalled areas should then be patched with a concrete patching mortar to restore the same profile of the original member. The rusted bearing plates at the ends of the beams and girders should be scraped clean of rust and painted with a protective coating.

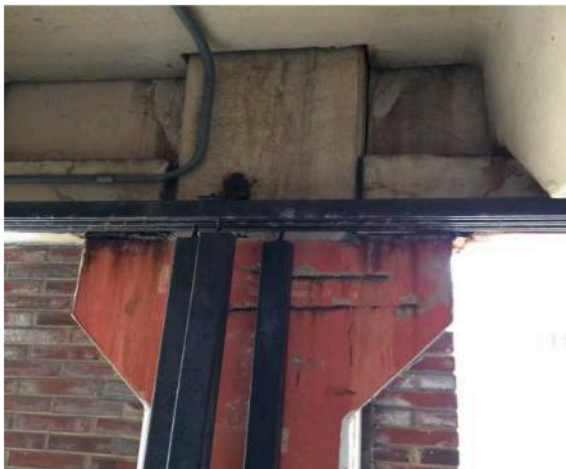
**Photo #M5 – Spall at Col./Corbel**

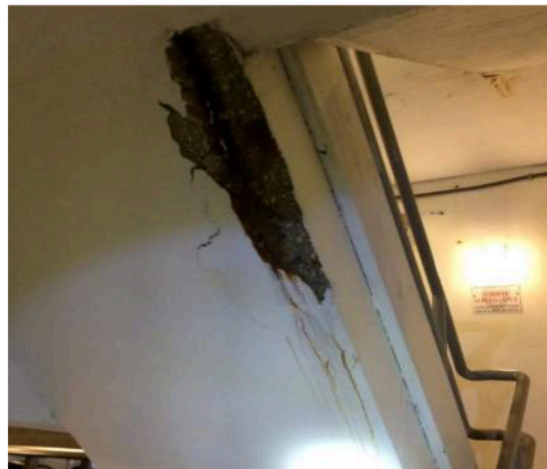
- Spalling concrete and cracks in the concrete were observed at the underside of the stairs on the Northwest corner of the parking garage. The spalling and cracks are caused by rusting of the stairs reinforcement due to water infiltration (see Photo #M6 - #M7).

**Photo #M6- Spall at Stairs**

- The spalling concrete at the stair should be cleaned and patched similar to the procedure for the spalling at the girders, beams, columns and corbels. The cracks in the stair concrete should be filled solid with an epoxy injection crack repair system and then coated with a surface sealer.

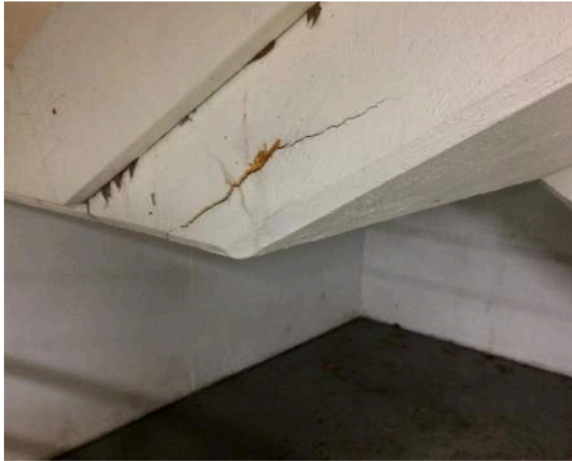
**Photo #M7 – Crack at Stair**

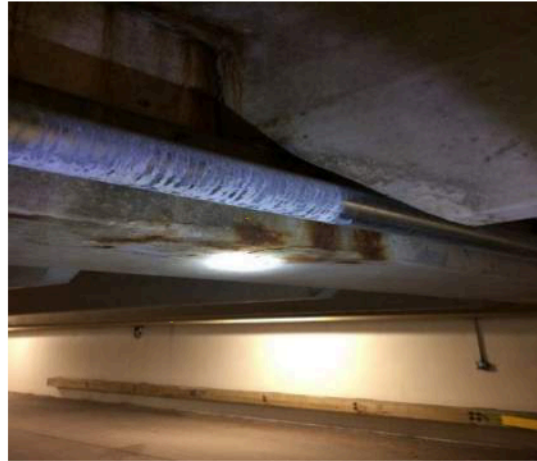
- Cracks in the concrete inverted "T" girders, the "T" beams, the column corbels, and the stairs were observed (see photo #M8 - #M9). This is due to rusting of the reinforcement on the interior of the members. The rust is caused by water infiltration.

**Photo #M8- Crack at “T” Girder and Beam**

- Cracks in the concrete girders, beams, columns and corbels should be filled solid with an epoxy injection crack repair system and then coated with a surface sealer.

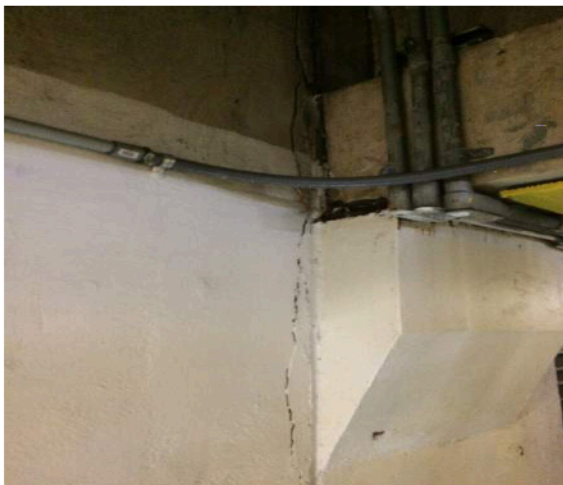
**Photo #M9 – Crack Near Column Corbel**

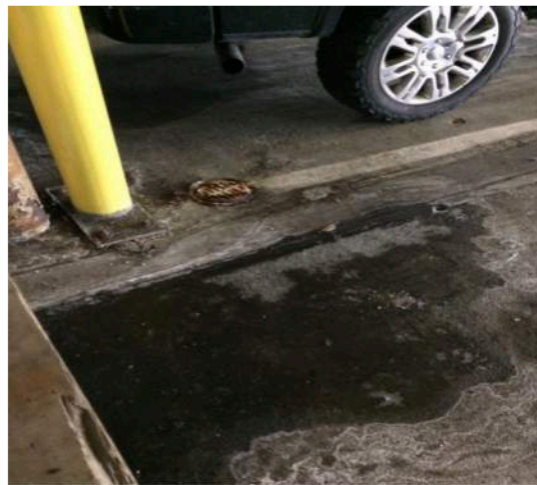
- Water ponding due to poor drainage within the center of the level was observed. This could be due to clogged drains and poor sloping in the topside of the concrete (see Photo #M10 - #M11).

**Photo #M10- Water Ponding**

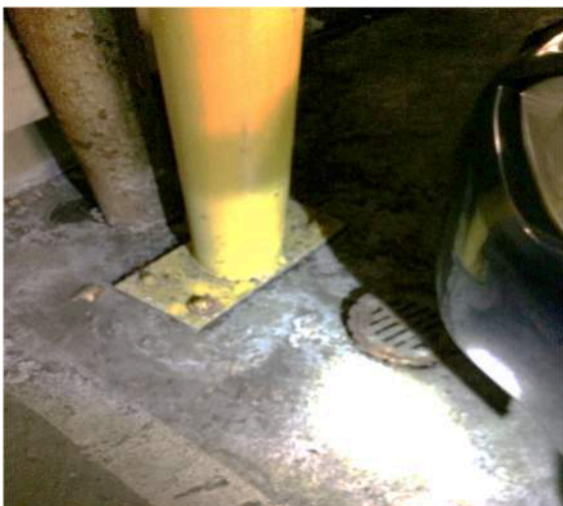
**Photo #M11 – Clogged Drain Pipes**

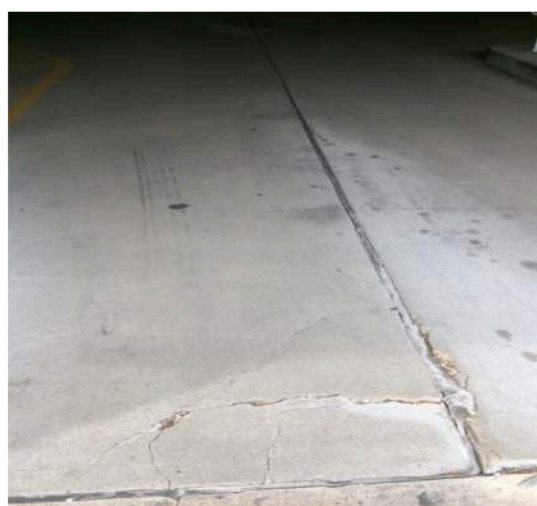
- A cracked section in the “T” beams was observed at the topside of the level at the building entrance. Filler joints around this area are also worn thin and the exterior slab at the face of the entrance seems to have settled in relationship to the parking garage level (see Photo #M12). The crack and thin joints appear to be allowing water into the lower level of the parking garage.

**Photo #M12- Cracking in “T” Beam at Entry**

- In order to match the settlement at the exterior slab, the top surface of the floor slab can be slightly ground down. The crack in the slab at the building entrance needs to be routed out and patched with a concrete patching mortar. The filler in the joints around this area all need to be scraped clean and then the joints can be filled with a new compressible filler. A new traffic surface should be applied over this area to protect the joints, repaired crack and the ground down surface of the floor slab.

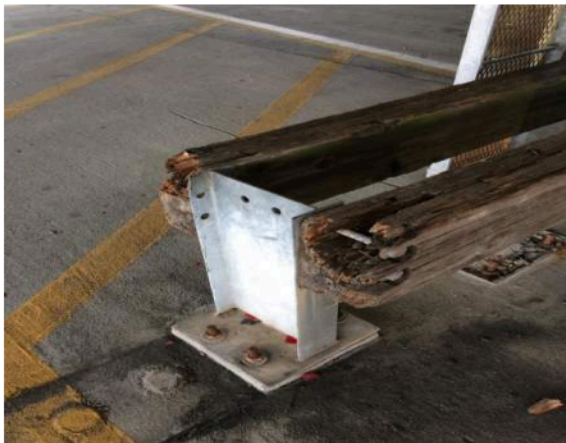
- Some sections of the original timber guardrails around the perimeter and down the center of the level was observed to be rotted or deteriorated (see Photo #M13).

**Photo #M13 – Rotted Timber Guardrail**

- The deteriorated timber guardrail sections should be removed and replaced with similar timber ties. The new ties can be bolted back to the existing guardrail posts.

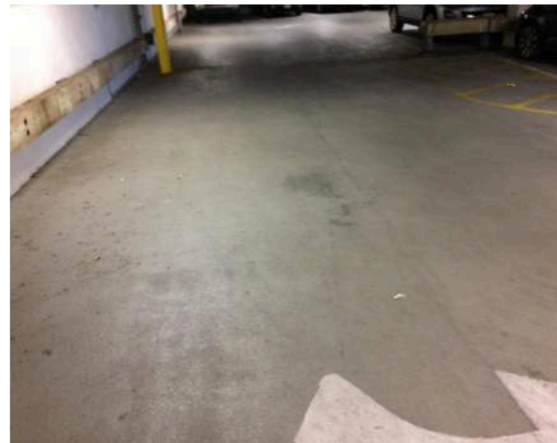
- Traffic surfaces around turn radius were worn down (see Photo #M14).
- Floor drains and drain pipes have signs of rust (see Photo #M15).
- Some areas of the newer steel that was part of the 2011 renovation show signs of minor rust (see Photo #M16).

**Photo #M14 – Worn Traffic Surface**

- Worn down traffic surfaces should be scraped clean from the top of the slab and a new traffic coating surface should be applied.
- Rust on floor drains and drain pipes should be scraped off and the drains and pipes should be cleaned and repainted with an exterior paint suitable for application to steel.

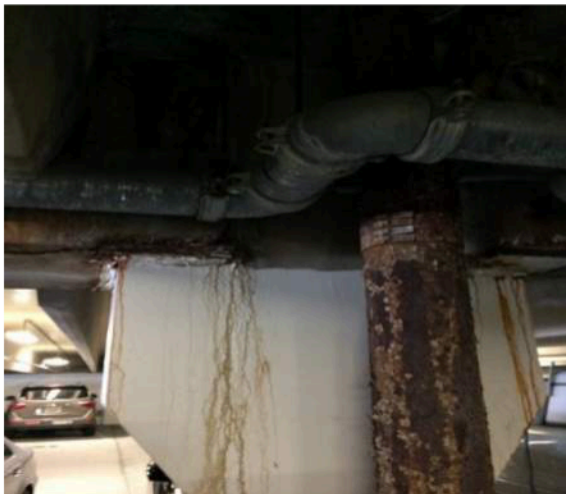
**Photo #M15- Rusty Floor Drain and Pipe**

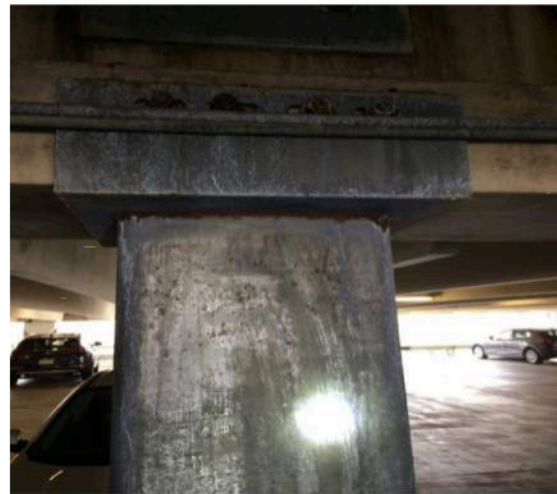
**Photo #M16 – Minor Rust at New Steel**

- The minor rust areas of the new steel columns should be scraped and cleaned. After cleaning, the areas should be touched up with zinc rich paint.
- The expansion material for the building expansion joints at the middle of the building should be cleaned out and replaced for the full length of the joints.

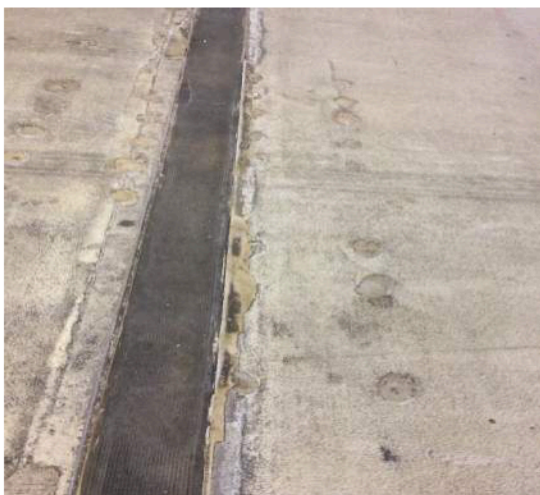
- The material for the building expansion joint at the middle of the building is deteriorated due to wear and tear (see Photo #M17).

**Photo #M15- Deteriorated Expansion Joint**

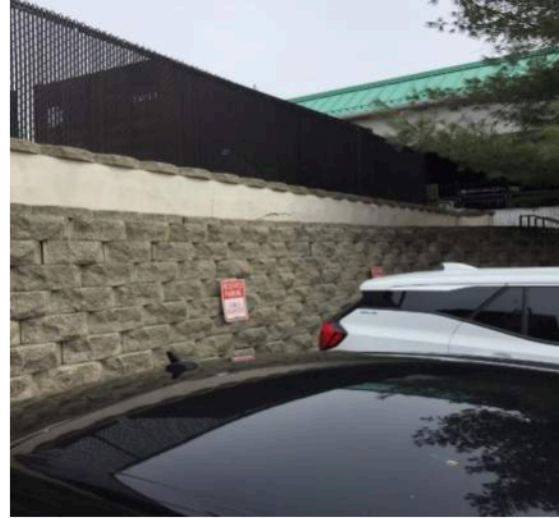
The lower modular block retaining wall appears to be in sufficient structural condition (see Photo R2). However, the upper concrete retaining wall has cracks (see Photo R3) and areas of failing sections in the stucco (see Photo R4) along most of the wall's length. Upon reviewing the condition of the concrete behind the stucco it appears that the concrete is in sufficient structural condition. Only the stucco on the upper retaining wall appears to be failing. Water might be getting trapped behind the stucco finish and freezing and thawing. The freezing and thawing of the water may be causing cracks and failure in the stucco.

**Photo #R2- Lower Modular Block Retaining Wall**

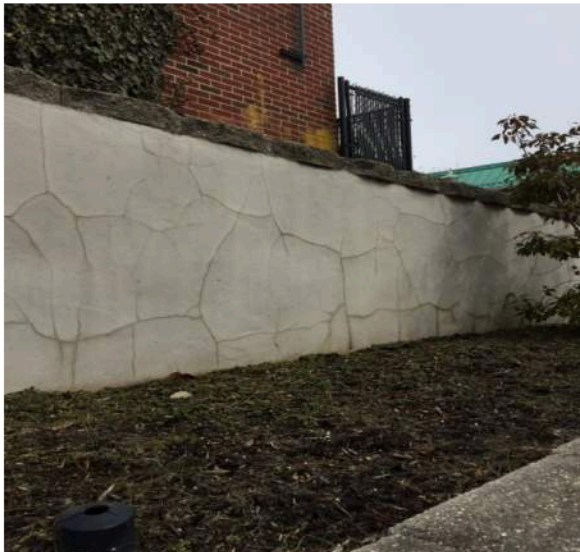
**Photo #R3- Cracking in the Upper Wall Stucco**

At the upper concrete retaining wall, the existing stucco finish should be removed for the full height and length of the wall. A review of the concrete condition of the upper retaining wall will be required upon removal of the stucco finish. It should be assumed that some patching of deteriorated concrete will be required at the exterior face of the retaining wall. New core drilled weep holes through the concrete wall may need to be provided if none are currently present in the wall. After the wall is repaired it should be painted with an exterior painting system that is suitable to be applied to a concrete surface. No repair work on the modular block retaining wall is required at this time.

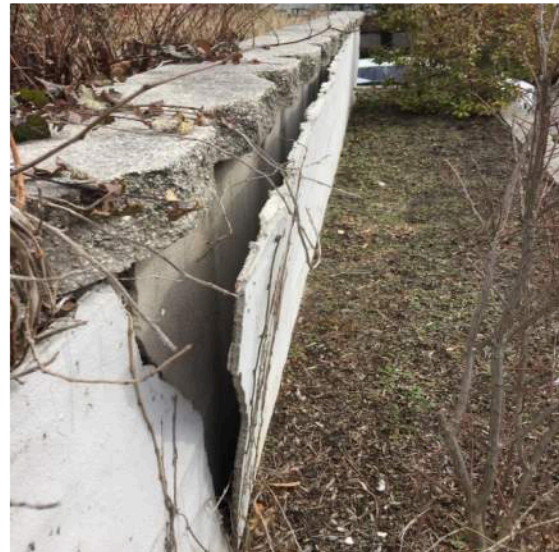
**Photo #R4- Failing Sections in the Upper Wall Stucco**
