## **ASBESTOS ASSESSMENT**

***East Brunswick Public Library  
2 Jean Walling Civic Center Drive  
East Brunswick, New Jersey 08816***

***Project #NJ23-0127***

***June 2023***

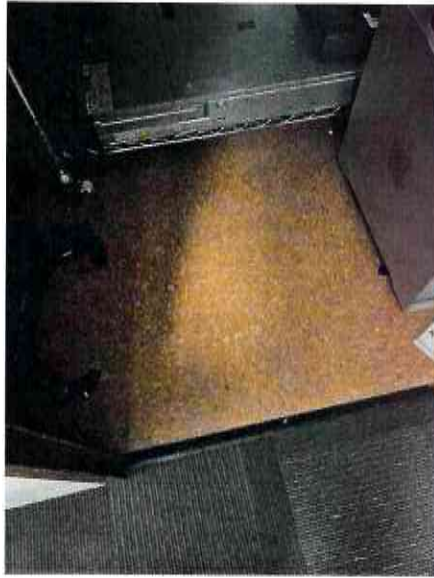
*Storage Room Floor Tile*

| <i>LOCATION</i> | <i>SAMPLE<br/>NUMBER</i> | <i>ASBESTOS<br/>CONTAINING<br/>MATERIAL</i> | <i>ASBESTOS<br/>PERCENTAGE</i> |
|---|---|---|---|
| Meeting Room<br>Storage | EBL-0605-1B | 12" x 12" Floor Tile | 2.00% |
| Meeting Room<br>Storage | EBL-0605-2B | 12" x 12" Floor Tile<br>Mastic | 4.00% |

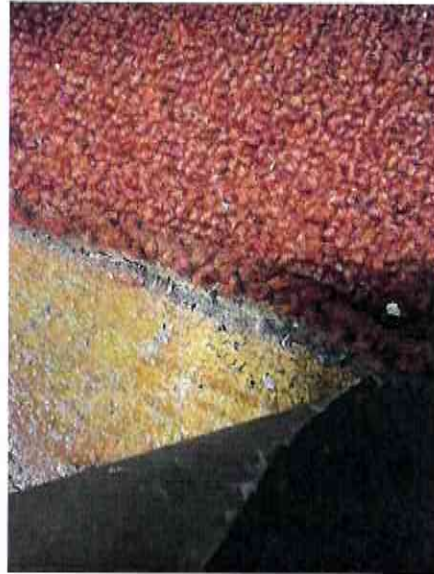
*Floor Area under carpet – No Floor Tile*

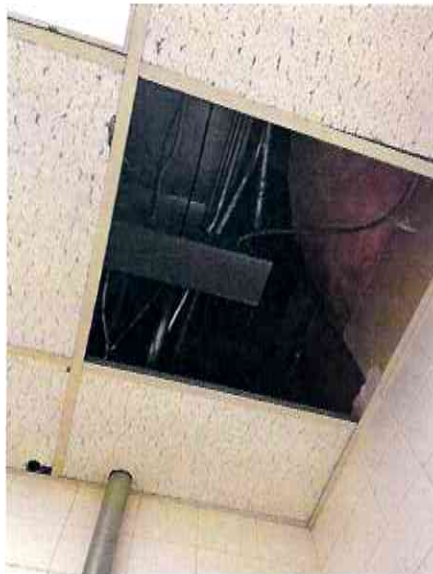
*Plenum Area – Clean Steel Deck*

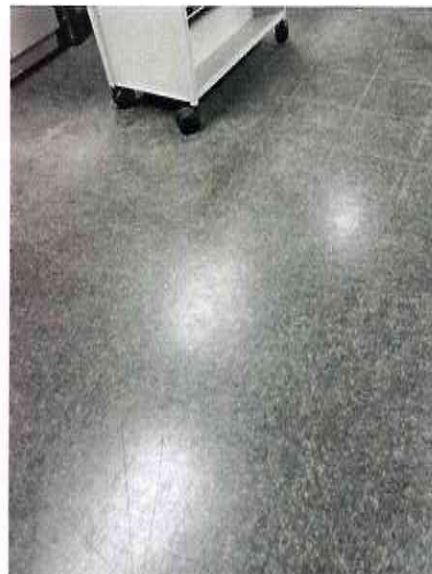
*Circulation Office – Floor Tile*

| 23 | Circulation Office | | 12'X12' brown tile | 2'X4' grid | | ELB-0605-2B |

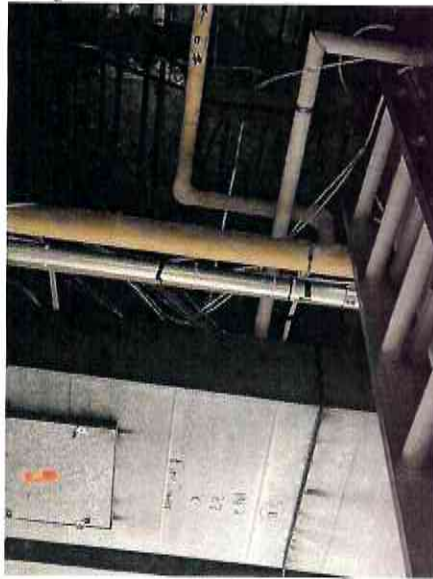
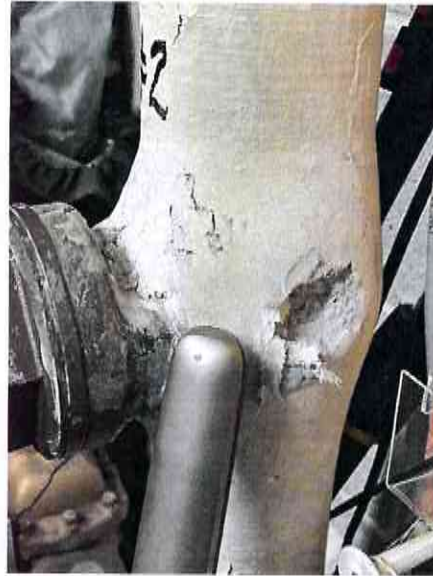
Overall, the asbestos containing materials are the existing floor tile. The visible and accessible piping has fiberglass insulation with non-asbestos containing elbow compound.

*Overhead Pipes – Fiberglass Insulation with Solid Elbows*

**No asbestos, above the EPA standard of <1.0%, was detected in the mechanical room elbow insulation sample. The Laboratory report is attached in the Appendix I.**

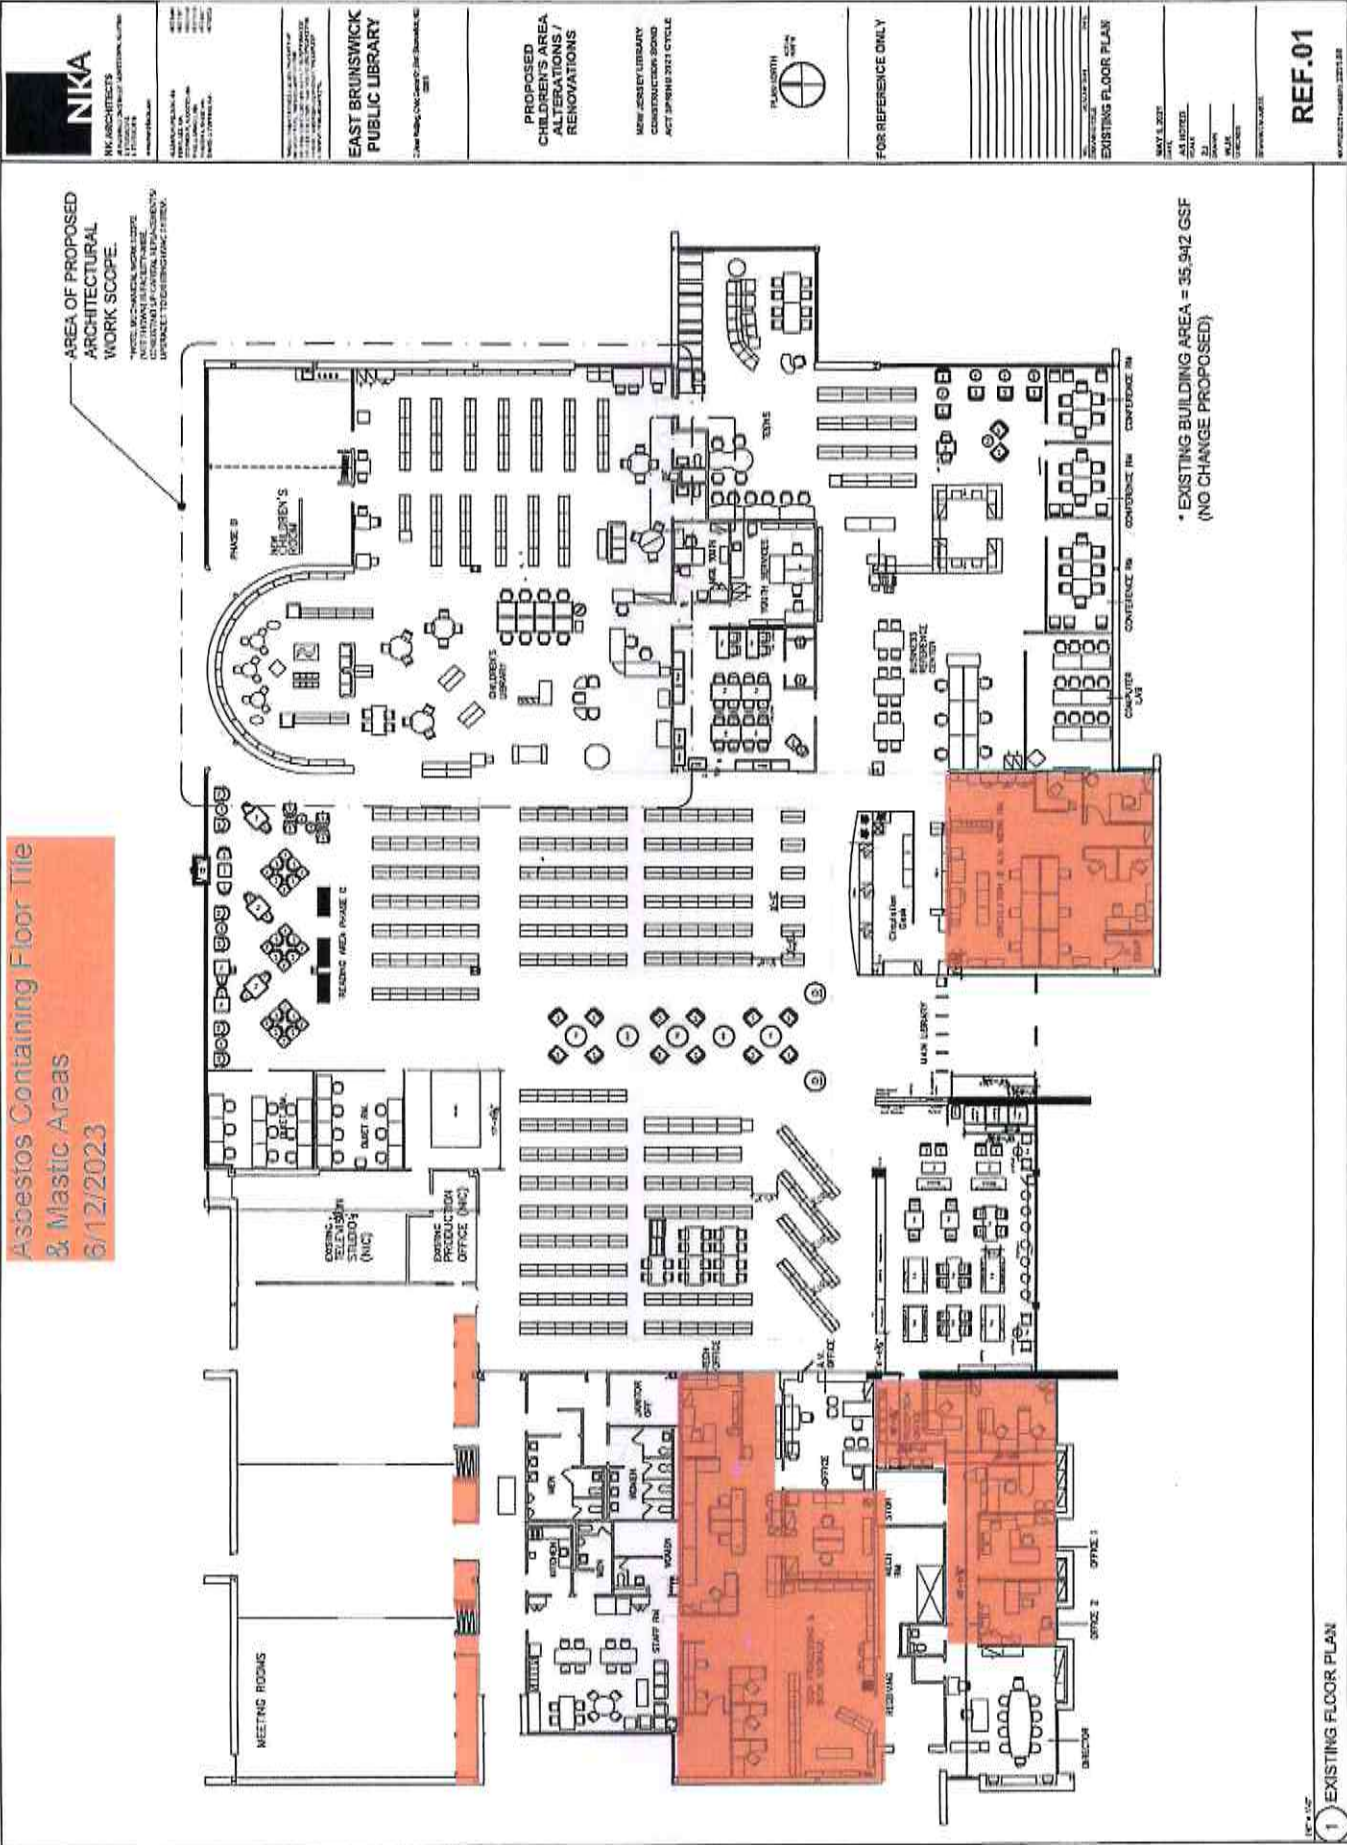
Asbestos Containing Floor Tile  
& Mastic Areas  
6/12/2023

The areas identified as asbestos containing floor tile areas are indicated on the provided site plan.
