To: **INDIVIDUAL SUBSURFACE SEWAGE DISPOSAL SYSTEM REPAIR**

Location: **1262 Bear Tavern Road**

## SEPTIC SYSTEM INSPECTION REPORT

Septic Inspection Summary Letter: 1262 Bear Tavern Road, Titusville, NJ;  
Otherwise known as Hopewell Township, Block: 62, Lot: 4.01.

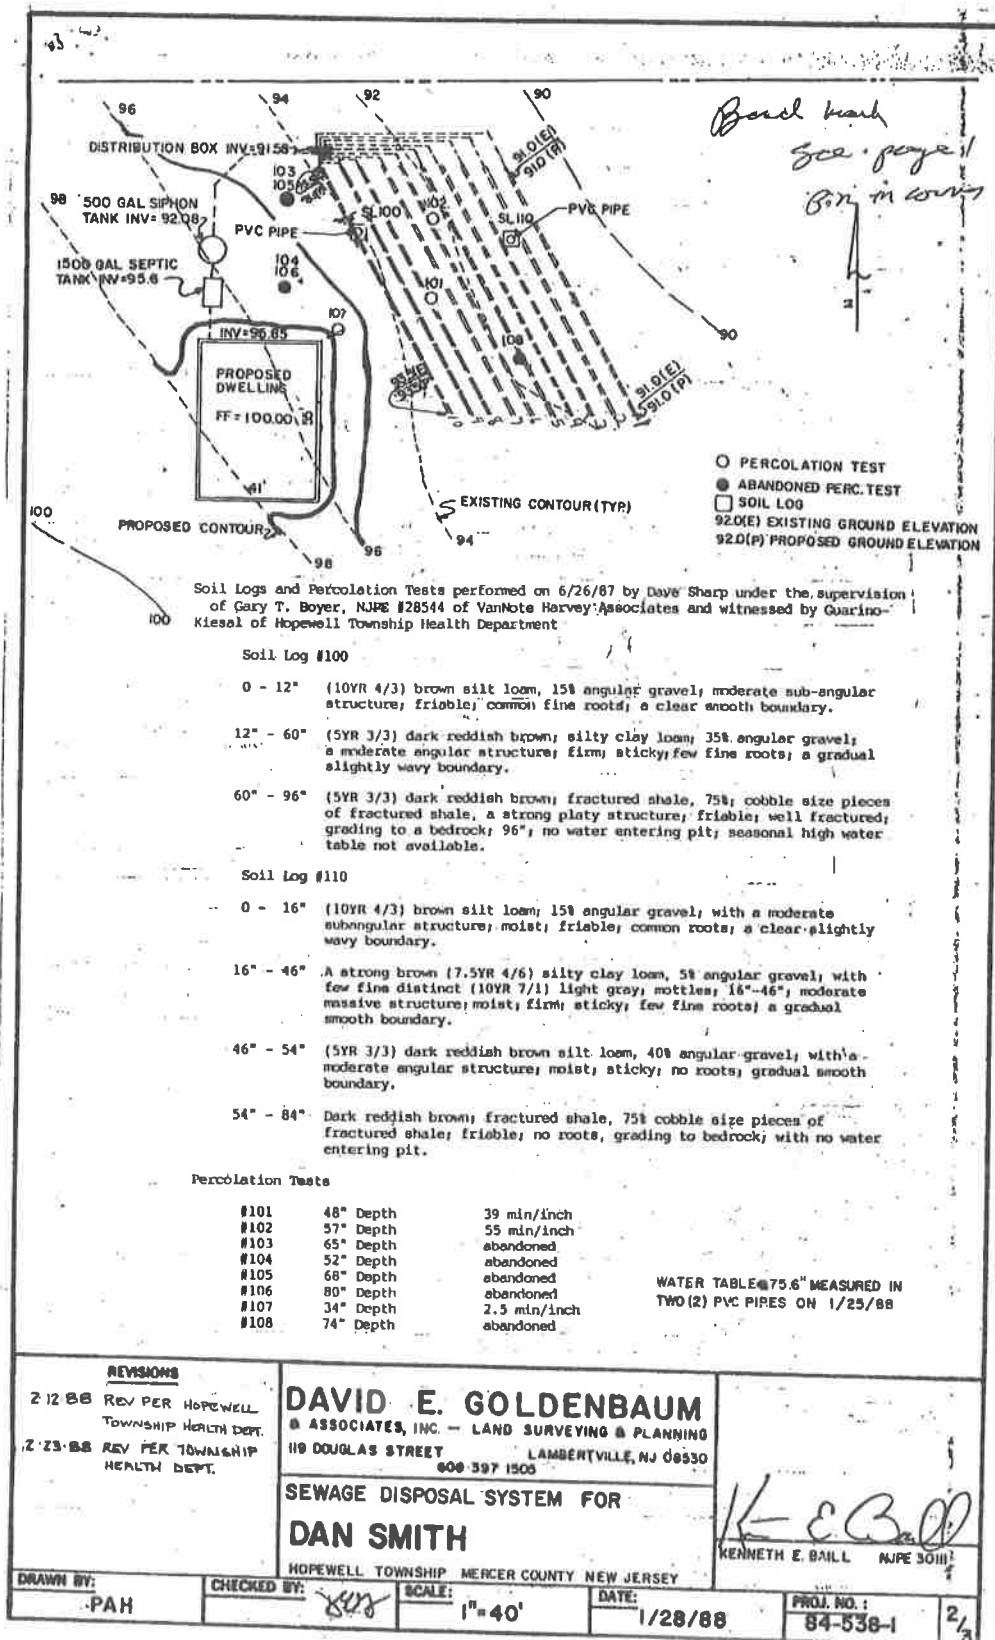
SEPTIC SYSTEM DIAGRAM, for information purposes only.

- The outlet pipe shows no signs of blockage and is in satisfactory condition.
- The distribution box is significantly deteriorated and is leaking wastewater, bypassing the absorption area.

- The tank is made of concrete, there were no signs of cracks or leaks and the water was at a normal operating level.
- The existing 6" tall 24" diameter concrete riser has multiple structural cracks and must be replaced.
- There is no alarm present, which would indicate if the Siphon did not operate and the waste-water level is rising, eventually leading to a back-up.

- The septic tank has a concrete lid that is buried. It is required that all access lids be brought up to the surface and they must be secured shut. Installing a 12" tall, 24" diameter poly riser is recommended, with a 24" poly lid.
- The existing riser located on the siphon tank has multiple structural cracks and must be replaced. Installing a 6" tall, 24" diameter poly riser with a 24" poly lid is recommended.
- The existing, 15-hole concrete distribution box is no longer holding water, as designed, and must be replaced.
- The laterals show accumulations of sewage sludge and must be jet-washed to clean them out.
