**TOWNSHIP of HOPEWELL**  
**MERCER COUNTY**  
**DEPARTMENT of HEALTH**

**APPLICATION FOR LETTERS OF REVIEW**

Block 99.03 Lot 3 Street Address 11 River Knoll Dr. Titusville  
Check One: ☒ Sale of Property ☐ Rental of Property ☐ Change in Use Settlement Date 3-30-16

Project Name: 11 River Knoll Dr

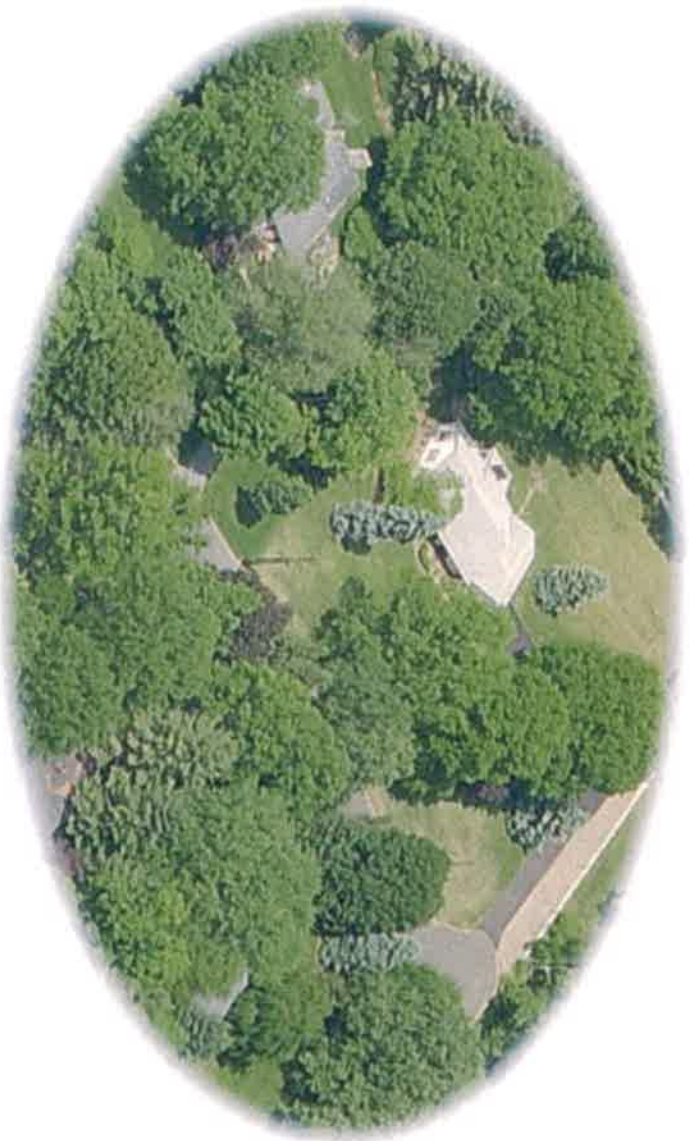
FOR

The attached site sketch presents the location of the primary septic system components. The septic system is comprised of a 1,000 gallon concrete septic tank and a disposal filed consisting of 5 laterals in a gravel bed. An onsite well provides the property with potable water. The water supply is currently fitted with a water treatment system that does backwash into the septic system. The kitchen sink is not equipped with a garbage disposal system at this time. The building is furnished with conventional plumbing fixtures that discharge into a common building sewer that exits the foundation wall at the front of the dwelling.

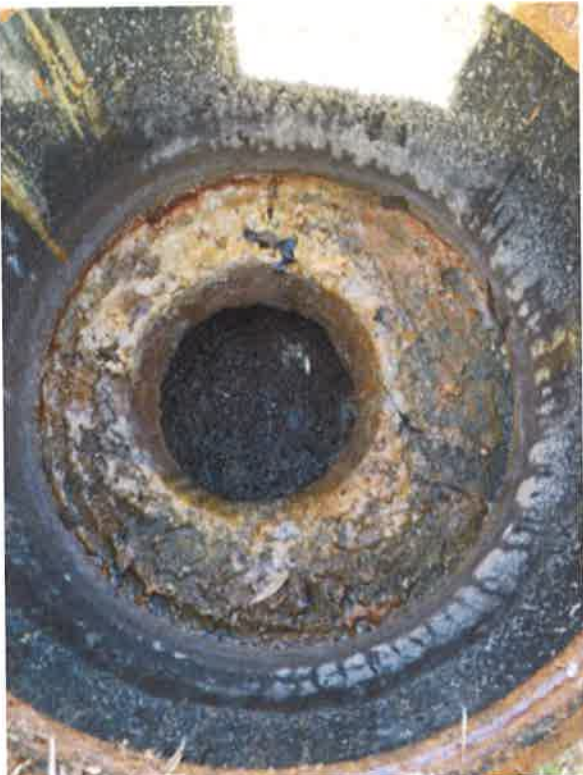
The septic tank manhole cover was removed to inspect the integrity of the tank. The main lid of the tank was found approximately 14" below the ground surface beneath the lid inside the riser. Minor evidence of past sludge surfacing above the top may have been caused by a previous clog in cast iron piping. The cast iron piping has been replaced with newer PVC. The liquid level within the tank was found to be at the lip of the outlet pipe. This is considered the correct operating level.

Looking into the manhole. Care should be given to the pumping to make sure all solids are removed, as this opening is only 12" in lieu of the newer tanks having a 24" opening.

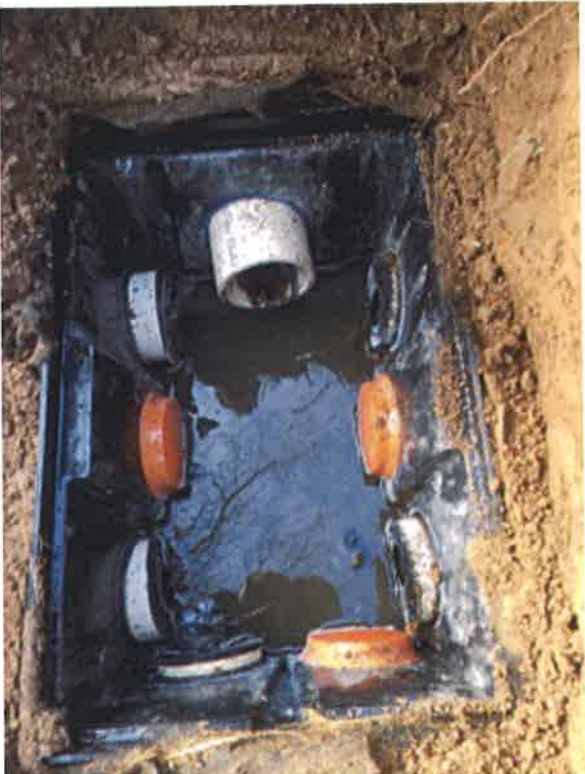
**NEWER PLASTIC D-BOX, AND PVC LINES. THE PVC LINES EXIT THE D-BOX AND ATTACHED INTO THE OLD ORANGEBURG LATERALS. SOME SLUDGE IN THE BOX AND IN THE LATERAL LINES. HOWEVER THE APPROX. 20' x 25' BED CONSISTED OF CLEAN STONE AS WAS DRY. I WOULD RECOMMEND THAT THE LATERAL LINES BE JET-WASHED (PRESSURE CLEANED) TO REMOVE THE BUILD-UP OF SLUDGE.**

Plastic Distribution Box.

Next, the camera was run out the outlets of the distribution box and the interiors of the laterals were observed on the monitor. We noted an accumulation of sludge within the lateral pipes. I recommend that this sludge be cleaned out, utilizing a pressure jet-washing of the lines. The field was probed to assess any saturation. We found the field to be clean and dry. Next a small excavation was made adjacent to the field to confirm the probing.

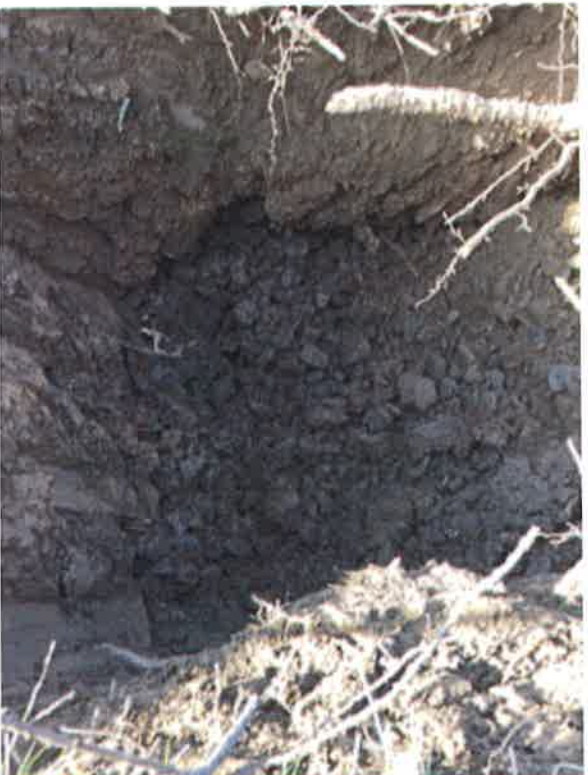
Dry gravel in the disposal area.

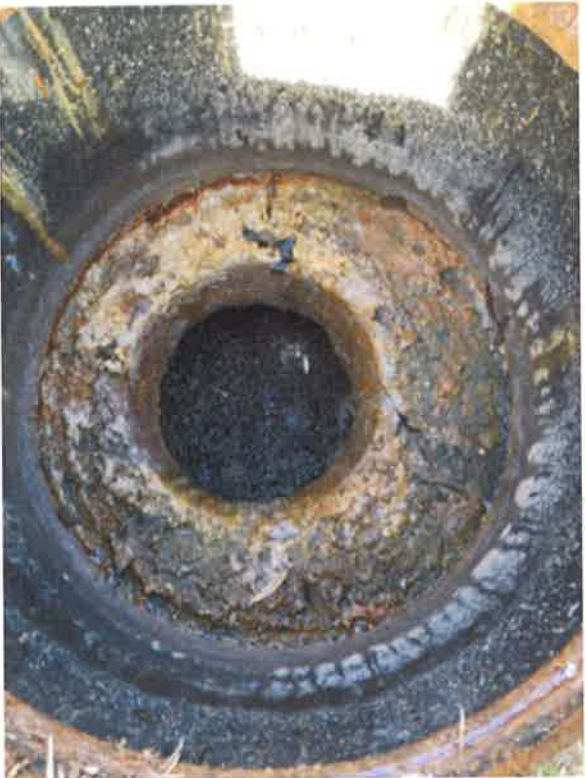
The septic tank manhole cover was removed to inspect the integrity of the tank. The main lid of the tank was found approximately 14" below the ground surface beneath the lid inside the riser. Minor evidence of past sludge surfacing above the top may have been caused by a previous clog in cast iron piping. The cast iron piping has been replaced with newer PVC. The liquid level within the tank was found to be at the lip of the outlet pipe. This is considered the correct operating level.

Looking into the manhole. Care should be given to the pumping to make sure all solids are removed, as this opening is only 12" in lieu of the newer tanks having a 24" opening.

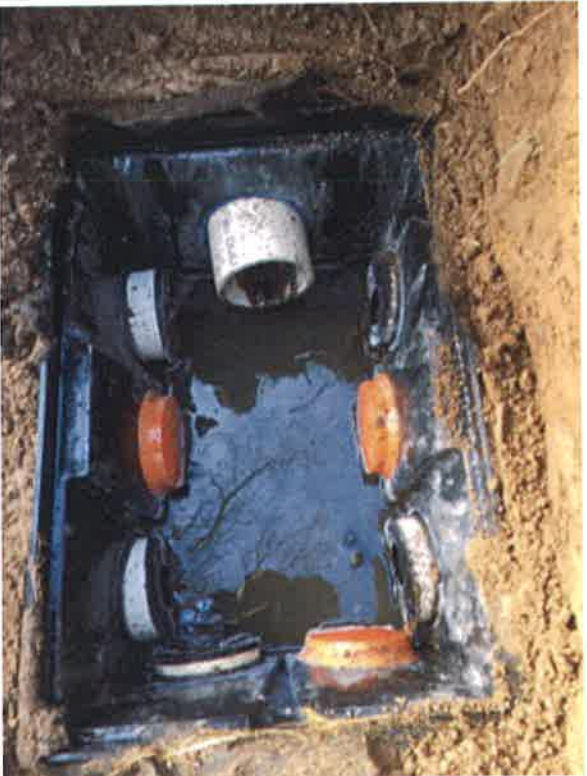
NEWER PLASTIC D-BOX, AND PVC LINES. THE PVC LINES EXIT THE D-BOX AND ATTACHED INTO THE OLD ORANGEBURG LATERALS. SOME SLUDGE IN THE BOX AND IN THE LATERAL LINES. HOWEVER THE APPROX. 20' x 25' BED CONSISTED OF CLEAN STONE AS WAS DRY. I WOULD RECOMMEND THAT THE LATERAL LINES BE JET-WASHED (PRESSURE CLEANED) TO REMOVE THE BUILD-UP OF SLUDGE.

Plastic Distribution Box.

Next, the camera was run out the outlets of the distribution box and the interiors of the laterals were observed on the monitor. We noted an accumulation of sludge within the lateral pipes. I recommend that this sludge be cleaned out, utilizing a pressure jet-washing of the lines. The field was probed to assess any saturation. We found the field to be clean and dry. Next a small excavation was made adjacent to the field to confirm the probing.

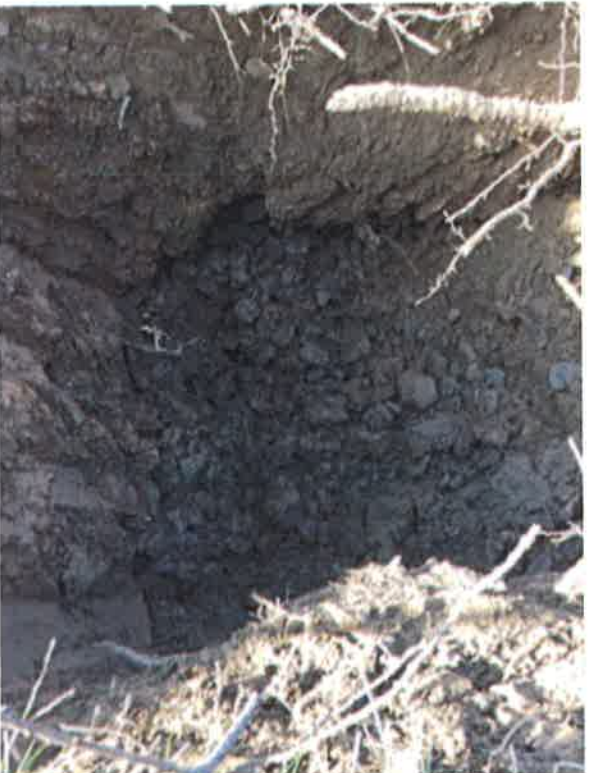
Dry gravel in the disposal area.

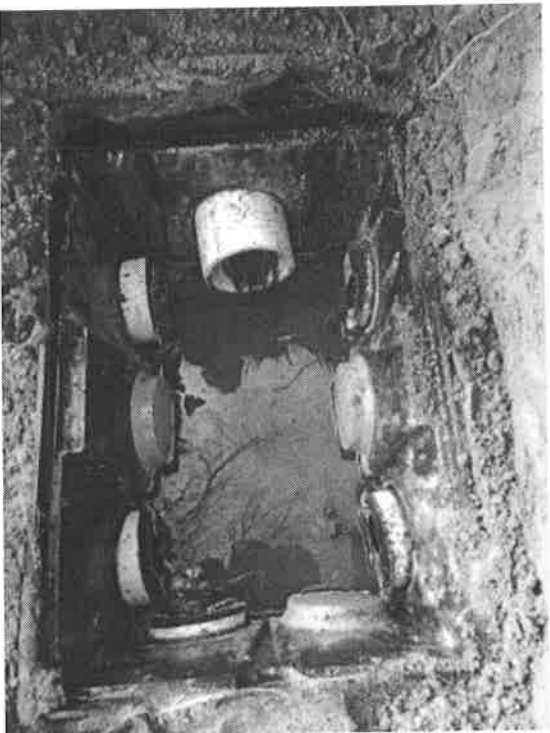
NEWER PLASTIC D-BOX, AND PVC LINES. THE PVC LINES EXIT THE D-BOX AND ATTACHED INTO THE OLD ORANGEBURG LATERALS. SOME SLUDGE IN THE BOX AND IN THE LATERAL LINES. HOWEVER THE APPROX. 20' x 25' BED CONSISTED OF CLEAN STONE AS WAS DRY. I WOULD RECOMMEND THAT THE LATERAL LINES BE JET-WASHED (PRESSURE CLEANED) TO REMOVE THE BUILD-UP OF SLUDGE.

Plastic Distribution Box.

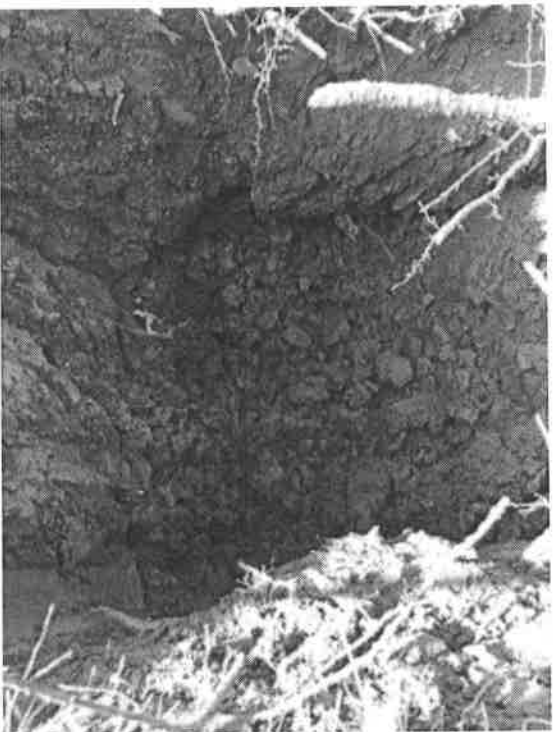
Dry gravel in the disposal area.
