# **E C L E C T I C ARCHITECTURE LLC**

## **MEETING MINUTES**

Project: Mount Bethel Methodist Church Phase II  
Meeting Date: **December 11, 2018**  
Location: site meeting  
Preparation Date: December 11, 2018  
Re: Project Meeting

**Mount Bethel Methodist Church, Phase II Repairs**  
 Township of Mansfield, Warren County, New Jersey  
 100 Port Murray Road, Port Murray, NJ 07865

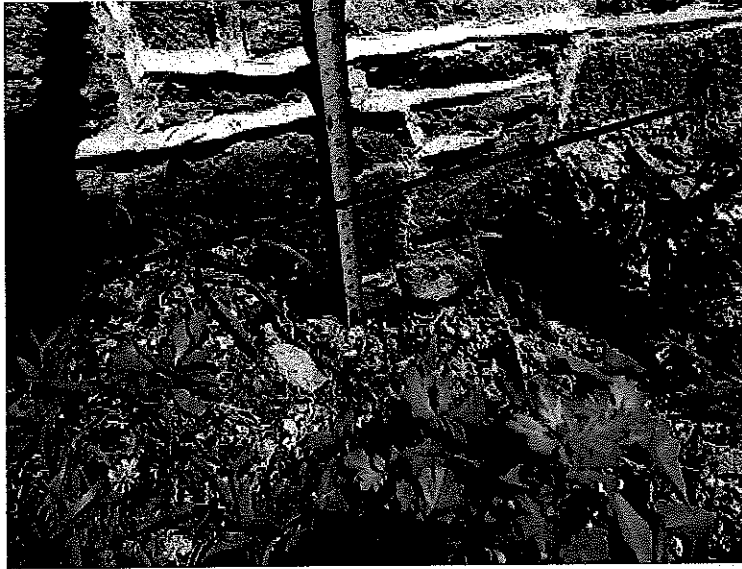
5. Observation pits where dug to view the masonry work below grade. However, the pits do not expose the 12" specified depth and do not show evidence that any re-pointing work was done below grade. It appears that the new pointing work stops at the top of grade and mortar below grade is missing in places, possibly removed to prepare for re-pointed that never happened. Masonry re-pointing must be done to 12" below grade on the south and west elevations.

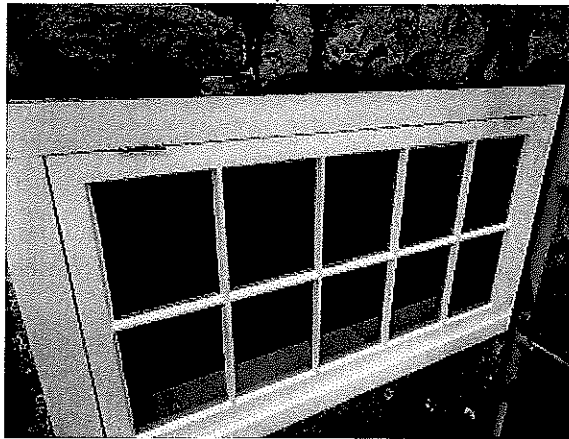
10. At the north side cellar window, the rusted hinges at the top of the sash haven't been replaced with stainless steel ones as had been promised several times.

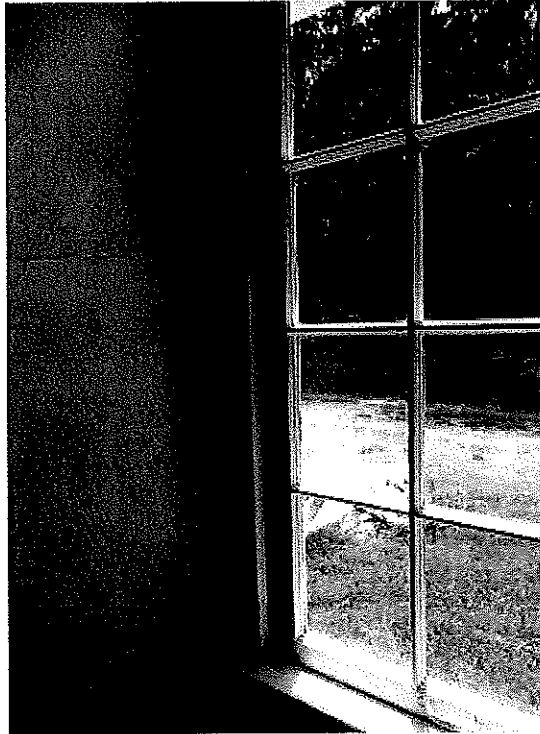
14. At the south side center main window at the interior the east side, the stop moulding and window stool have been recently gouged and not repaired or refinished.

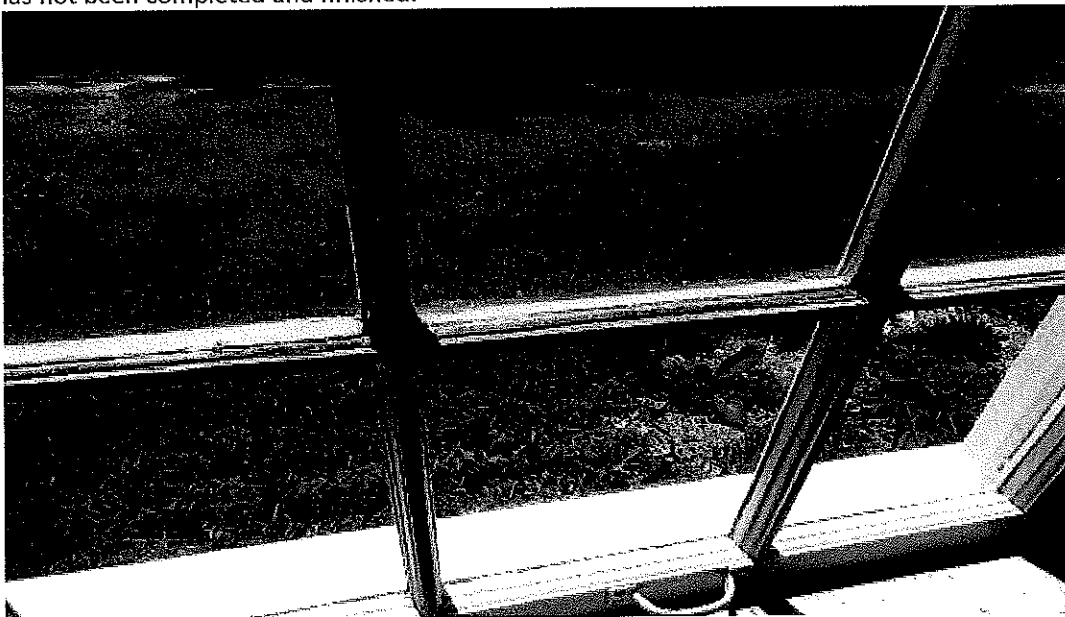
15. At the south side center main window, epoxy repair work at the muntins of the lower sash has not been completed and finished.

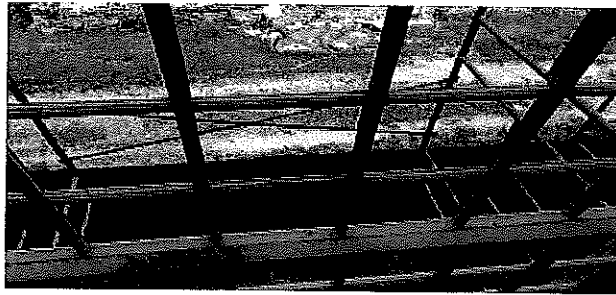
18. At the upper sash of the north side main window at the west end it is evident that epoxy filler work at the muntins is incomplete, as well as at the window stool and stop moulding.

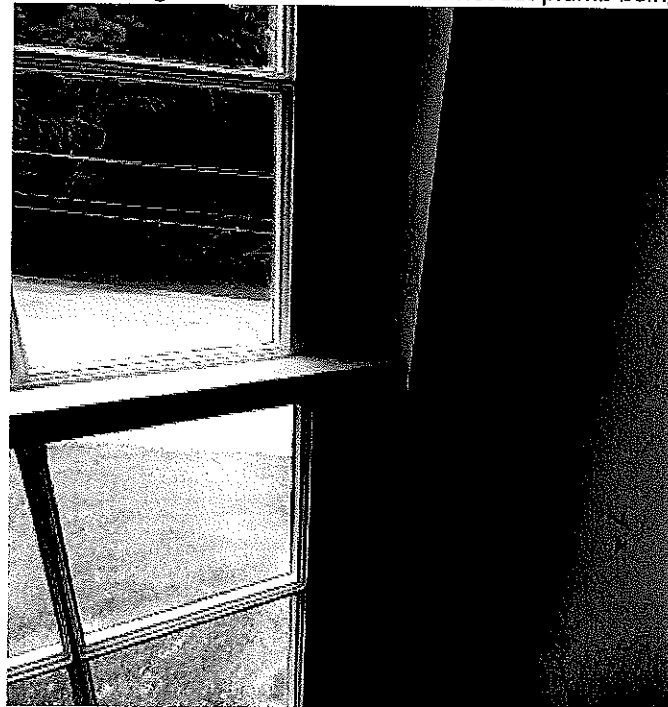
20. Window sash at the 2<sup>nd</sup> floor balcony facing west have not been installed properly. The window sash parting strips are missing. The original existed when the project commenced and were removed by the contractor when the sash were removed. No replacement was installed but rather the window sash have been loosely screwed in place to pinch the sash. The condition is not appropriate or weathertight and the lower sash are not set plumb being canted inward.
