| New Jersey Police<br>Crash Investigation Report | | | | | | | | | | | | Case Number<br>2018-00029159 | | | Page 2 of 3 | |

New Jersey Police Crash Investigation Report  
Motor Vehicle Crash Diagram

Police Dept: Brick Police Code: 01  
Station:        Case No: 2018-00029159

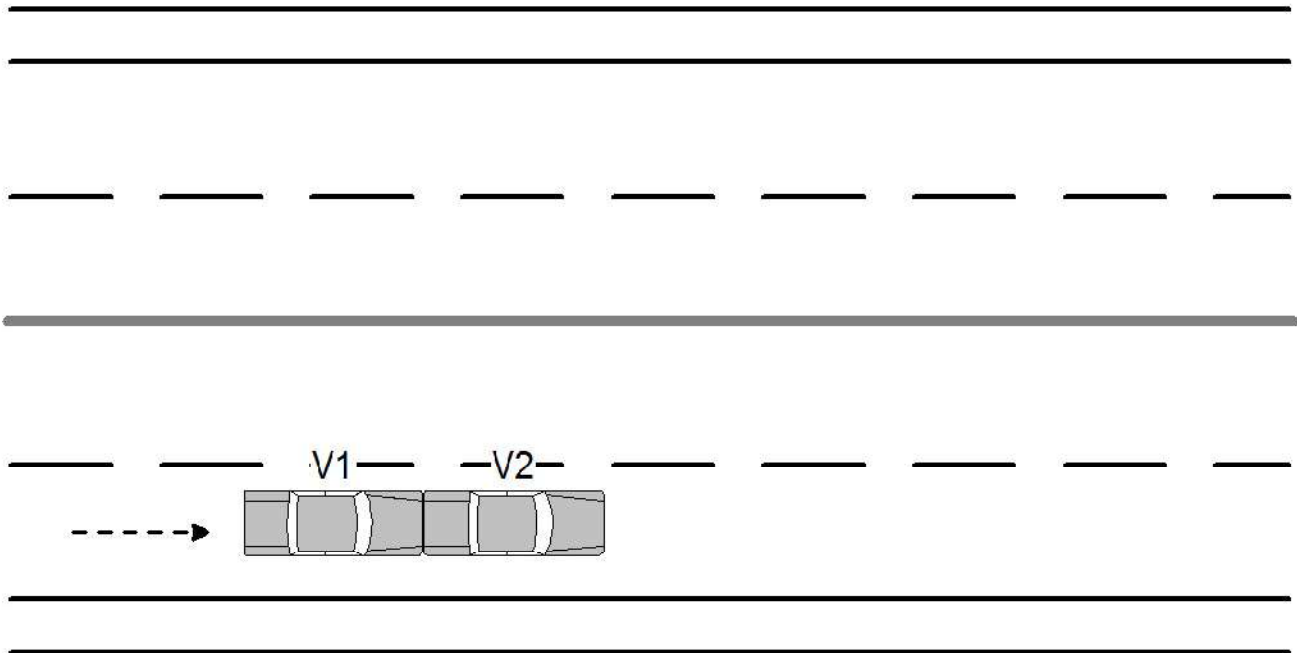
144 Crash Diagram (NOT TO SCALE)

Vehicle 1 and 2 were both traveling eastbound on Rt 70 in the rightmost lane. Vehicle 2 began slowing due to traffic. Vehicle 1 failed to observe vehicle 2 slowing, causing it to collide with the rear of it.

Route 70

The driver of vehicle 1 advised she was traveling eastbound on Rt 70 in th rightmost lane behind vehicle 2. Driver 1 further advised she observed vehicle 2 begin slowing and she applied her brakes. Driver 1 stated she skid on the wet pavement then collided with the rear of vehicle 2.

The driver of vehicle 2 advised she was traveling eastbound on Rt 70 in the rightmost lane when she began slowing due to traffic. Driver 2 further advised she was then struck in the rear forcefully by vehicle 1.

The driver of vehicle 1 is found to be at fault for the collision and has been issued a summons for Careless Driving (39:4-97) on summons T 157518. Driver 1 was also issued an additional summons for Unsafe Tires (39:3-72) on summons T157519.
