New Jersey Police  
Crash Investigation Report

2017-00025532

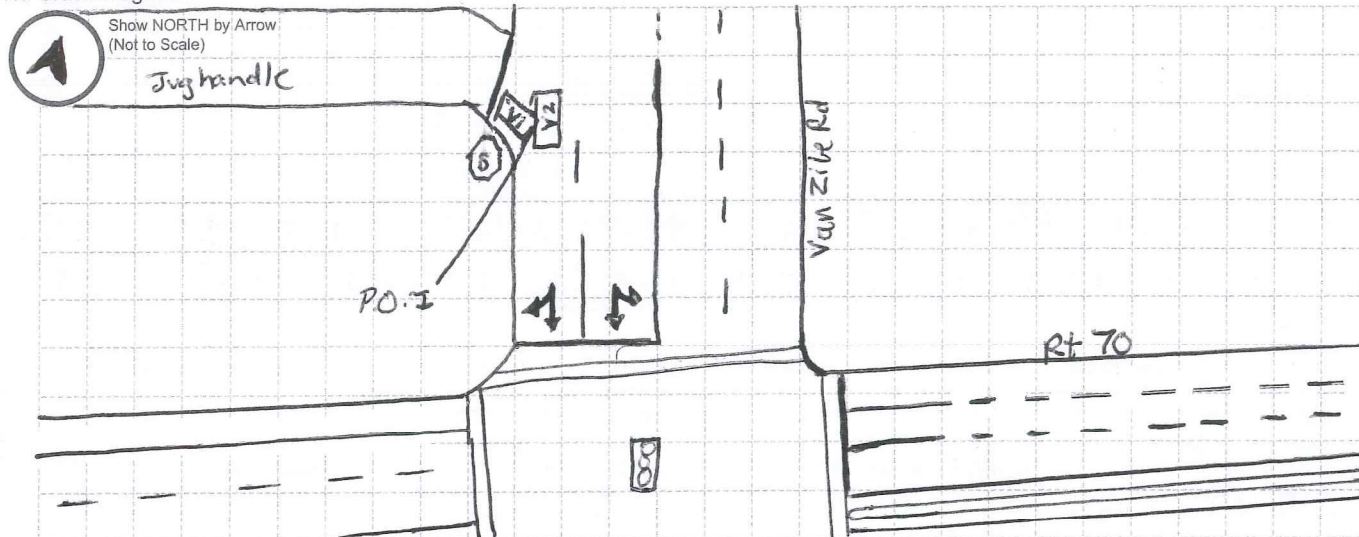
144. Crash Diagram

Driver 1 exited the jughandle to travel South on Van Zile Rd and struck the passenger side doors of Vehicle 2 with the front bumper of Vehicle 1. Vehicle 2 was traveling South in the right lane on Van Zile when it was struck by Vehicle 1.

Driver 1 advised she believed Vehicle 2 was traveling in the left lane on Van Zile Rd and was able to exit the jughandle. Driver 2 advised he was traveling South in the right lane of Van Zile Rd and was struck by Vehicle 1.

Based upon my observations and statements made by both drivers, I find Driver 1 at fault for failing to observe Vehicle 2 traveling South in the right lane on Van Zile Rd.
