## New Jersey Police Crash Investigation Report

## Motor Vehicle Crash Description

Station: **Brick Police**Case No: **2016-00081980**

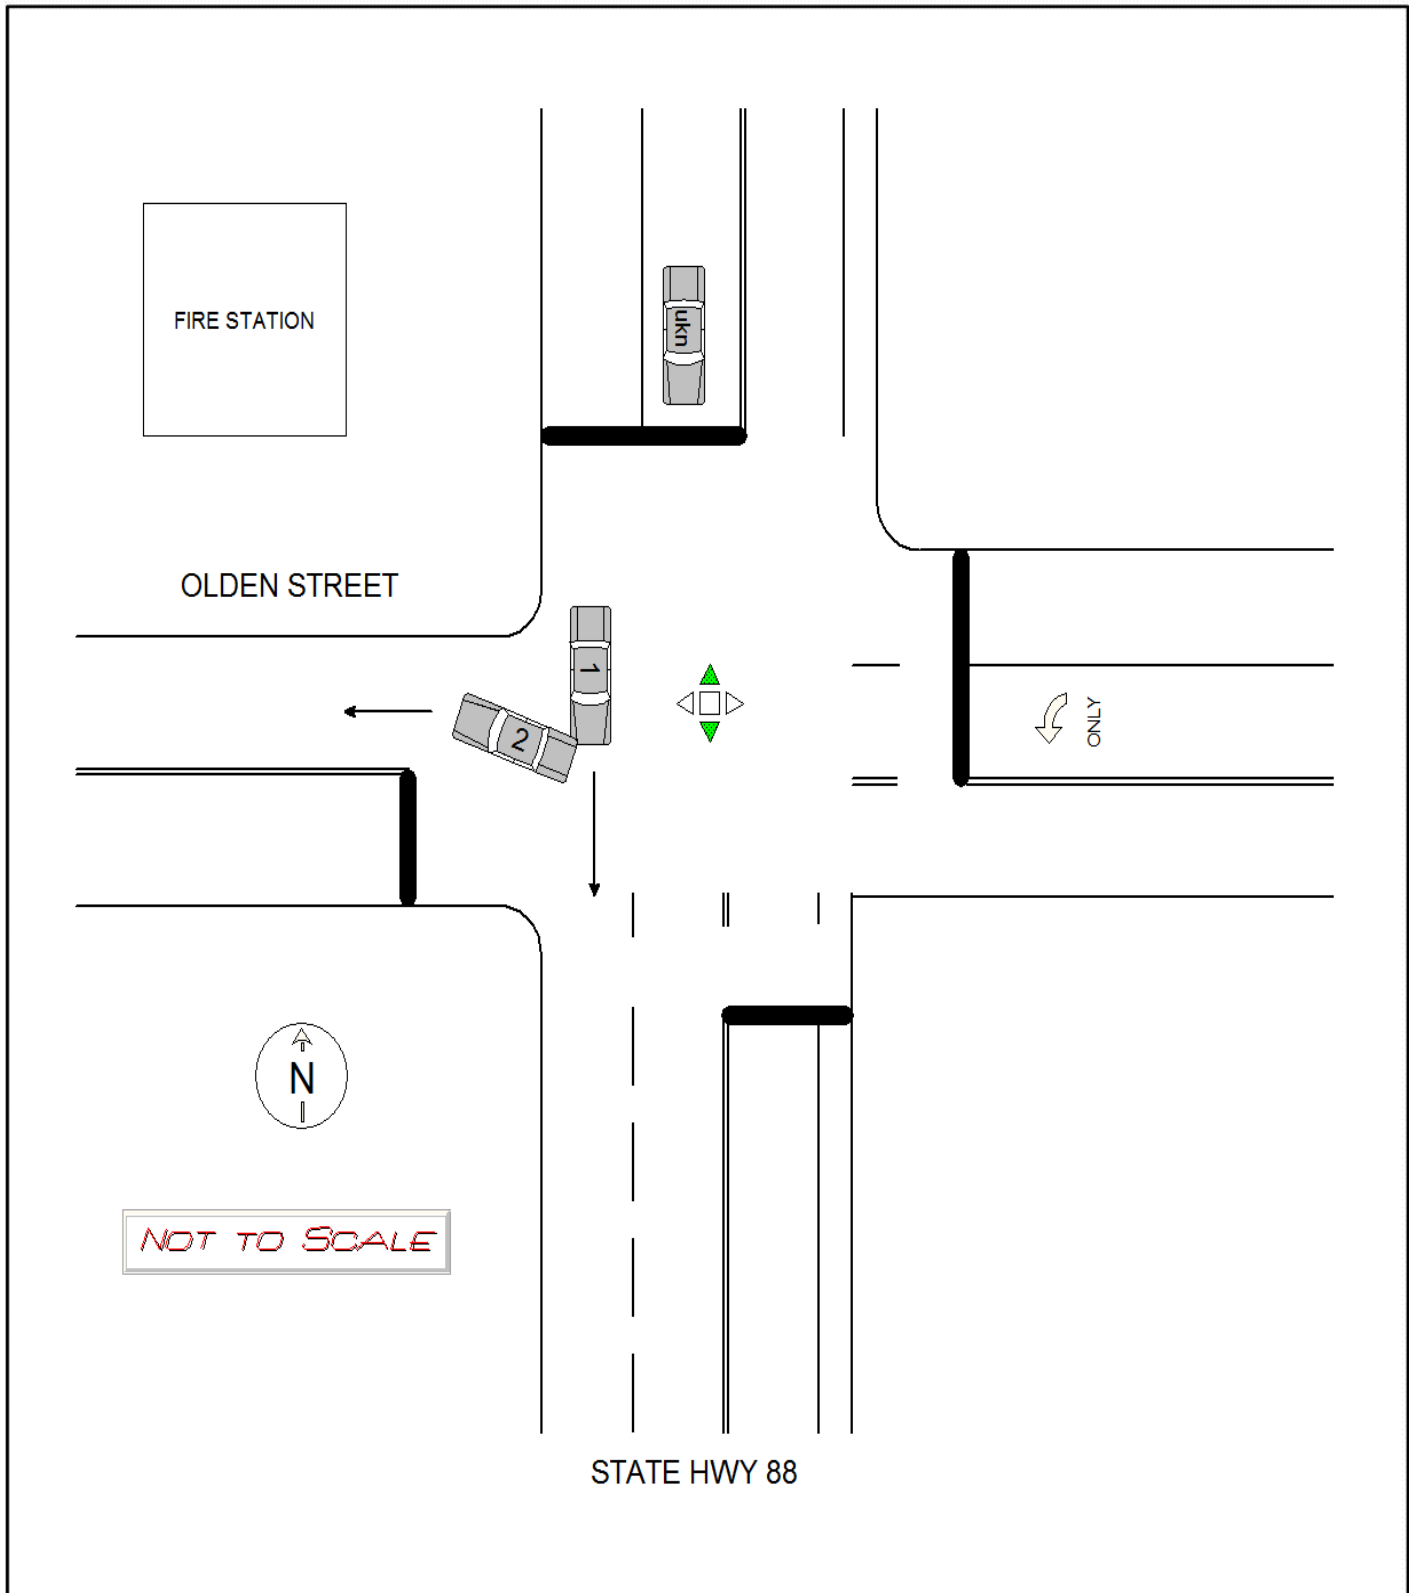
Motor Vehicle Crash Diagram

Investigation at the scene revealed vehicle 1 was traveling east bound on Rt 88 as vehicle 2 was traveling west bound. As they entered into the intersection of Olden St vehicle 2 began turning left onto Olden St. Vehicle 1 entered the intersection after changing lanes, but could not stop in time due to wet road conditions and crashed into vehicle 2. Due to debris in the roadway and point of impact on both vehicles, it was determined vehicle 2 was nearly all the way through the intersection prior to the crash. Vehicle 1's lower right front crashed into vehicle 2's lower right rear causing damage to both vehicles. No injuries were reported at this time.
