## New Jersey Police Crash Investigation Report

## Motor Vehicle Crash Description

Station: **Brick Police**Case No: **2016-00030787**

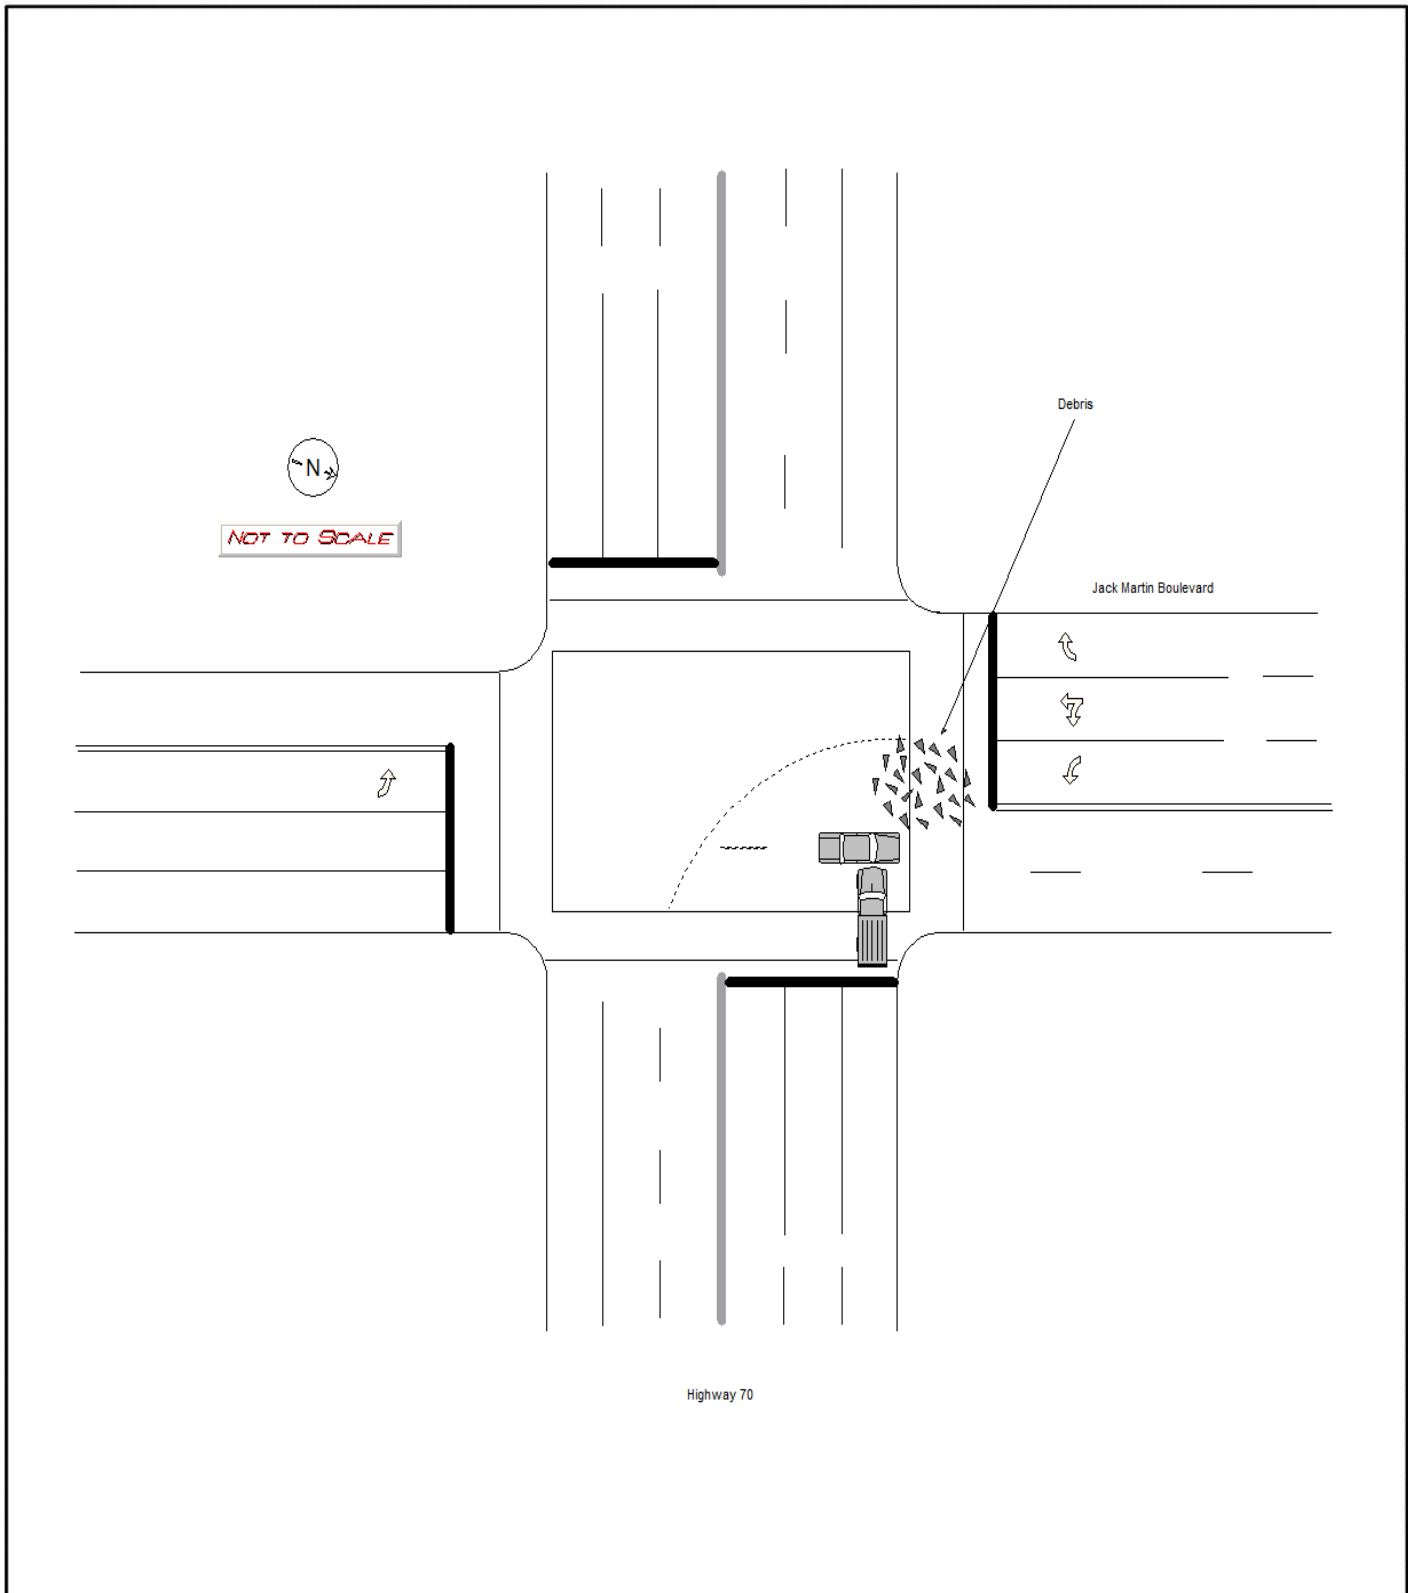
Motor Vehicle Crash Diagram

Vehicle 2 was traveling west on Rt. 70 in the right lane of travel. As Vehicle 2 entered in to the intersection of Rt. 70 and Jack Martin Blvd, it collided with Vehicle 1. Vehicle 2's front portion of the Vehicle collided with the right middle portion of Vehicle 1.

Vehicle 1 was traveling south on Jack Martin Blvd. Vehicle 2 entered the intersection of Jack Martin Blvd and Rt. 70. As Vehicle 1 was approximately three quarters of the way into the intersection it collided with Vehicle 2.

Upon conclusion of my investigation, I am un able to determine who is at fault for the crash. Both Driver 1 and Driver 2 are stating that the other party ran the red traffic signal. There were no witnesses to the crash. The scene revealed skid marks approximately 10 feet long, prior to the impact location which Vehicle 1 was traveling.
