## New Jersey Police Crash Investigation Report

Station: **Brick Police**Case No: **2016-00036162**

Motor Vehicle Crash Diagram

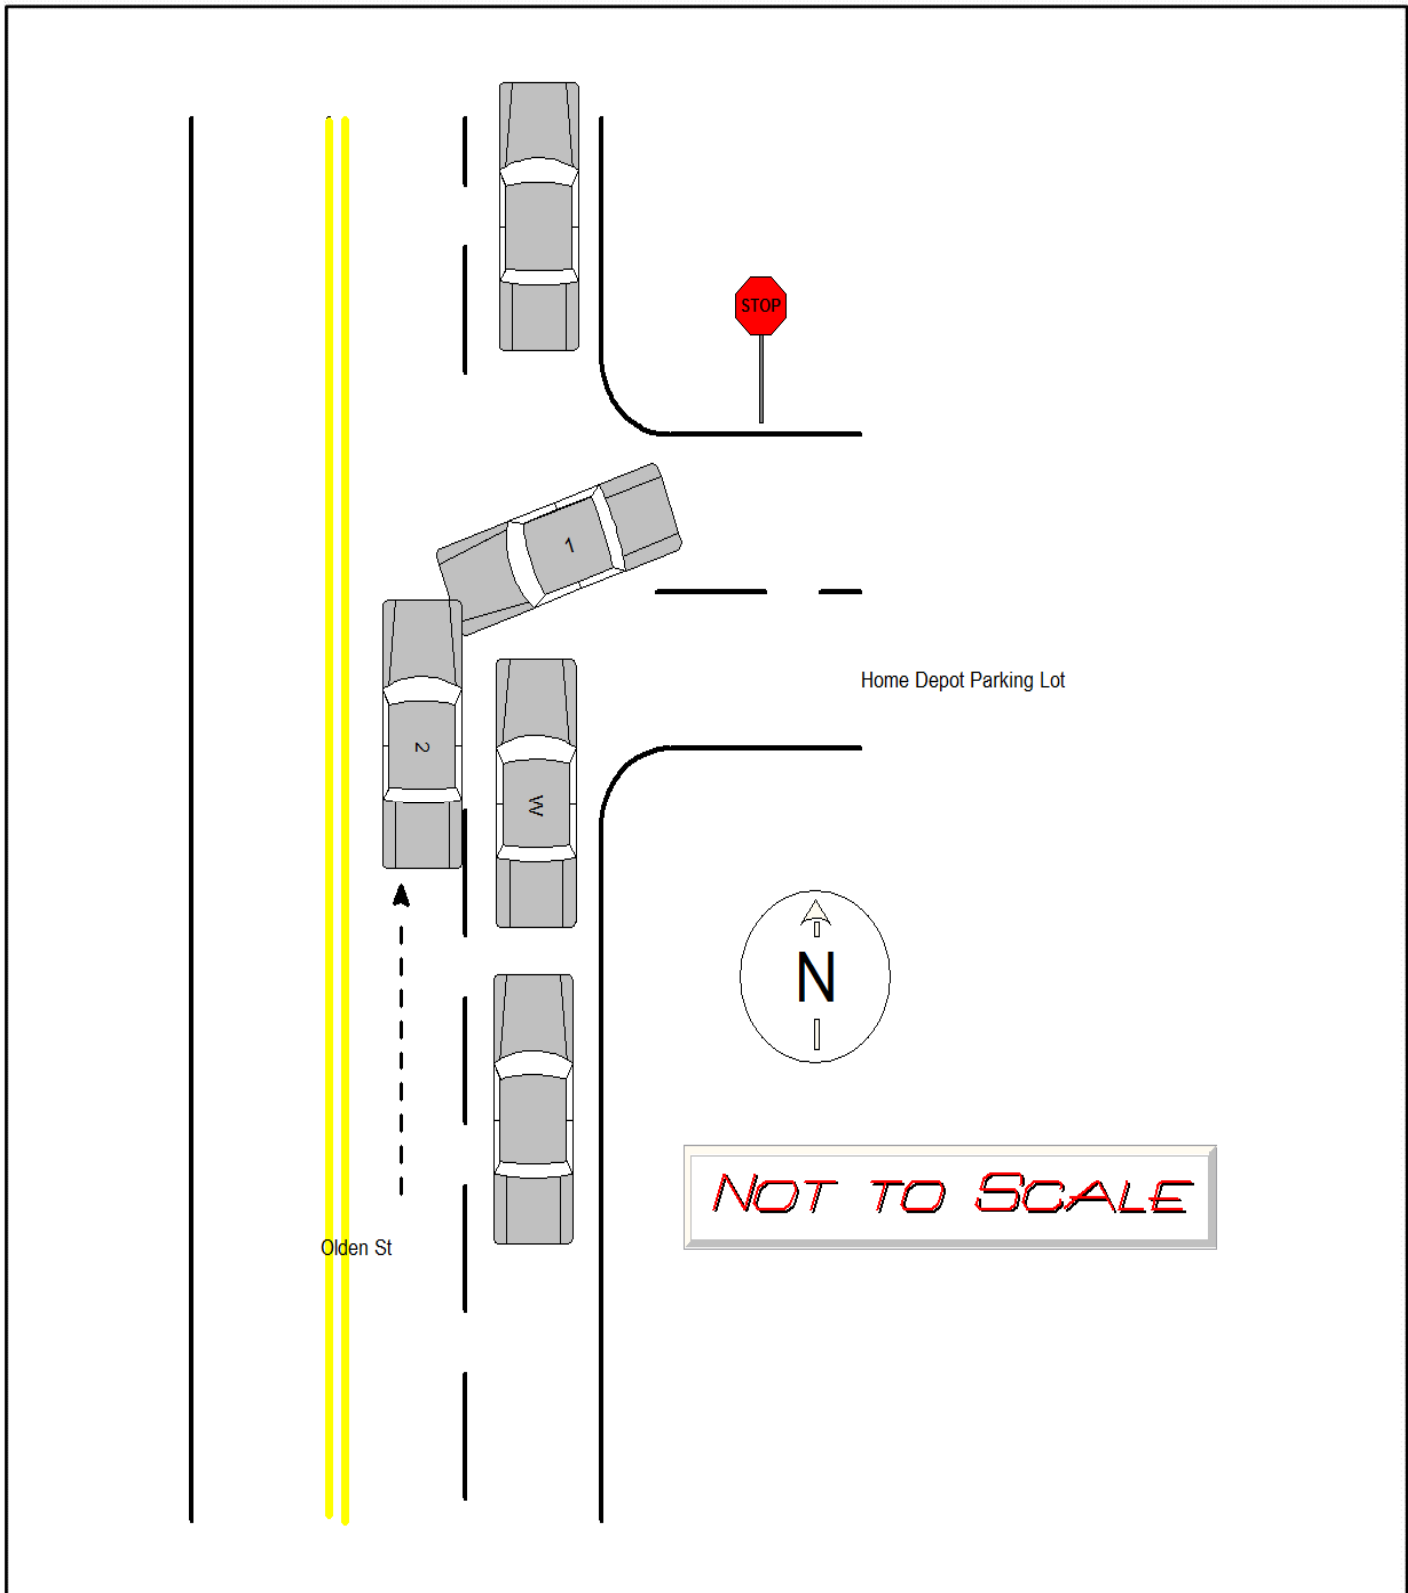
Vehicle 1 was stopped at the exit for the Home Depot at 1722 Rt 88 preparing to turn left onto Olden, to head towards Rt 70.

Vehicle 2 was traveling North on Olden from Rt 70 towards Rt 88.

Driver 1 saw the witness waving him out onto the roadway and assumed it was safe to enter into traffic. Driver 1 did not see Vehicle 2 approaching in the left lane and pulled directly in front of Vehicle 2. Vehicle 2 was unable to stop in time and collided with Vehicle 1.

The front of Vehicle 1 sustained moderate damage and was towed from the scene by D&L Towing. The front and driver side of vehicle 2 sustained moderate damage and had an airbag deployment in the front compartment. Vehicle 2 was towed from the scene by Frank's Towing.

Driver 1 was issued a summons for failure to yield, 39:4-90.
