## New Jersey Police Crash Investigation Report

## Motor Vehicle Crash Description

Station: \_\_\_\_\_ Case No: **2016-00029289**

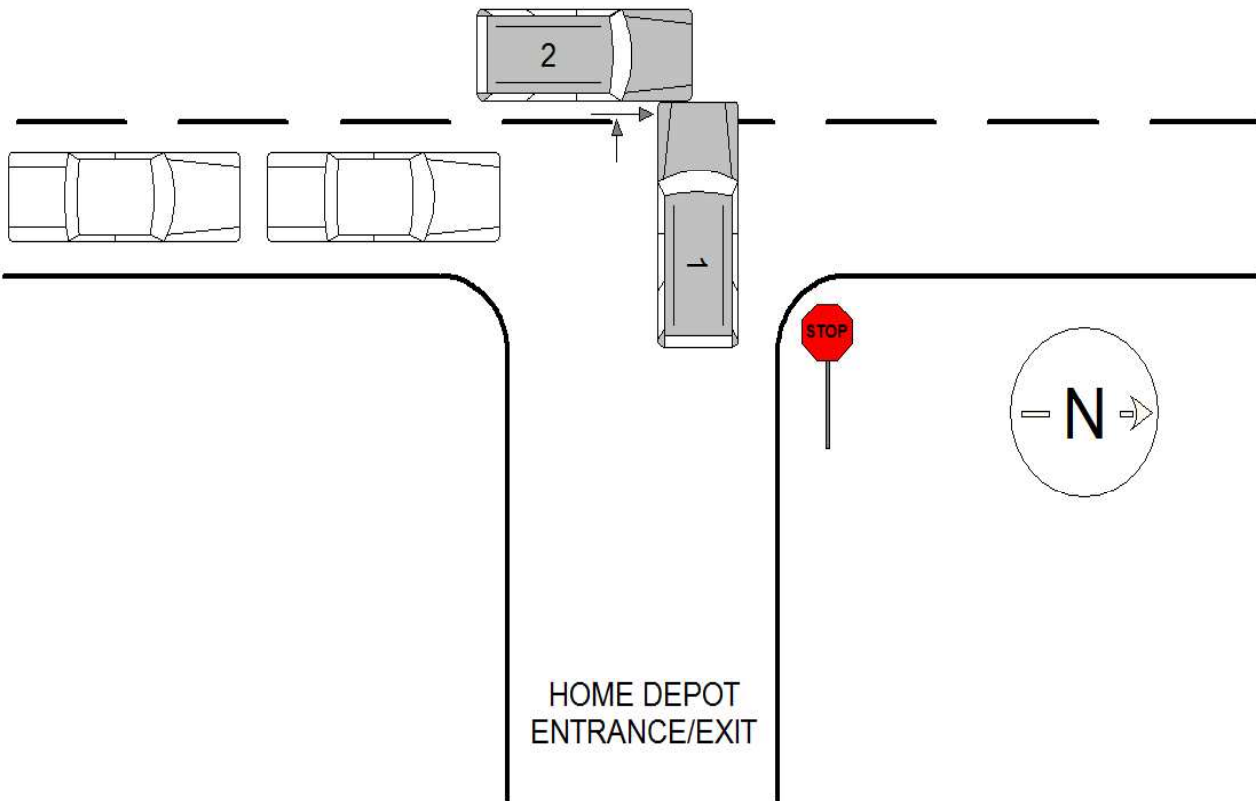
Motor Vehicle Crash Diagram

Vehicle 1 was at rest at the entrance/exit of Home Depot onto Olden Street. Vehicle 2 was traveling Olden Street northbound going straight ahead in the left lane. Vehicle 1 proceeded to initiate a left turn onto Olden Street and impacted the front passenger corner of Vehicle 2 as Vehicle 1 crossed over the northbound lanes.

Driver 1 stated that an uninvolved vehicle left a gap in traffic for her to proceed and waved her out onto Olden Street prior to initiating the left turn. Driver 1 reported that she was traveling very slowly prior to impact due to the amount of traffic in the right lane obscuring her view.

Damage was observed to the front of Vehicle 1 and the front passenger side corner of Vehicle 2. No injuries were reported on scene and both vehicles were able to be driven away.

As a result of this crash investigation, it was determined that Driver 1 was the at-fault party due to failing to yield the right of way to Vehicle 2. Driver 1 was issued a summons for Failure To Yield (39:4-144, E16 002974).
