| 96 | 05 | Page 1 of 3 | | New Jersey Police Crash Investigation Report | | <input checked="" type="checkbox"/> Reportable | | <input type="checkbox"/> Non-Reportable | | <input type="checkbox"/> Change Report | | 118a |
| 97 | 01 | 1 Case Number | | 2013-00057359 | | 10 Crash Occurred On: 1872 Rt. 88 | | 11 Speed Limit | | | | 99 |

| <b>New Jersey Police Crash Investigation Report</b><br><br><b>Motor Vehicle Crash Description</b> | Police Dept: <b>Brick PD</b> Code: <b>01-Municipal Police</b><br>Station: <b>---</b> Case No: <b>2013-00057359</b> |

## 135 Crash Description

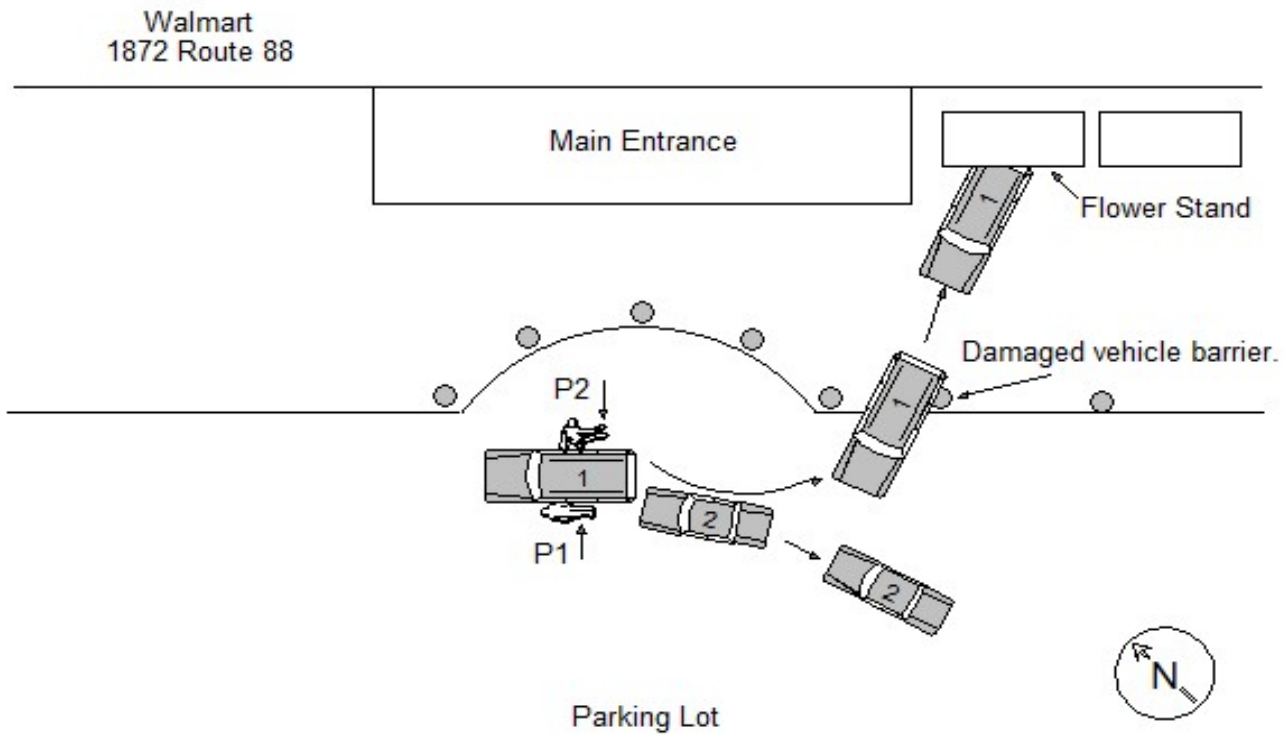
134 Crash Diagram (NOT TO SCALE)

Investigation at the scene revealed that Vehicle #1 had parked directly in front of the main entrance at the Walmart store at 1872 Route 88.. Vehicle #2 then pulled directly behind Vehicle #1, in front of the main entrance.

I then watched the surveillance video from Walmart and observed the incident. It appears that the driver of Vehicle #1 had placed the gear select in reverse before exiting the vehicle. The video shows the passenger in Vehicle #1 exiting the vehicle and getting struck by the passenger side front door. The passenger is knocked to the ground and the vehicle front tire narrowly misses running her over. Vehicle #1 quickly moved backwards and then struck the front end of Vehicle #2. Vehicle #2 then backed up after the collision and Vehicle #1 then continued in reverse, striking a cement vehicle barrier before colliding with a flower stand.
