| New Jersey Police<br>Crash Investigation Report | | | | | | | | | | | | Case Number<br>2021-00002378 | | | Page 2 of 3 | |

New Jersey Police Crash Investigation Report  
Motor Vehicle Crash Diagram

Police Dept: Brick Police Code: 01  
Station:        Case No: 2021-00002378

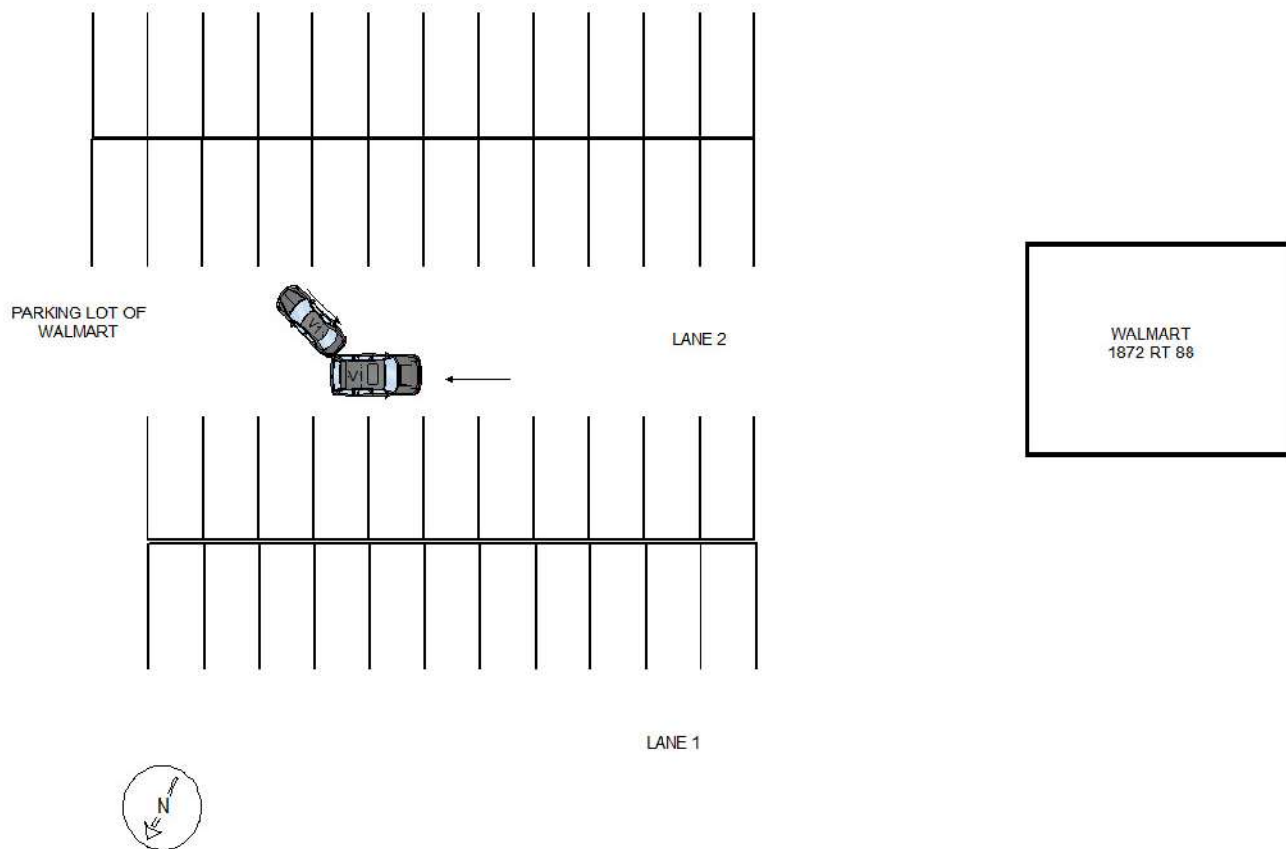
144 Crash Diagram (NOT TO SCALE)

Vehicle 1 was backing in lane 2 of the Walmart (1872 RT 88) parking lot and struck Vehicle 2 in the rear left bumper with its rear left bumper. Vehicle 1 received minor damage. Vehicle 2 received moderate damage. The passenger of Vehicle 2 stated he had neck pain, but did not want an ambulance on scene.

I entered Walmart and observed the crash on surveillance camera footage. Vehicle 2 was observed stopped after backing out of a parking space while Vehicle 1 backed a distance and then struck Vehicle 2.

Based on my observations of the surveillance camera, I find Driver 1 at fault for unsafe backing. Driver 1 was issued traffic summons E21 000200 for careless driving (39:4-97).
