| New Jersey Police<br>Crash Investigation Report | | | | | | | | | | | | Case Number<br>2020-00074914 | | | Page 2 of 4 | |

New Jersey Police Crash Investigation Report  
Motor Vehicle Crash DescriptionPolice Dept: Brick Police Code: 01Station: — Case No: 2020-00074914

New Jersey Police Crash Investigation Report  
Motor Vehicle Crash Diagram

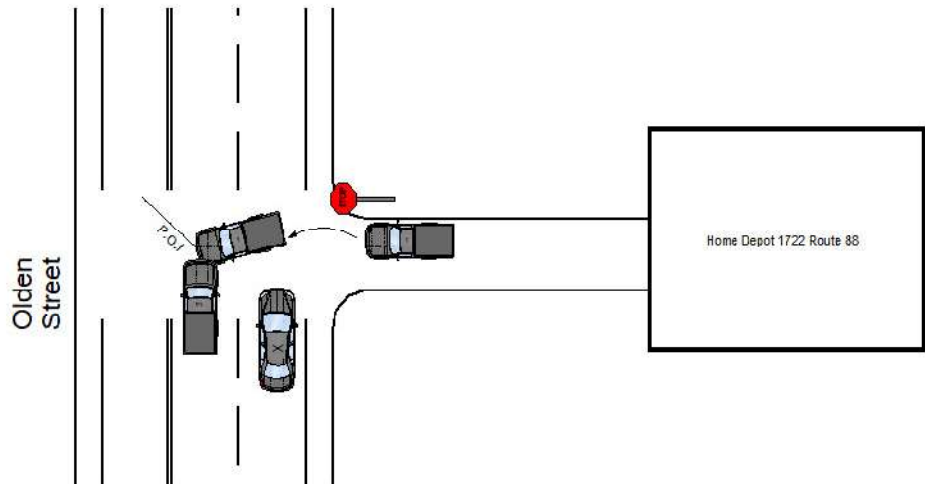
144 Crash Diagram (NOT TO SCALE)

Crash investigation reveals a two vehicle, left turn crash. Vehicle 1 was stopped for a marked stop sign in the Home Depot parking lot, 1722 Route 88, awaiting to turn left onto Olden Street. Vehicle 2 was traveling south on Olden Street in the left lane approaching the entrance/exit area for the Home Depot parking lot.

The driver of vehicle 1 stated the right lane southbound traffic on Olden Street was backed up and congested as he was awaiting to turn left out of said parking lot. While still stopped at the marked stop sign, an unknown vehicle (which was stopped in the right lane on Olden Street due to the traffic) waived/signaled to the driver of vehicle 1 to turn left onto Olden Street.

After being waived/signaled to turn, the driver of vehicle 1 proceeded to turn left out of the aforementioned parking lot and onto Olden Street. As vehicle 1 was turning left, it turned directly into the path of vehicle 2 who was traveling in the left lane on Olden Street going southbound. The aforementioned left lane where vehicle 2 was going straight ahead at the time did not have any traffic/congestion and wasn't backed up like the right lane was.

As vehicle 1 proceeded to turn left onto Olden Street, the driver of vehicle 1 stated he did not see vehicle 2 traveling in the left lane during his turn. As a result of vehicle 1 turning directly into the path of vehicle 2, the front end of vehicle 2 crashed into the upper left front side of vehicle 1 causing damage to both vehicles.
