| <b>Crash Investigation Report</b> | | | | | | | | | | | | 2020-00025433 | | | | | |

New Jersey Police Crash Investigation Report  
Motor Vehicle Crash DescriptionPolice Dept: Brick Police Code: 01Station: — Case No: 2020-00025433

New Jersey Police Crash Investigation Report  
Motor Vehicle Crash Diagram

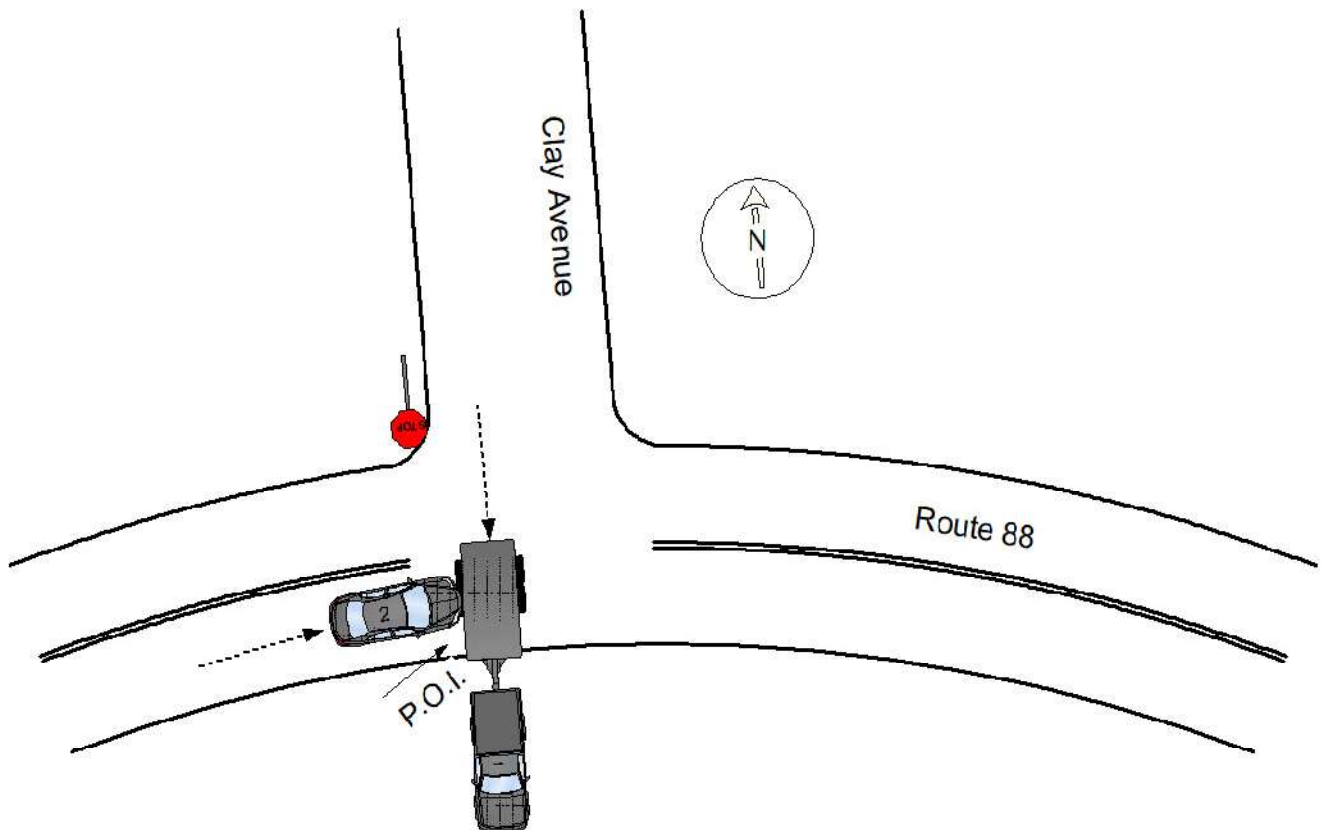
144 Crash Diagram (NOT TO SCALE)

Vehicle 1 was towing a trailer, traveling south on Clay Avenue and attempting to cross over Route 88. Vehicle 2 was traveling east on Route 88 approaching Clay Avenue. Vehicle 1 entered the intersection of Route 88 and was unable to fully cross through the intersection in time, in front of vehicle 2, and vehicle 2 subsequently collided with the trailer within the intersection.

Investigation revealed that the cause of the crash was due to driver 1's inattentiveness to the cross traffic on Route 88 and not ensuring the roadway was free and clear of traffic to safely make it completely through the intersection.
