| New Jersey Police<br>Crash Investigation Report | | | | | | | | | | | | Case Number<br>2019-00075496 | | | Page 2 of 4 | |

New Jersey Police Crash Investigation Report  
Motor Vehicle Crash DescriptionPolice Dept: Brick Police Code: 01Station: — Case No: 2019-00075496

New Jersey Police Crash Investigation Report  
Motor Vehicle Crash Diagram

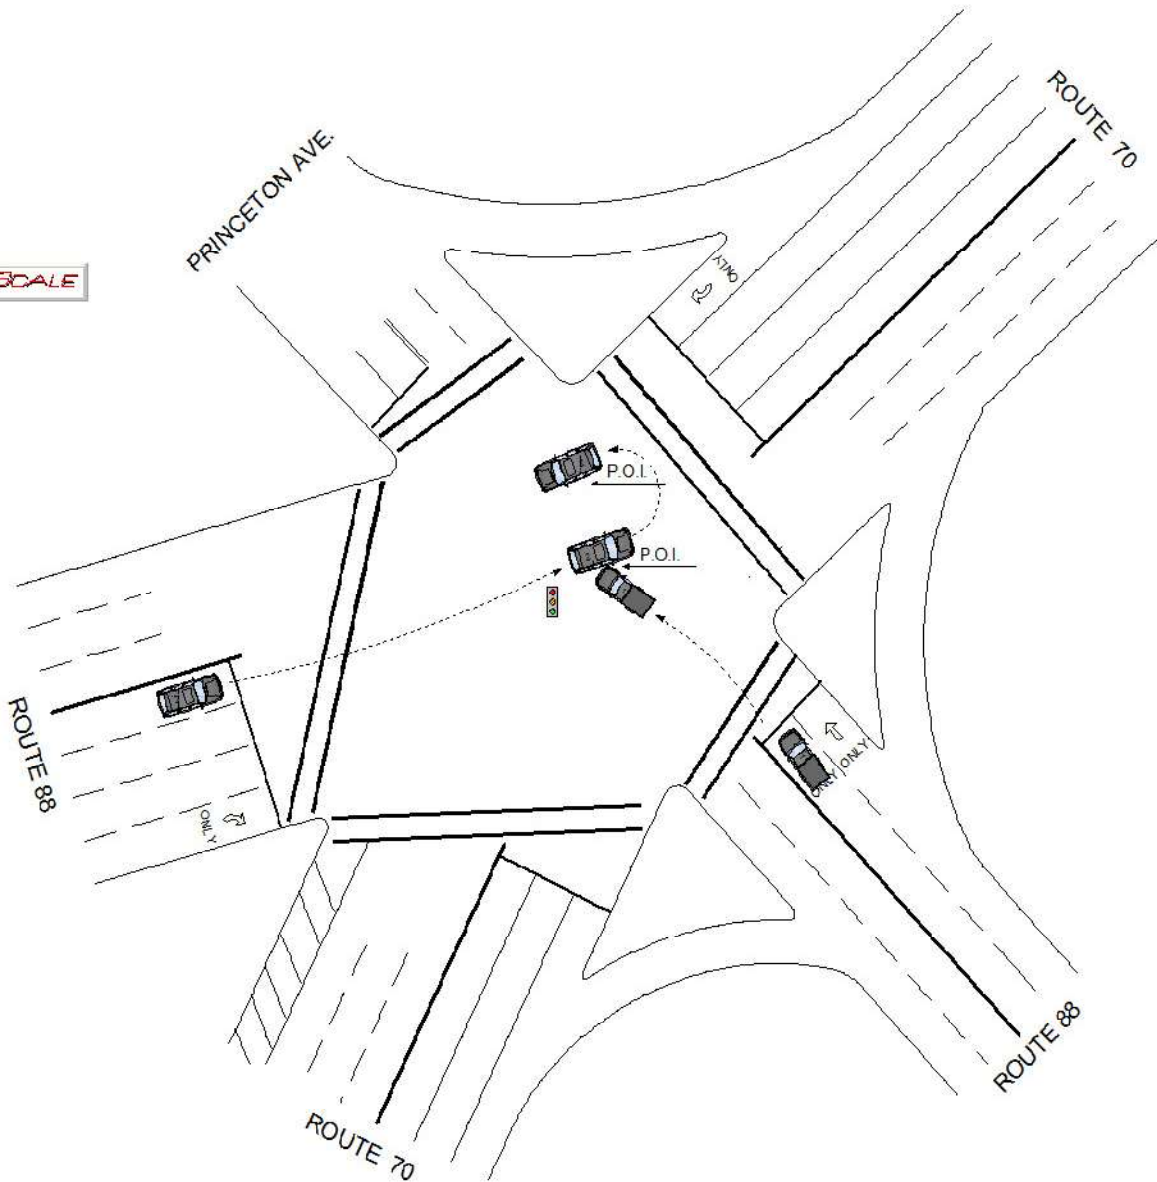
144 Crash Diagram (NOT TO SCALE)

Vehicle 1 was traveling on Route 88 east and went through the red light at the intersection of Route 70, attempting to turn left and continue on Route 88 east. Vehicle 2 was west on Route 88, at the intersection of Route 70. Vehicle 2 proceeded into the intersection when the traffic signal turned green, making a left onto route 70 west. Vehicle 1 collided with vehicle 2 at a right angle on the passenger side, within the intersection. The impact caused vehicle 2 to flip onto it's driver's side and spin 180 degrees, coming to a stop in that position within the intersection.

A witness on scene who is an off duty police officer stated he observed vehicle 2 turning left from Route 88 west onto Route 70 west through a green traffic signal. He also stated that he observed vehicle 1 traveling on Route 88 east, go through the red light at the intersection of Route 70, subsequently colliding with vehicle 2, causing the rollover. A witness statement form was completed.

Investigation revealed that the cause of the crash was due to driver 1 failing to stop at a red traffic signal.
