| New Jersey Police<br>Crash Investigation Report | | | | | | | | | | | | Case Number<br>2021-00054136 | | | Page 2 of 3 | |

New Jersey Police Crash Investigation Report  
Motor Vehicle Crash Diagram

Police Dept: Brick Police Code: 01  
Station:        Case No: 2021-00054136

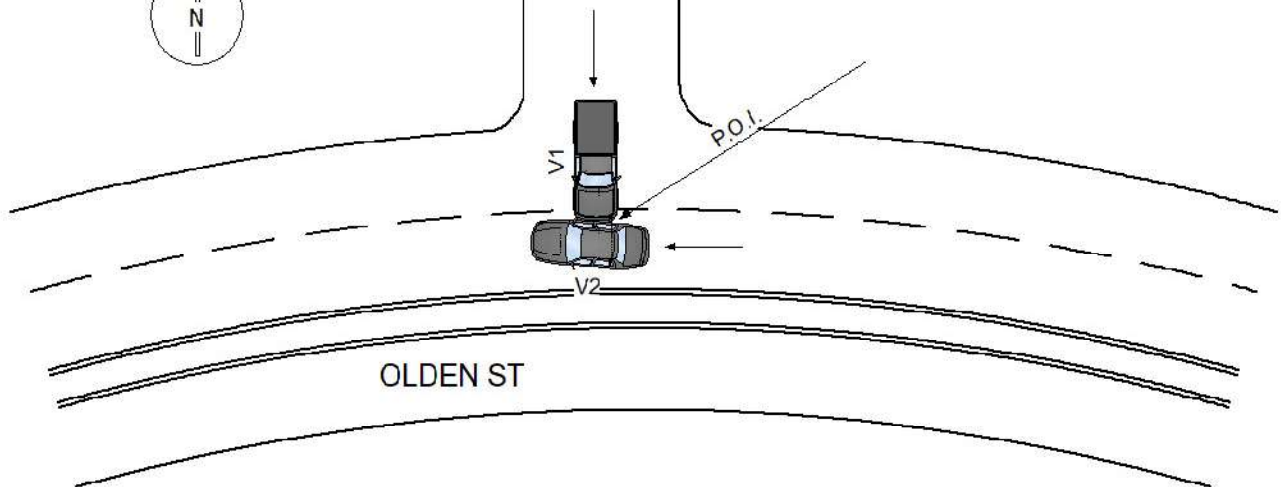
144 Crash Diagram (NOT TO SCALE)

A motor vehicle crash occurred on Olden Street, approximately 100 feet east of Route 88.

Driver 1 stated that they were making a left turn out of the Home Depot parking lot on to Olden Street when they struck Vehicle 2 which was traveling west on Olden Street.

Driver 2 stated they were traveling west on Olden Street when Vehicle 1 struck them.

Vehicle 1 had minor damage to the front grill area. Vehicle 2 had moderate damage to the passenger side doors.

My investigation revealed Driver 1 was turning left out of the parking lot and struck Vehicle 2 which was traveling west on Olden Street. Driver 1 is the at fault driver for failure to yield and driver inattention.
