| New Jersey Police<br>Crash Investigation Report | | | | | | | | | | | | Case Number<br>2019-00047129 | | | Page <u>2</u> of <u>4</u> | |

New Jersey Police Crash Investigation Report  
Motor Vehicle Crash Description

New Jersey Police Crash Investigation Report  
Motor Vehicle Crash Diagram

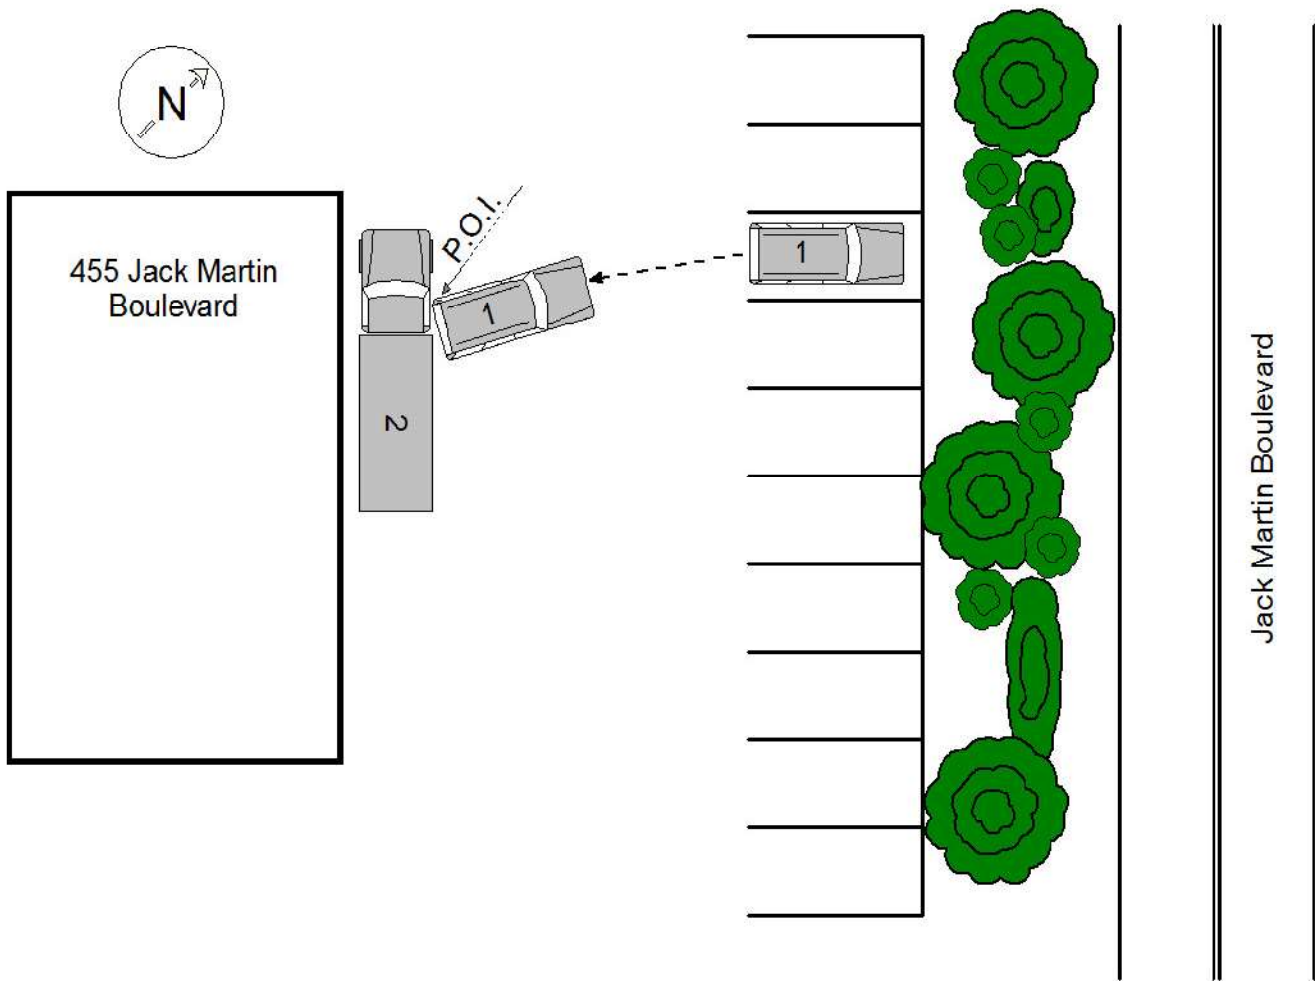
144 Crash Diagram (NOT TO SCALE)

Vehicle 1 was backing out of a parking spot on the same side of the building and backed up into vehicle 2.

Driver 1 stated vehicle 2 was parked next to the building and she was parked in a parking spot on the same side of the building. Driver 1 stated she began to back up out of the parking spot and backed up into vehicle 2.

Investigation revealed that the cause of the crash was due to multiple factors. First, vehicle 2 was parked outside a legal parking spot, unable to park in a marked spot, due to the size of the vehicle. Second, driver 1

failed to observe her proximity to vehicle 2 as she was backing out of the parking spot, causing her vehicle to collide with vehicle 2.
