| New Jersey Police<br>Crash Investigation Report | | | | | | | | | | | | Case Number<br>2019-00026270 | | | Page 2 of 4 | |

New Jersey Police Crash Investigation Report  
Motor Vehicle Crash DescriptionPolice Dept: Brick Police Code: 01Station: — Case No: 2019-00026270

New Jersey Police Crash Investigation Report  
Motor Vehicle Crash Diagram

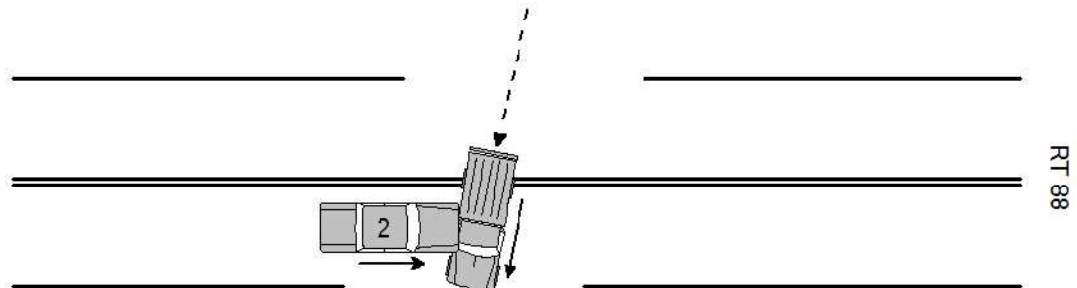
144 Crash Diagram (NOT TO SCALE)

Vehicle 2 was traveling west on RT 88 approaching the area of J's Garden Spot (2039 RT 88). Vehicle 1 exited the parking lot of J's Garden Spot, traveled north across RT 88 towards the entrance to the mulch yard, and crossed in front of Vehicle 2, causing Vehicle 2 to crash into the right middle of Vehicle 1.

Driver 1 stated she had just finished paying for a load of mulch and was waiting for a break in traffic to exit the parking lot of J's Garden Spot. Driver 1 stated the mulch was in the lot directly across the street, and after an unknown vehicle traveling east on RT 88 stopped in traffic to let her out she started forward into the roadway. Driver 1 stated she looked to her right for oncoming westbound traffic and observed Vehicle 2 far off in the distance. Driver 1 stated she felt Vehicle 2's distance was far enough that it would be safe for her to continue across RT 88 into the mulch lot. Driver 1 stated as she proceeded forward it appeared Vehicle 2 was travelling much faster than she anticipated and ultimately crashed into her before she could finish crossing the roadway.

Driver 2 stated he was traveling west on RT 88 when he observed Vehicle 1 pulling out of the parking lot of J's Garden Spot. Driver 2 stated when Vehicle 1 initially stopped pulling forward, he figured Driver 1 saw he was

approaching and would remain stopped. When Vehicle 1 instead proceeded forward, crossing into his lane, he was unable to stop or avoid a collision.
