| New Jersey Police<br>Crash Investigation Report | | | | | | | | | | | | Case Number<br>2018-00069784 | | | Page 2 of 4 | |

New Jersey Police Crash Investigation Report  
Motor Vehicle Crash Diagram

144 Crash Diagram (NOT TO SCALE)

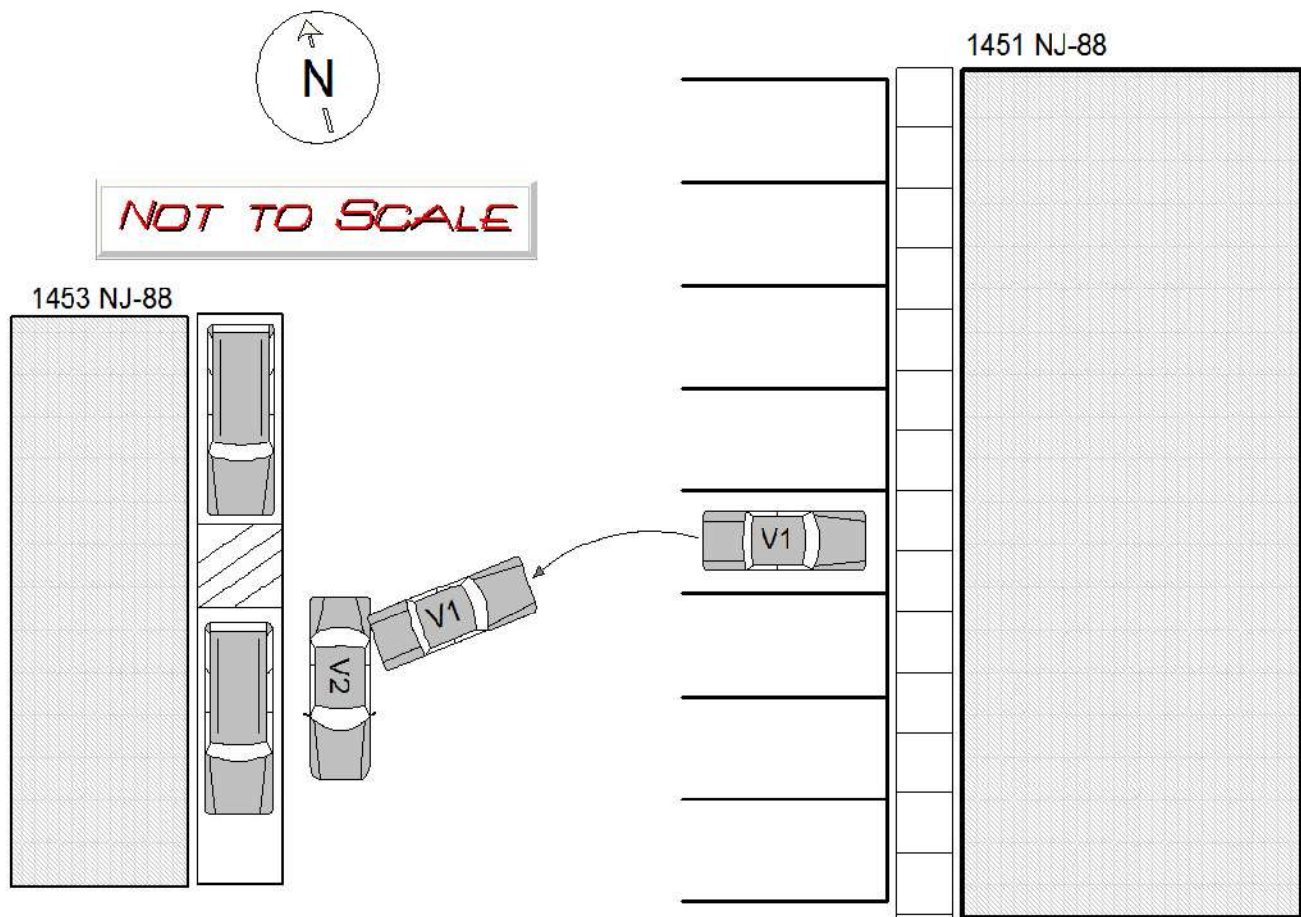
Investigation revealed that vehicle 1 was backing out of a parking spot in the parking lot of 1453 State Highway 88. While vehicle 1 was backing, the driver side of its rear bumper struck the driver side rear fender of vehicle 2. Vehicle 2 was unoccupied, and parked perpendicular behind vehicle 1 in a non-designated parking spot. Upon arrival, vehicle 1 was moved back into its original parking spot, while vehicle 2 remained parked where it was. Both vehicles were operable, and no injuries were reported.

Vehicle 1 sustained minor damage to its rear bumper, on the driver side. Vehicle 2 sustained minor damage to the rear fender, behind the wheel well, on the driver side.

Based on my investigation, I believe both drivers were at fault. Driver 1 was at fault for backing improperly and not paying attention to what was behind her vehicle. Driver 2 was also at fault for parking improperly in a fire zone, and not in a designated parking spot.
