| New Jersey Police<br>Crash Investigation Report | | | | | | | | | | | | Case Number<br>2018-00062653 | | | Page 2 of 3 | |

New Jersey Police Crash Investigation Report  
Motor Vehicle Crash Diagram

Case No: 2018-00062653

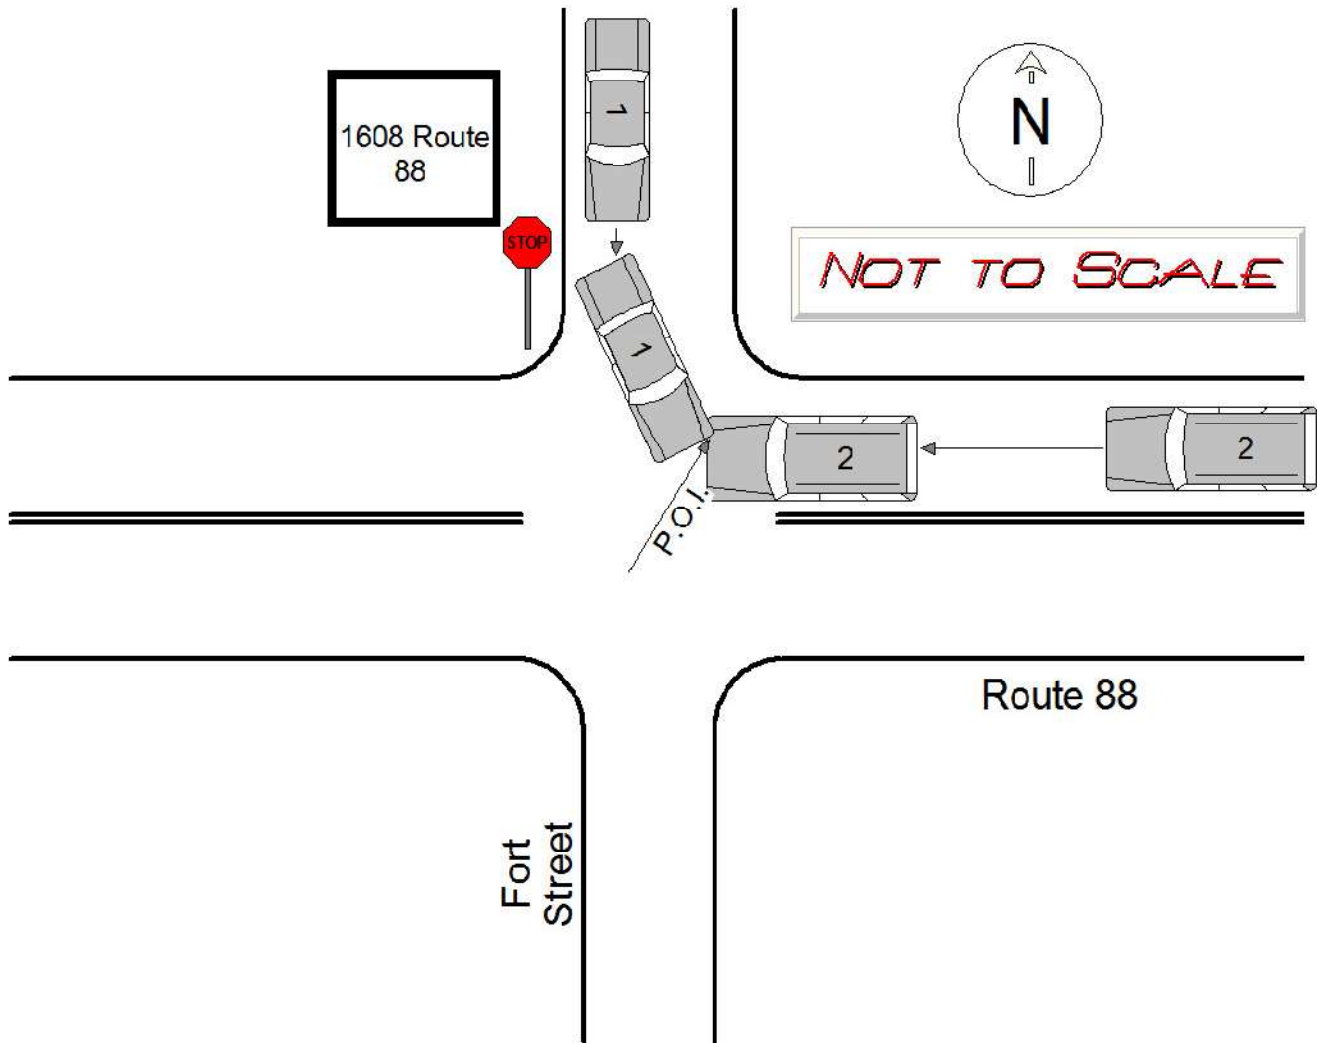
144 Crash Diagram (NOT TO SCALE)

Crash investigation reveals a two vehicle, right angle crash. Vehicle 1 was stopped at a marked stop sign in the parking lot of 1608 Route 88 awaiting to turn left onto Route 88 W. Vehicle 2 was traveling west bound on Route 88 approaching the intersection of Route 88/Fort Street which is where the entrance/exit is located for 1608 Route 88.

As vehicle 2 was traveling west on Route 88, the driver of vehicle 2 stated vehicle 1 turned left onto Route 88 directly into the path of vehicle 2 causing the front end of vehicle 2 to crash into the left upper front of vehicle 1. The driver of vehicle 1 stated she observed vehicle 2 traveling west on Route 88 and believed she had enough time to make the left turn onto Route 88 from the lot of 1608 Route 88.
