NJTR-1 (Rev. 01/22)

New Jersey Police Crash Investigation Report  
Motor Vehicle Crash Diagram

Station: B060 Case No: B060202502108C

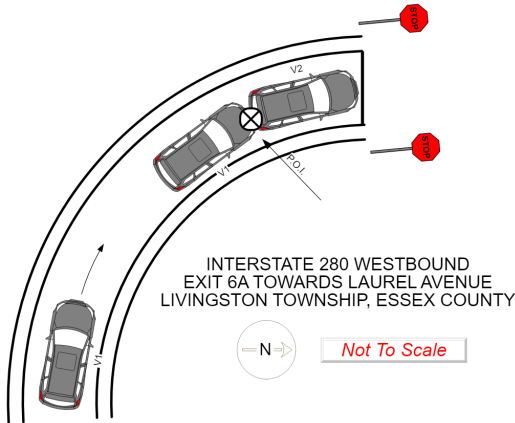
144. Crash Diagram

Investigation Revealed: Vehicle 1 was traveling on Interstate 280 Westbound Exit 6A ramp towards Laurel Avenue in Livingston Township, Essex County. Vehicle 2 was stopped ahead of vehicle 1. Driver 1 was following vehicle 2 too closely and subsequently rear-ended vehicle 2. As a result, vehicle 1 sustained minor damage to the front of the vehicle and vehicle 2 sustained minor damage to the rear of the vehicle. No injuries were reported at the scene.
