New Jersey Police Crash Investigation Report NJTR-1 (Rev. 01/22)

**New Jersey Police Crash Investigation Report  
Motor Vehicle Crash Diagram**

Police Dept: Franklin Township Police Department/Somerset Co. Code: 01

Station: FTPD Case No: 23054765

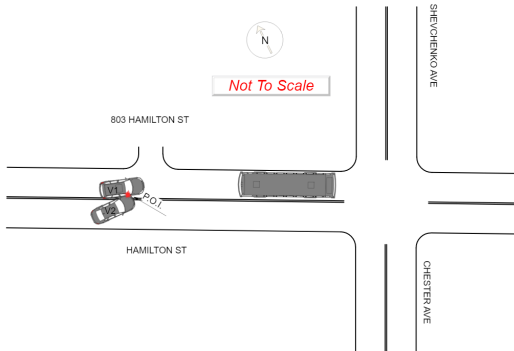
144. Crash Diagram

V1 AND V2 IMPACTED ON HAMILTON ST BY SHEVCHENCKO AVE.

D1 STATED THAT SHE WAS INITIALLY STOPPED FOR A STOPPED SCHOOL BUS. D1, WHILE THE SCHOOL BUS WAS STOPPED, MADE A LEFT INTO THE ABOVE PARKING LOT. WHILE MAKING A LEFT TURN INTO 803 HAMILTON ST WHEN V2 TURNED IN FRONT OF HER AND IMPACTED HER VEHICLE.

D2 STATED SHE WAS STOPPED FOR A SCHOOL BUS. SHE BEGAN TO MAKE A LEFT TURN AND V1 IMACTED HER VEHICLE SUDDENLY.

I OBSERVED FTPD STREET CAMERA FOOTAGE THAT SHOWED V1 ATTEMPTING TO PASS V2 ON THE LEFT OVER THE DOUBLE YELLOW LINE.

INVESTIGATION REVEALED THAT V1 WAS ILLEGALLY PASSING V2, RESULTING IN THE ABOVE IMPACT.
