# West Passaic Street Area in Need of Redevelopment Study

Township of Rochelle Park

Bergen County, New Jersey

October 24, 2022

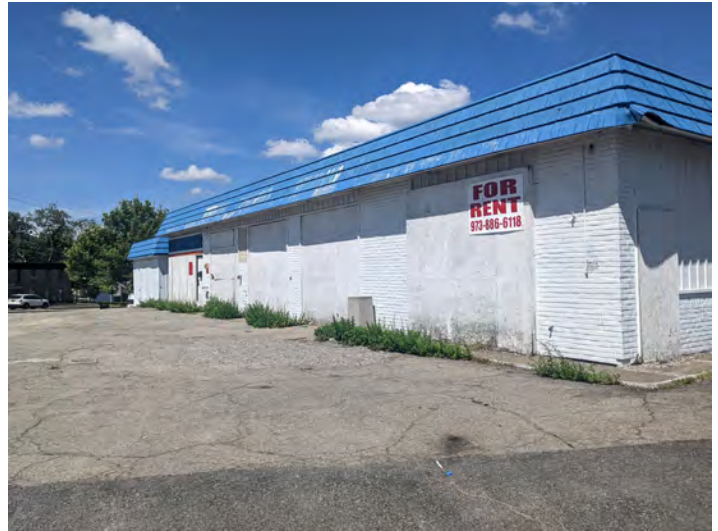
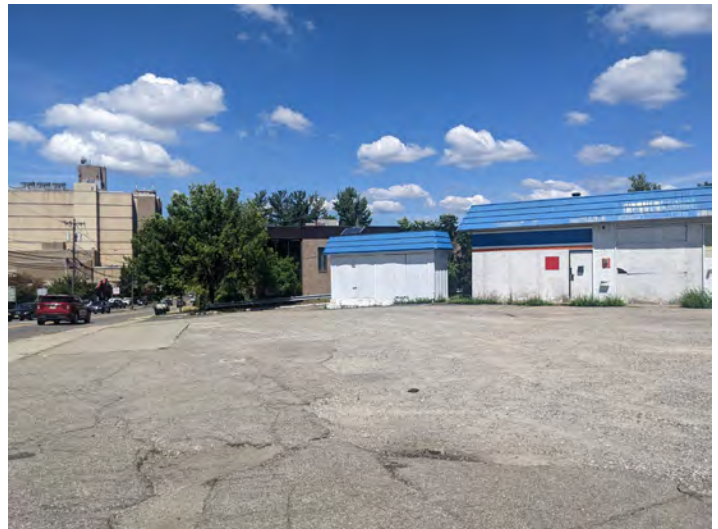
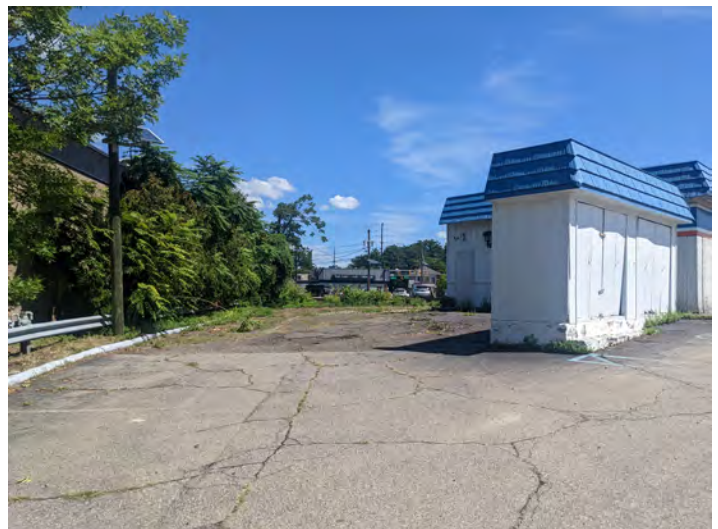
*PHOTO OF 433 ROCHELLE AVENUE TAKEN JULY 28, 2017*

The building is currently boarded up. The paint on the roof is chipping and there is a hole in at least one of the boards. The property is almost completely impervious except for an overgrown patch of vegetation at the front corner of the lot. The asphalt is cracked through and vegetation is growing through the cracks in multiple areas. The fence separating the property from Lot 1.03 is in disrepair.

The photos taken in 2017 and 2022 show that conditions on the property have barely changed and there has been no occupancy or commercial activity for at least five years.

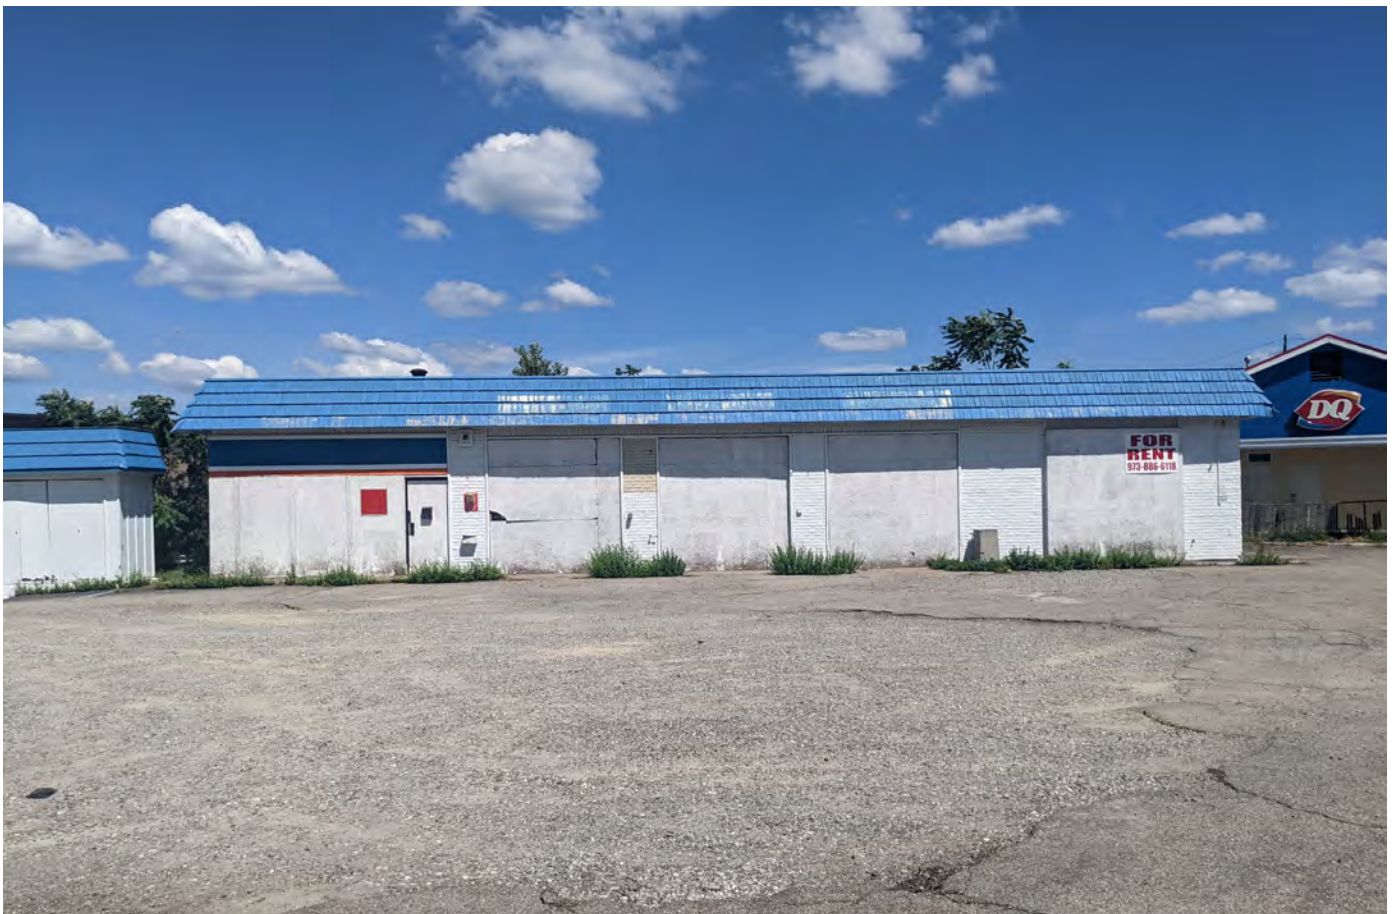
*PHOTO OF 433 ROCHELLE AVENUE TAKEN AUGUST 16, 2022*

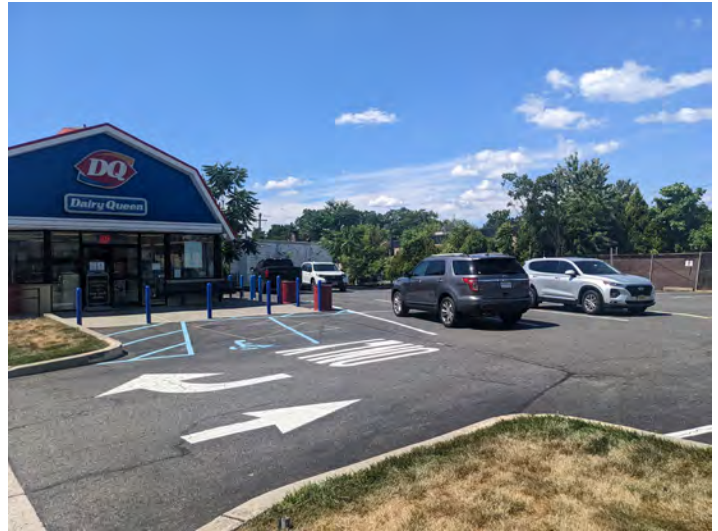
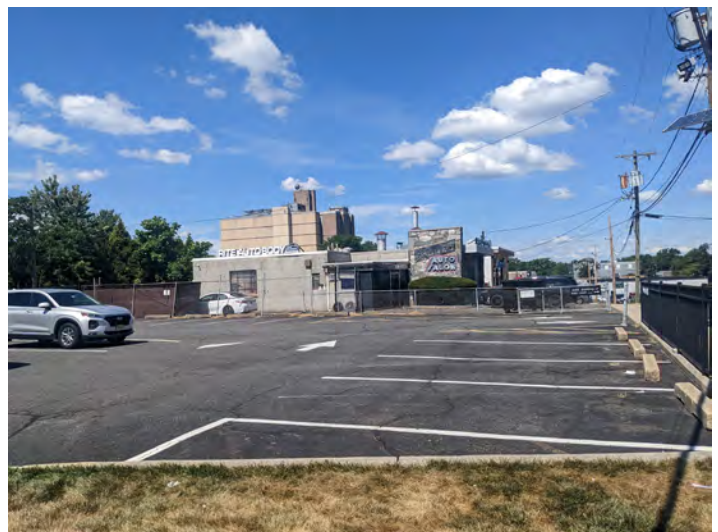
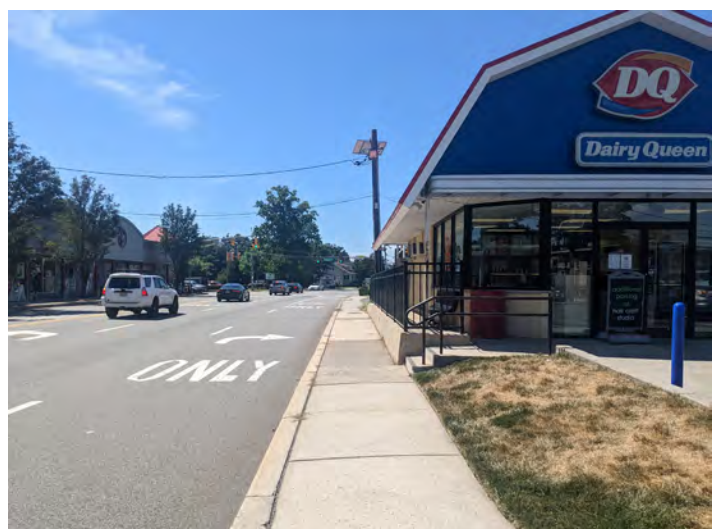
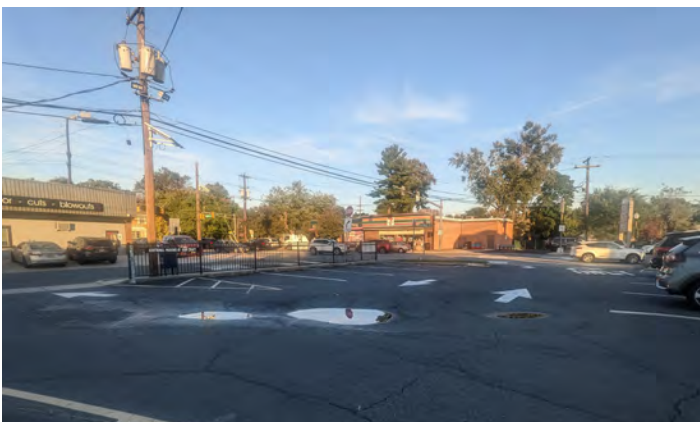
Aside from several small lawn areas near the driveways around the perimeter of the parking lot, the site is entirely impervious. Water was observed ponding on the property during a site visit.

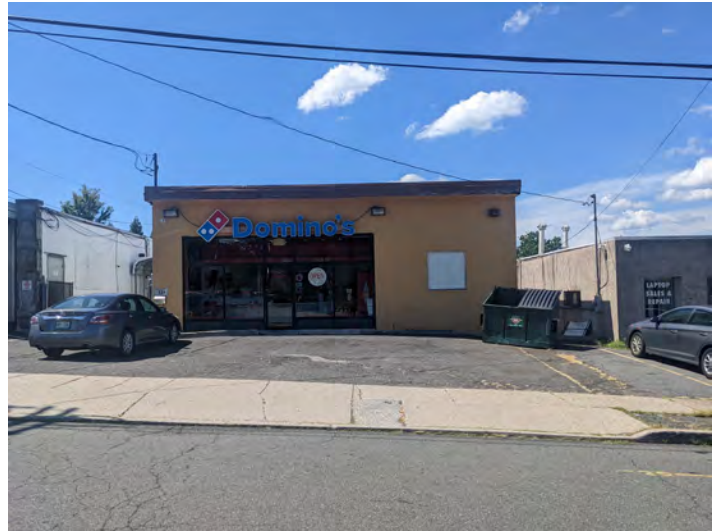
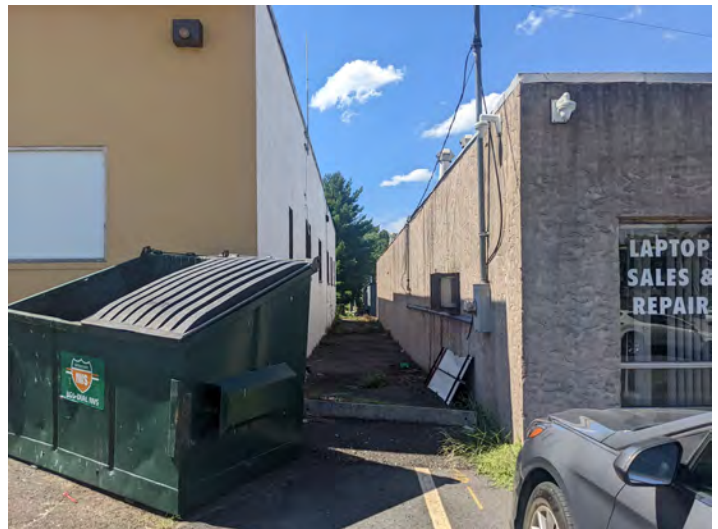
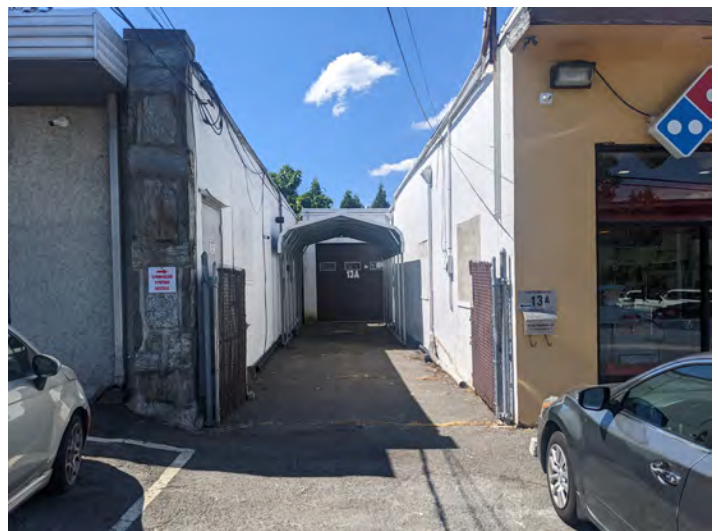
The front yard acts as a parking lot. Vehicles exiting the property have to back into Overlook Avenue since there is no room to maneuver on-site. There is no striping for parking spaces and the asphalt is deteriorating as there are areas of cracking where vegetation is growing through. An unenclosed dumpster is adjacent to the front building façade in the parking area. The property lacks proper ADA parking and access.

The façade of the building shows signs of disrepair. One of the windows is boarded up, and the concrete in front of the building entrance appears uneven and chipped. The paint on the trim of the roof is chipping and appears worn. Zoning and building permits show a permit was issued in January of 2021 to remove and replace the rubber roof.

On the northwest side of the building, there are a few feet of space between the restaurant and the building on Lot 32. The area is unpaved with sporadic vegetative growth and accumulating trash.

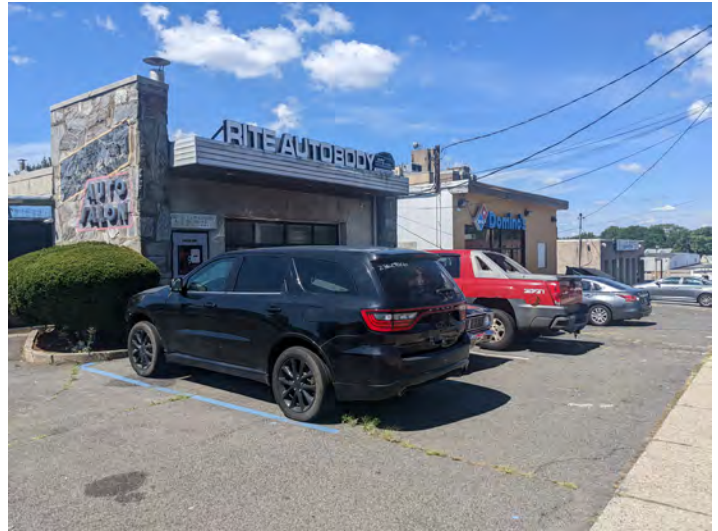
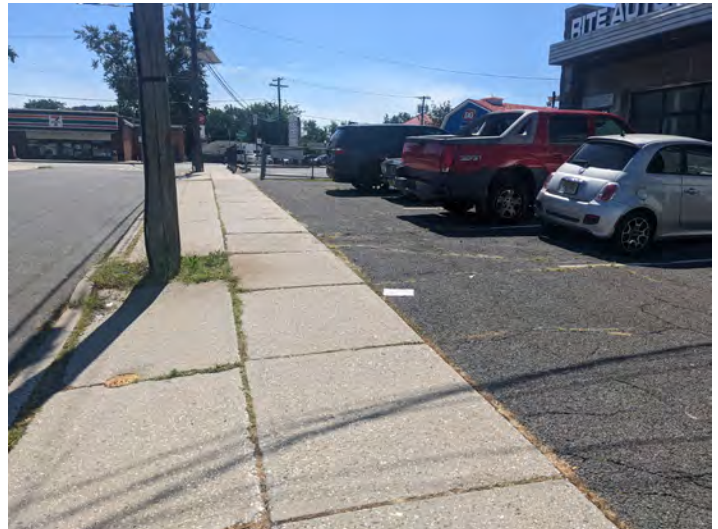
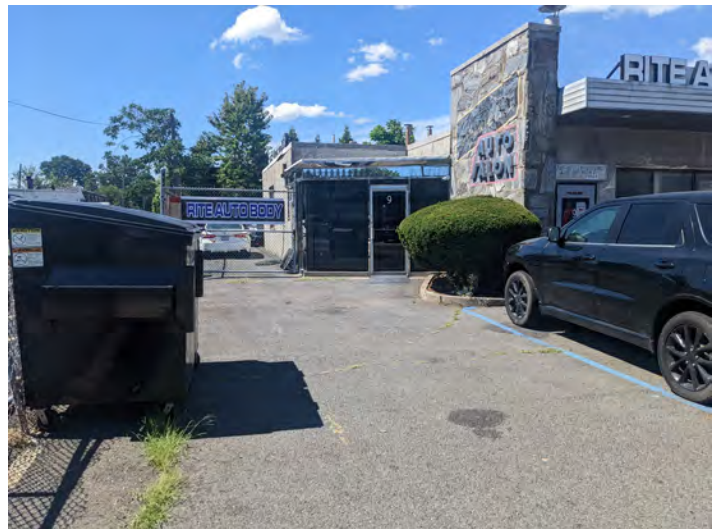
The roof downspout empties into the parking area. The grading of the site has the elevation decrease toward the neighboring Domino's, so the water likely flows onto the neighboring property. No stormwater management facilities were observed on the entirely impervious site.

There are four parking spaces in the parking area, one of which is marked as an ADA accessible space, but there is no access aisle. The space closest to the northwest property line is directly in front of a utility pole. Entering and leaving the parking space risks hitting the pole. There are cracks in the asphalt with vegetation growing through. There is also evidence of previous spills or leakage on the property. An unenclosed dumpster is in the front parking area against the neighboring chain link fence.

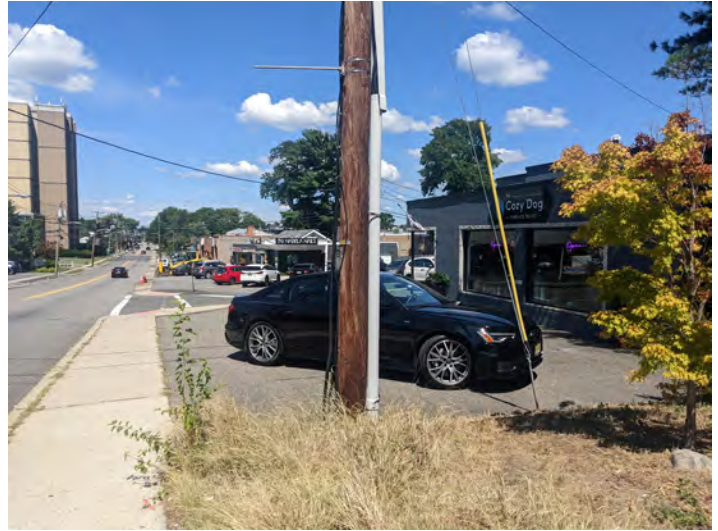
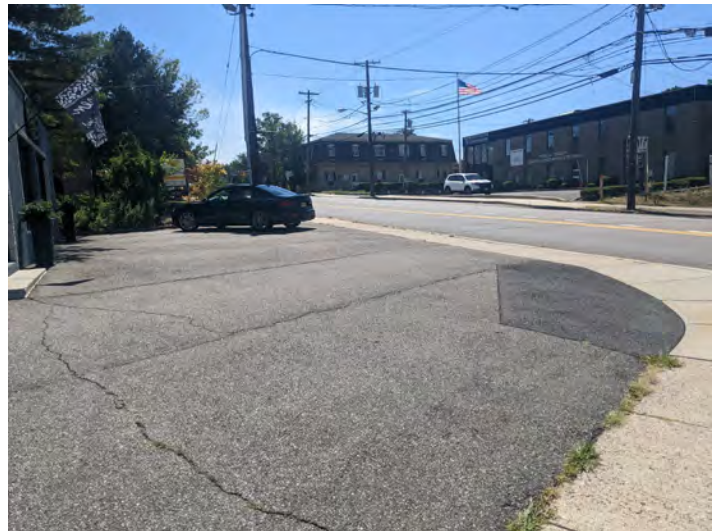
The front yard of the property is entirely impervious and serves as parking for the store. The pavement shows wear as there are cracks throughout. No stormwater management facilities were observed on-site.

There are no painted lines for the parking areas, but the parking configuration allows for a single line of cars along the building. This configuration requires cars to back out into the right-of-way to leave. Additionally, an unenclosed, open dumpster is located alongside the building in the parking area. No ADA parking or other accessible facilities were observed.

UNCONTROLLED DRIVEWAY AND PARKING LOT ALONG WEST PASSAIC STREET

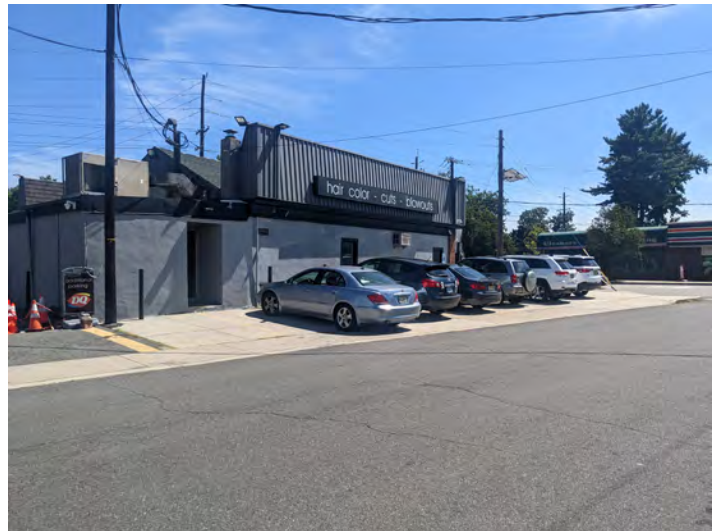
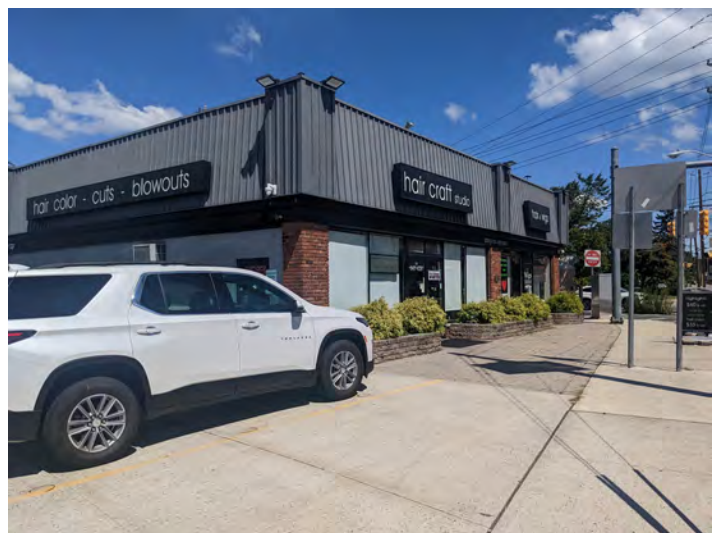
On two separate site visits in August and October 2022, the parking area was observed to be suffering from faulty arrangement and overcrowding. During both visits, one late weekday morning and the other late weekday afternoon, vehicles were observed parked outside designated parking areas on the sidewalk. The parking area along Overlook Drive extends into the right-of-way and over the sidewalk. The designated ADA accessible parking space near the intersection of Overlook Drive and Rochelle Avenue lacks the appropriate clear access area and striping. In sum, the conditions are reflective of faulty parking design and demonstrate that the site cannot accommodate the level of activity that is taking place.

VEHICLE PARKED BLOCKING SIDEWALK AND PORTION OF THE DRIVEWAY

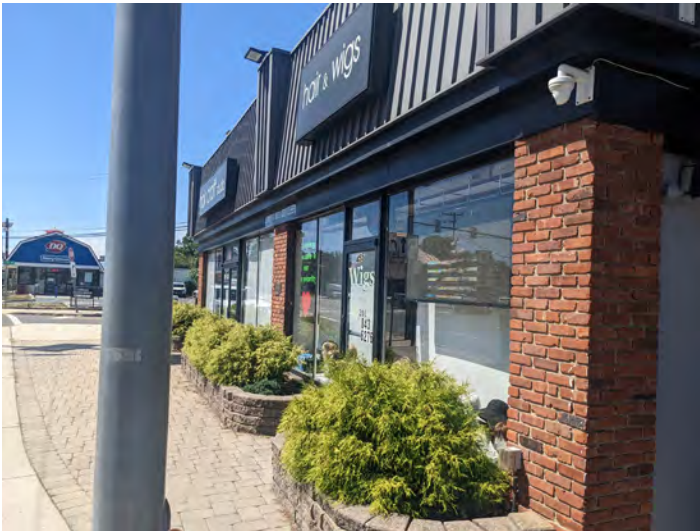
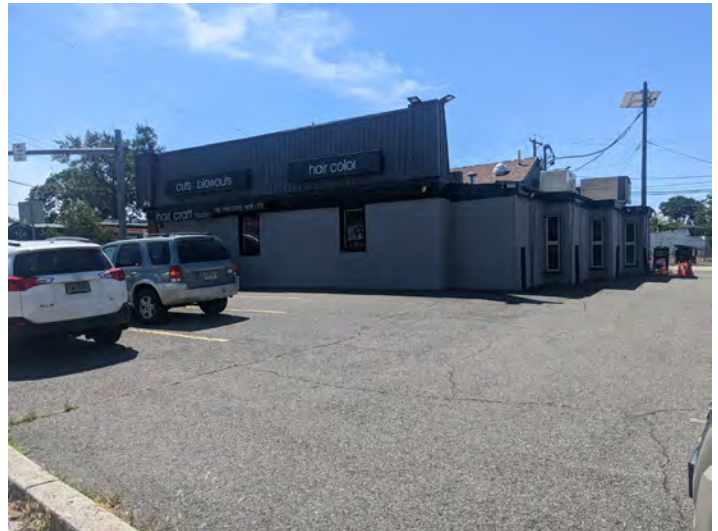
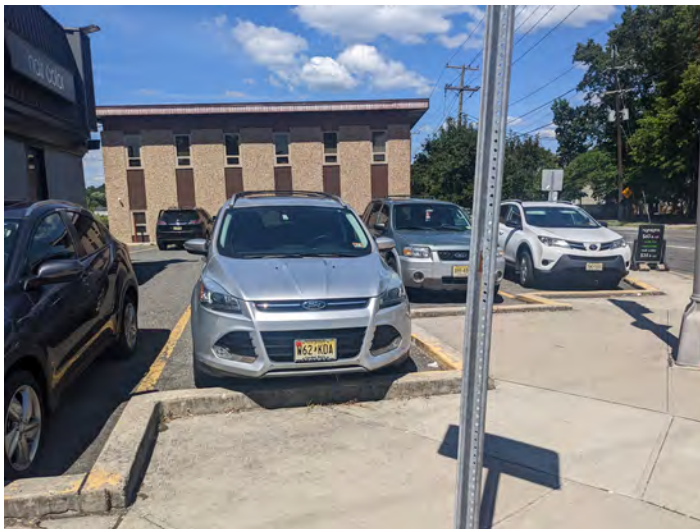
The lack of properly designed ADA accessible features, the overflow of the parking into pedestrian areas and the right-

of-way, and the arrangement of the parking that requires backing into the street are all potentially detrimental to the general welfare.

*PARKING THAT HAS TO BACK INTO THE STREET*

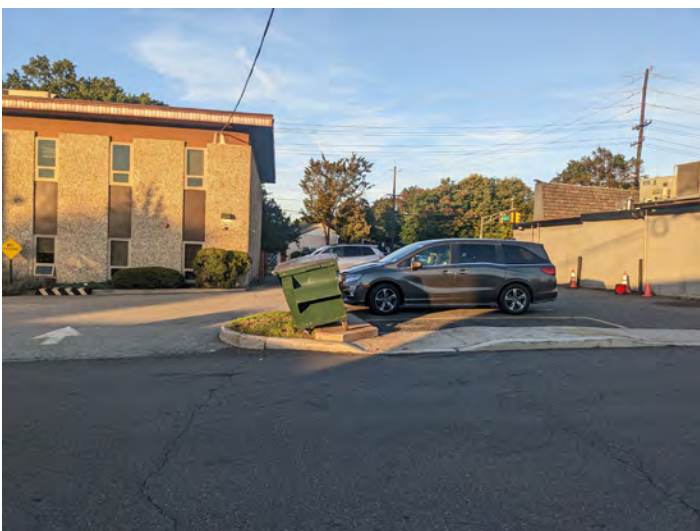
*DUMPSTER TIPPING TOWARD NEIGHBORING PROPERTY*

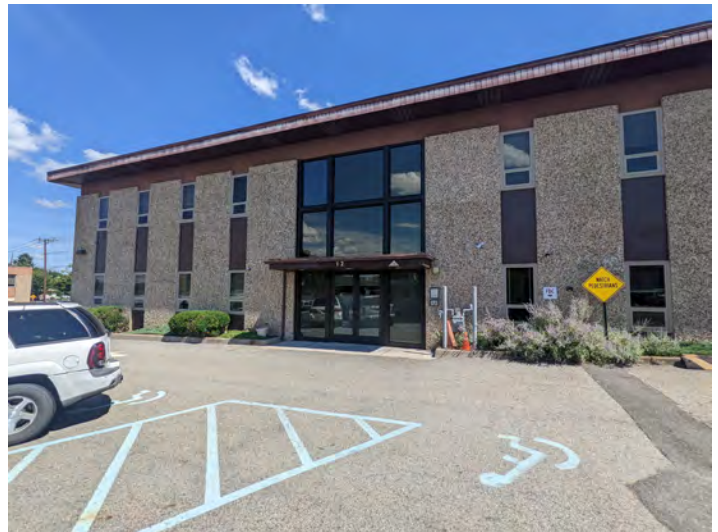
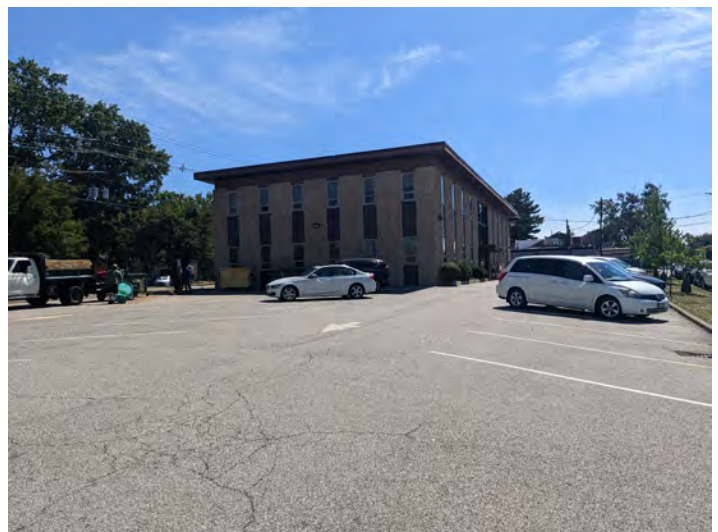
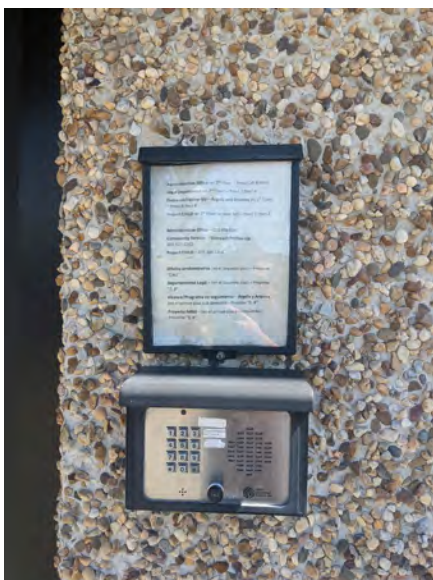
The exterior of the building is in fair condition. The coloring on the roof eave is fading and some of the trim is buckling.

The portion of the parking lot on Lot 5 has 31 parking spaces, two of which are ADA accessible. Eleven spaces are at 90 degrees while the remaining 20 parking spaces are at 45 degrees. Three of the parking spaces are blocked by three unenclosed dumpsters in the parking lot. There is some cracking in the parking lot asphalt, and the parking lot has no pedestrian amenities such as crosswalks or sidewalks.

The lot generally slopes toward Overlook Avenue. The only stormwater management infrastructure visible on the property is an inlet drain near the driveway to Overlook Avenue.

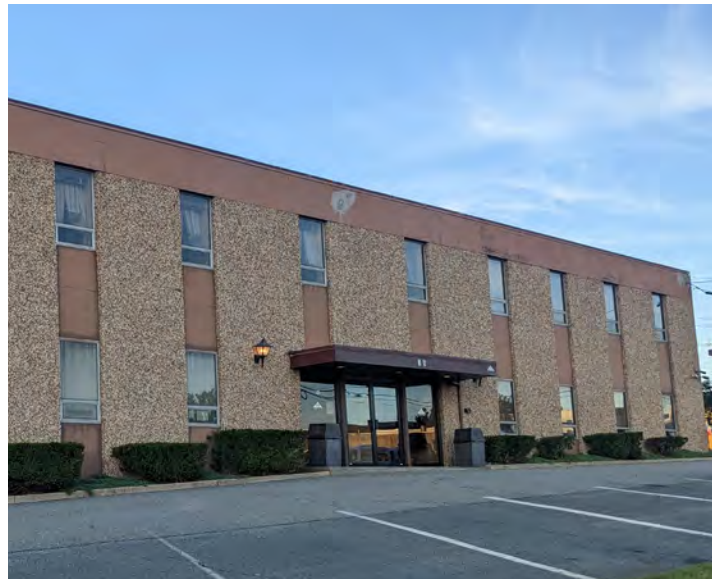
The building façade shows signs of damage. The paint is peeling in multiple areas and is completely gone in others. There appears to be water damage near the building foundation facing Overlook Avenue. Vegetation at the northern corner of the lot along Overlook Avenue is overgrown and blocking the right-of-way.

There is no visible stormwater management infrastructure in the parking lot. The property slopes from east to west toward an inlet in the Overlook Avenue right-of-way.

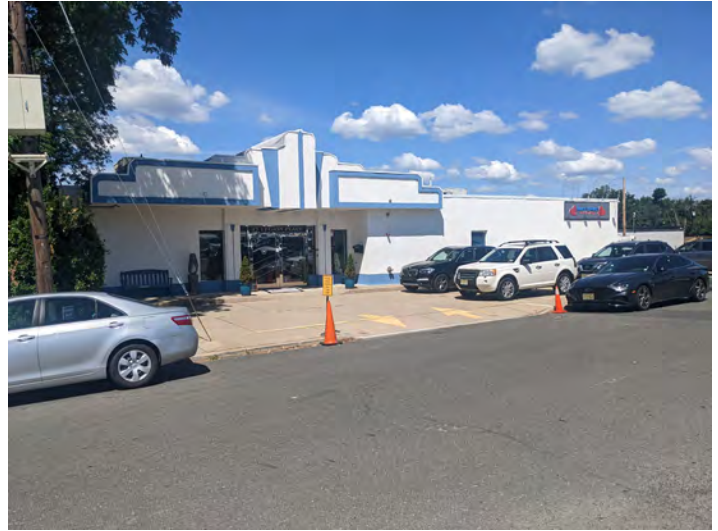
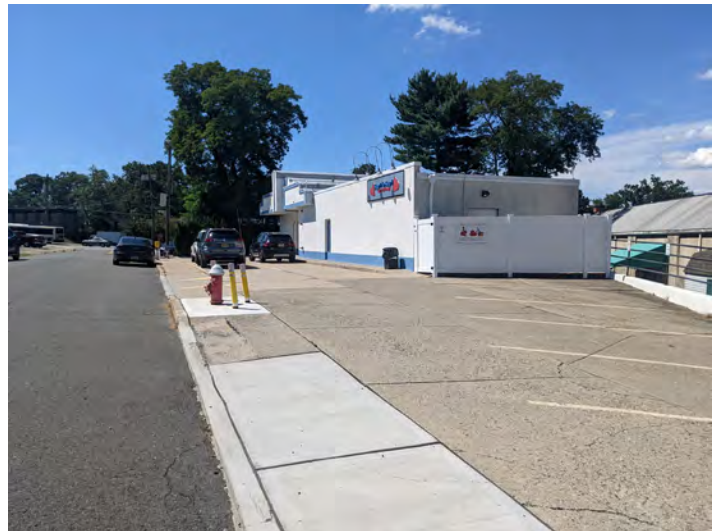
The parking lot is accessed through three curb cuts, all along Legion Place. Two pick-up / drop-off lanes run in front of and parallel to the building and Legion Place. There are seven angled parking spaces next to the building. There are no ADA accessible parking spaces despite one being depicted on the site plan that was approved by the Board (see Figure 6).

The pavement is showing signs of deterioration with cracks throughout. There is a fire hydrant between the angled parking spaces and the road, cordoned off by yellow bollards to prevent cars from accidentally running into it. The angle of the parking spaces and the width of the parking aisle require pulling out into the right-of-way to exit the parking area.

*APPROXIMATE LOCATION OF ADA SPACE SHOWN ON THE SITE PLAN*

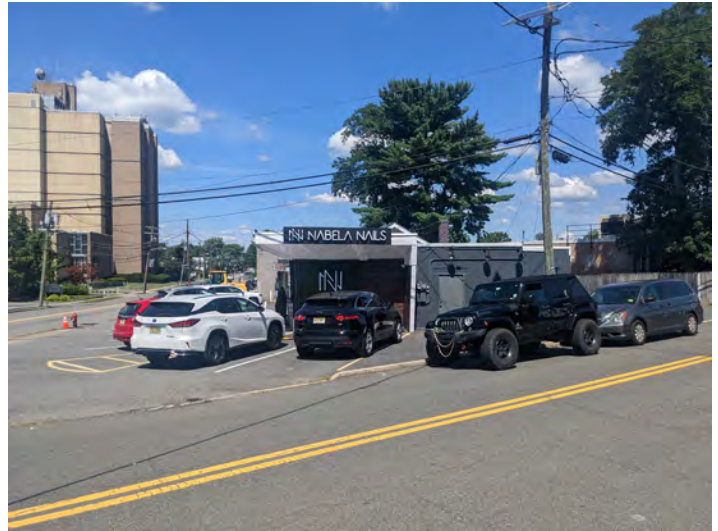
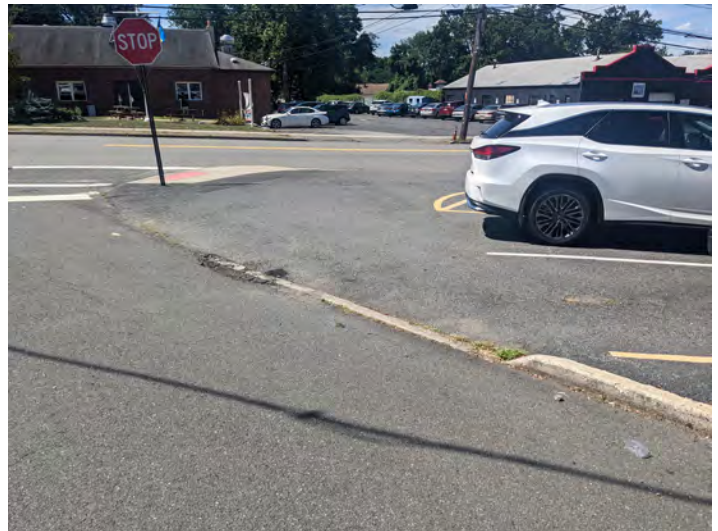
Leaving the two parking spaces accessed from Legion Place requires backing out into the right of way at the stop sign and pedestrian crosswalk with potentially obstructed vision of oncoming traffic because of cars parked along the road. There are no curbs along the parking lot, regulating access and circulation at any point. However, for the spaces along West Passaic Street, the existing fire hydrant poses a hazard when backing out and entering the lot. A traffic cone was observed next to the hydrant, but there is no permanent protective barrier between the hydrant and drive aisle.

*PARKING SPACES THAT REQUIRE BACKING INTO THE INTERSECTION*

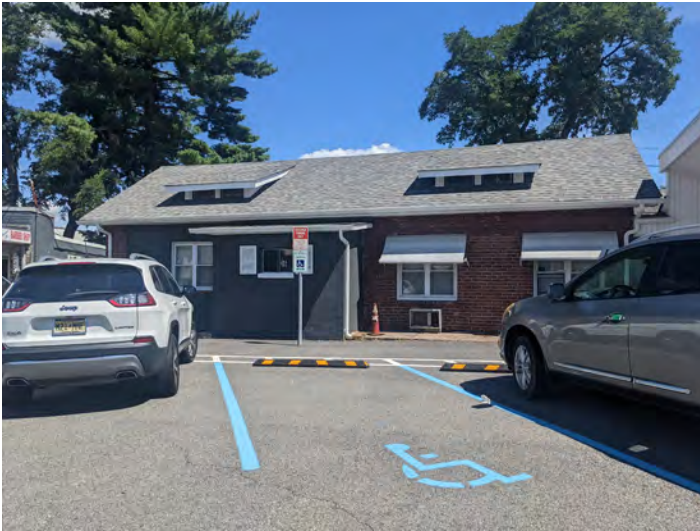
ADA SPACE WITHOUT ACCESS AISLE

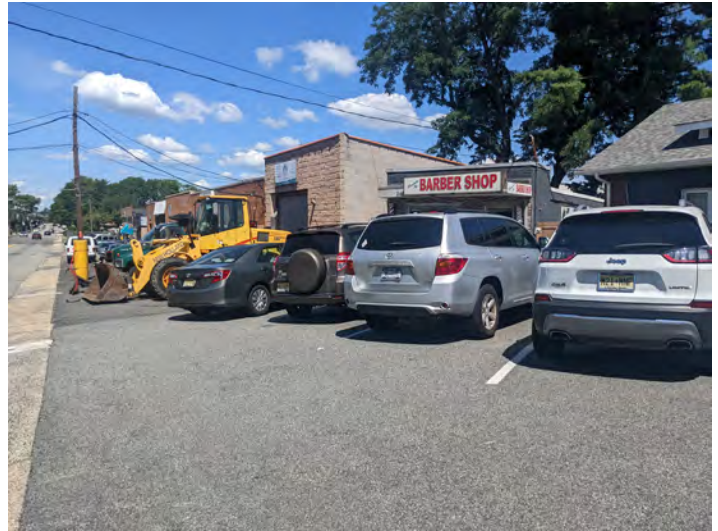
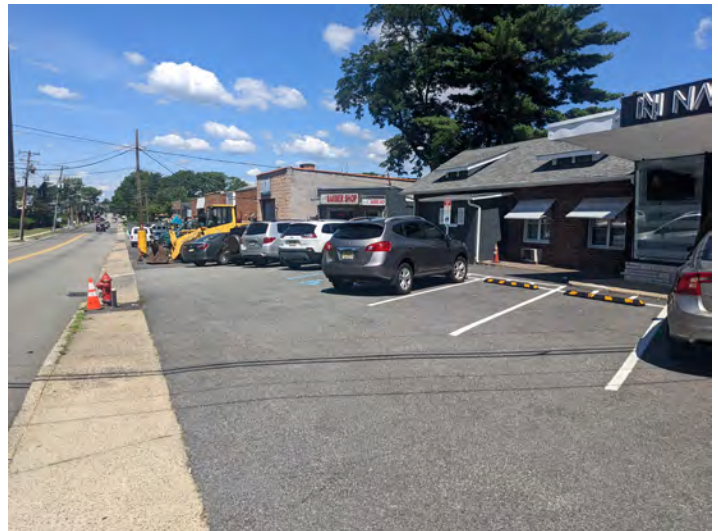
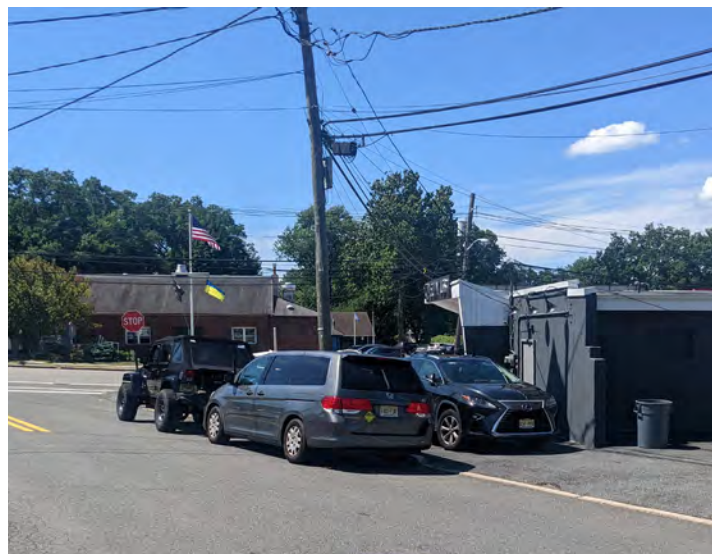
HYDRANT ALONG PROPERTY FRONTAGE OBSTRUCTING SIDEWALK AND VULNERABLE TO VEHICLES ENTERING AND EXITING THE SITE

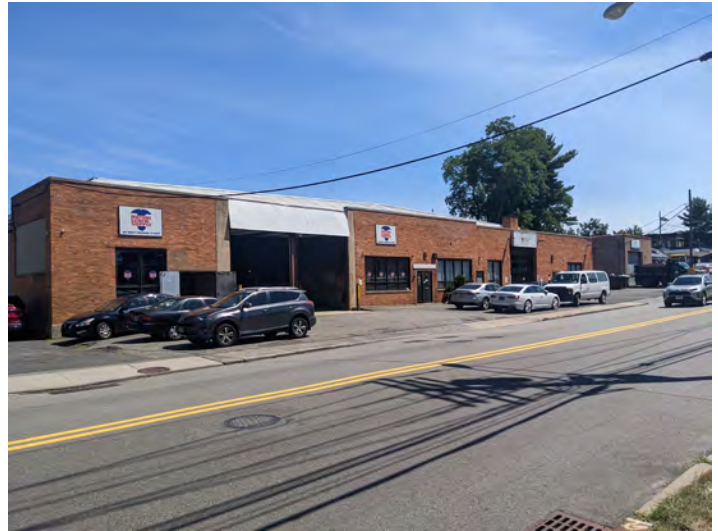
The front yard of the property is entirely impervious with no curb and functions as a parking lot for both uses. The asphalt shows signs of deterioration as sections are cracked and uneven.

FRONT YARD PARKING ALONG WEST PASSAIC STREET

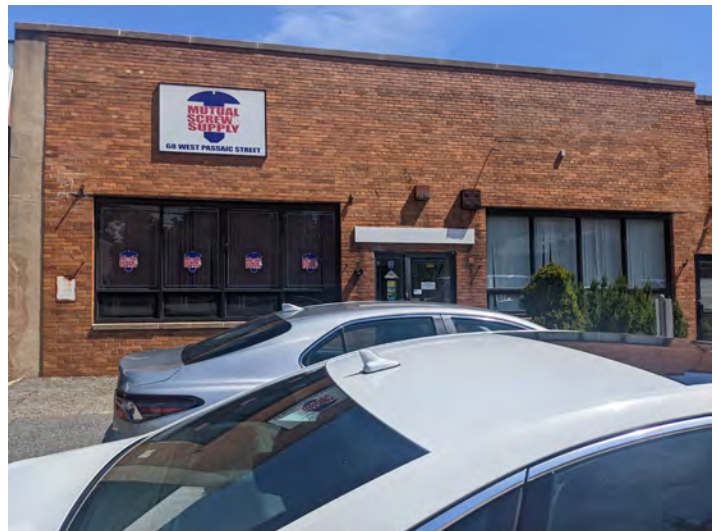
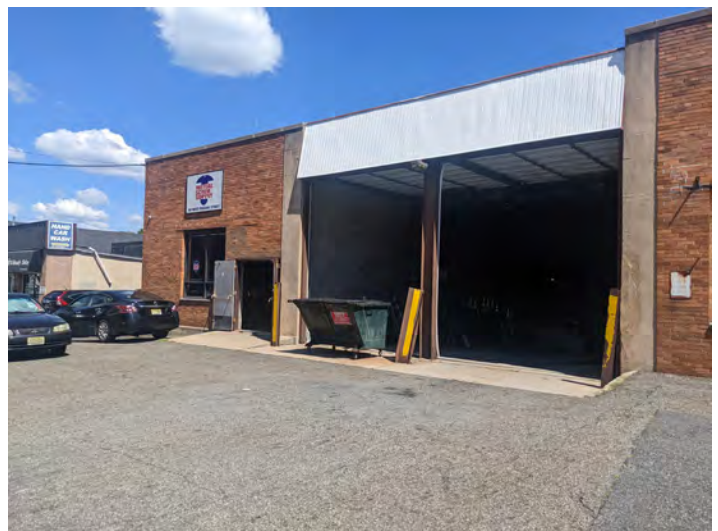
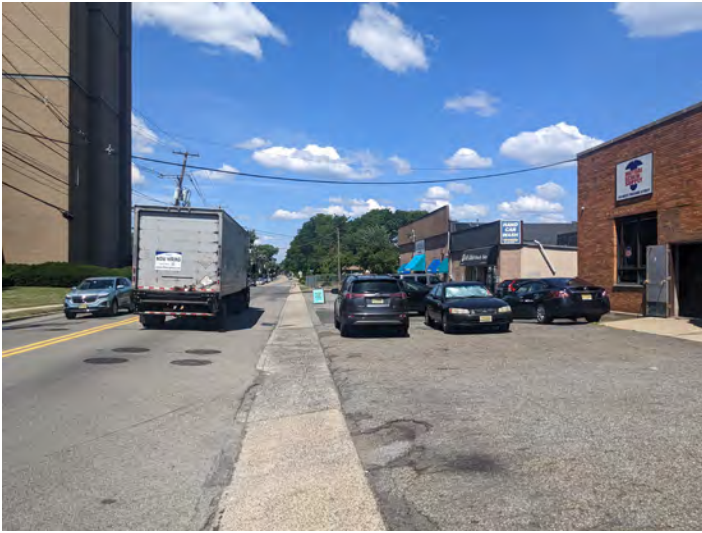
*PARKING IMMEDIATELY ADJACENT TO WEST PASSAIC STREET*

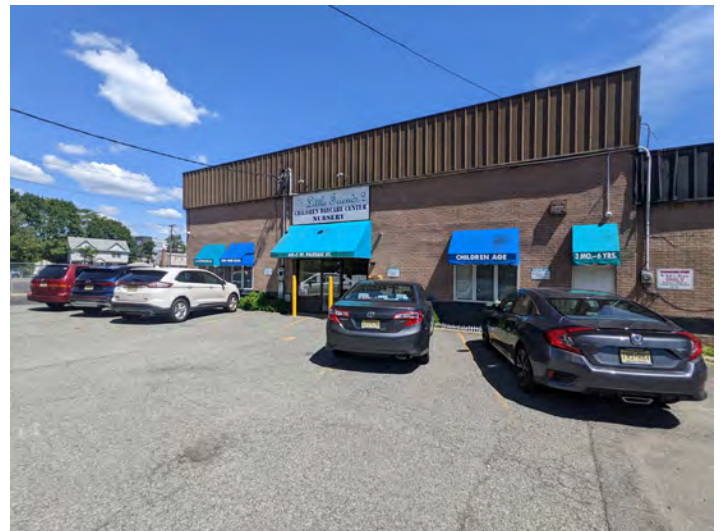
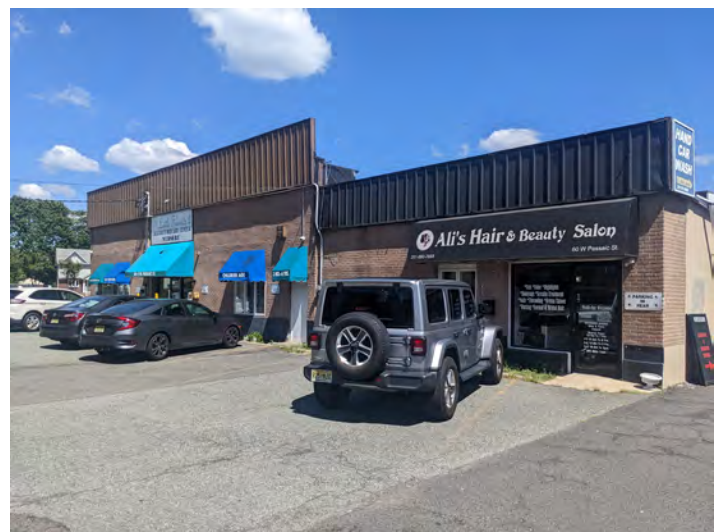
During the site visit on a sunny summer morning, the car wash line was observed multiple times extending into West Passaic Street. The overcrowded conditions and faulty arrangement of the property create a detriment to both the on-site users and the general welfare by disrupting travel on West Passaic Street and creating potentially dangerous uncontrolled circulation conditions on the property.

*CAR WASH LINE BACKING INTO WEST PASSAIC STREET*

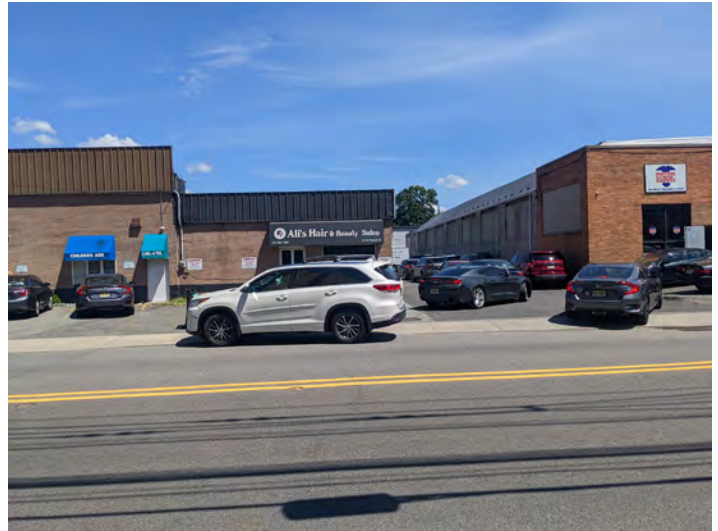
*CHAOTIC CIRCULATION BETWEEN CAR WASH LINE AND FRONT YARD PARKING*

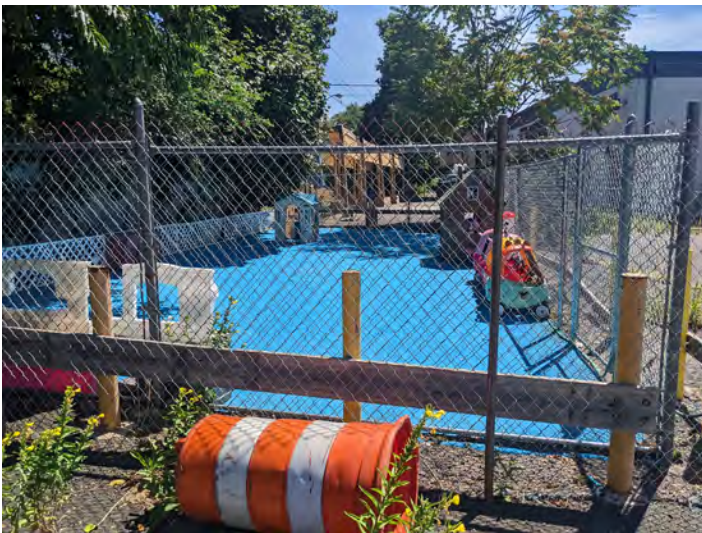
*PLAYGROUND IN THE REAR YARD*

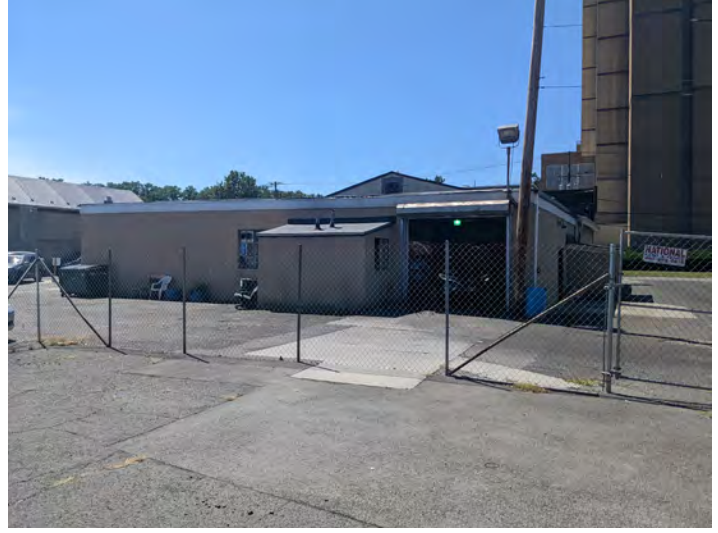
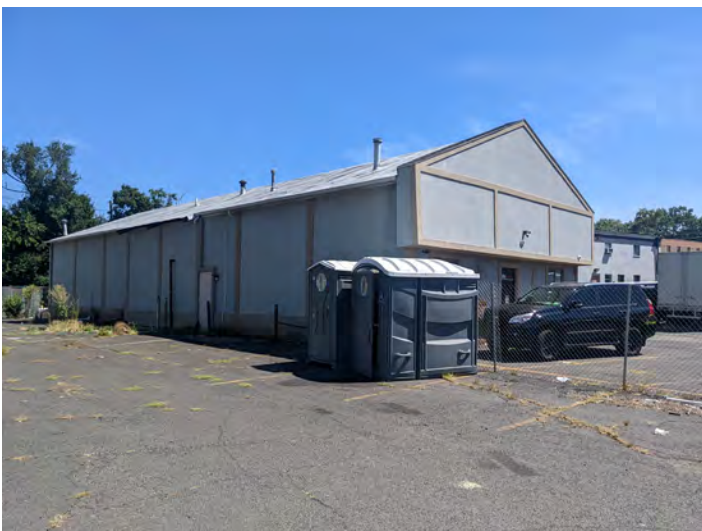
*MITE BUSTER PEST CONTROL*

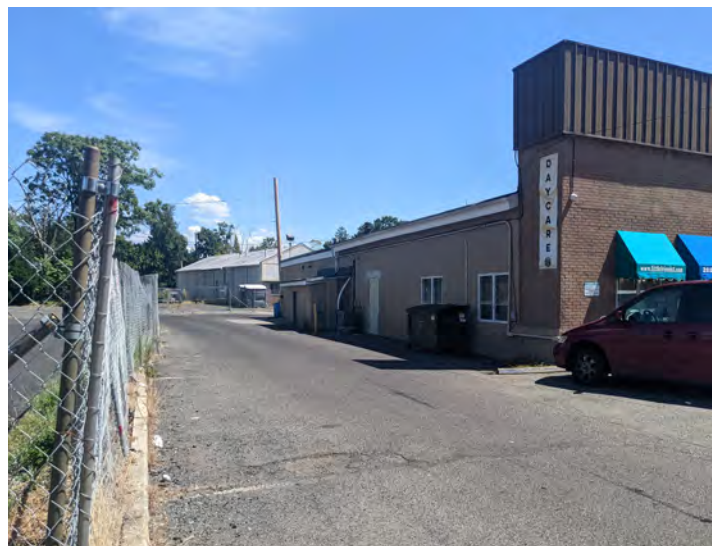
*WEST SIDE OF THE BUILDING - DAYCARE IN THE FRONT, CAR WASH IN THE BACK*

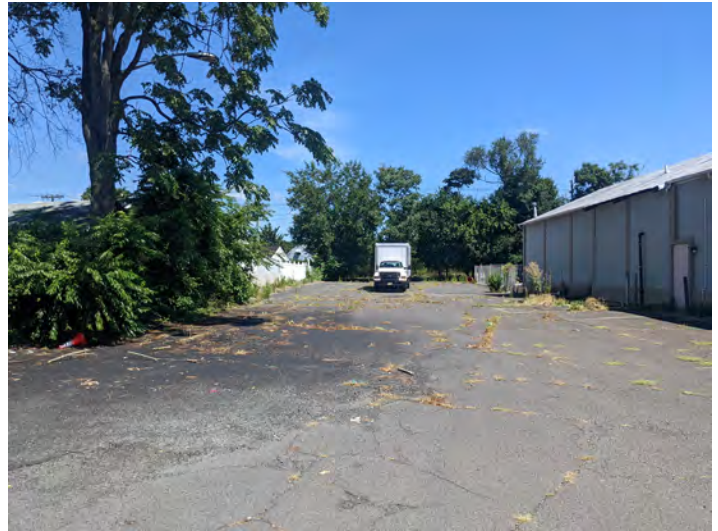
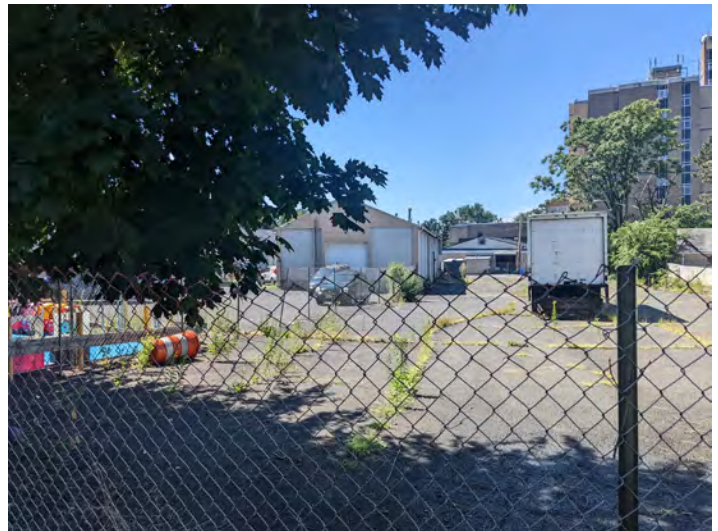
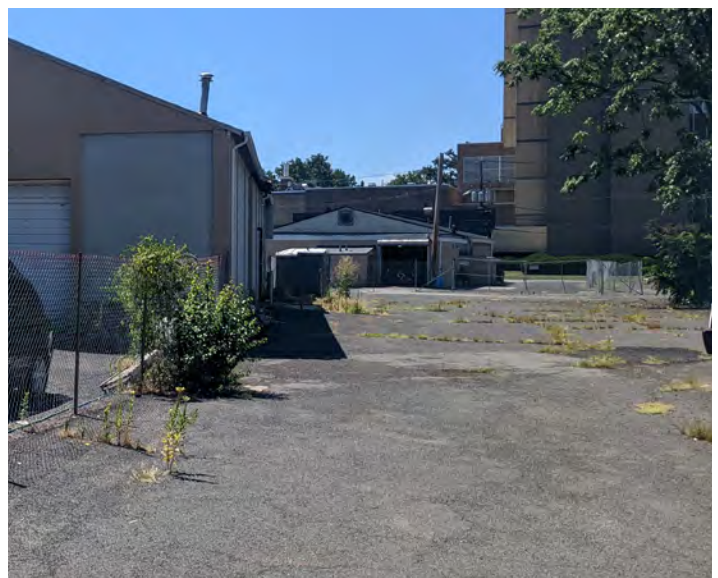
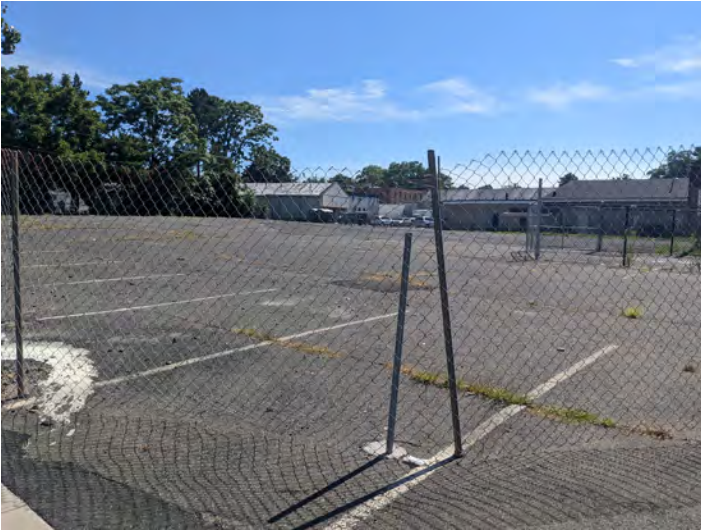
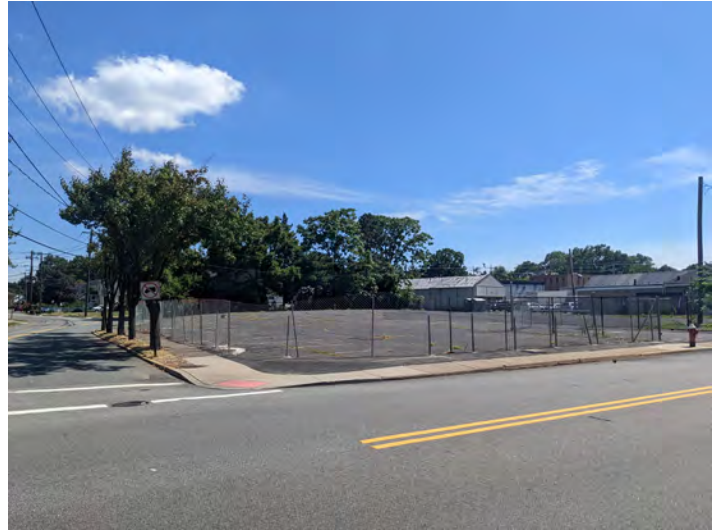
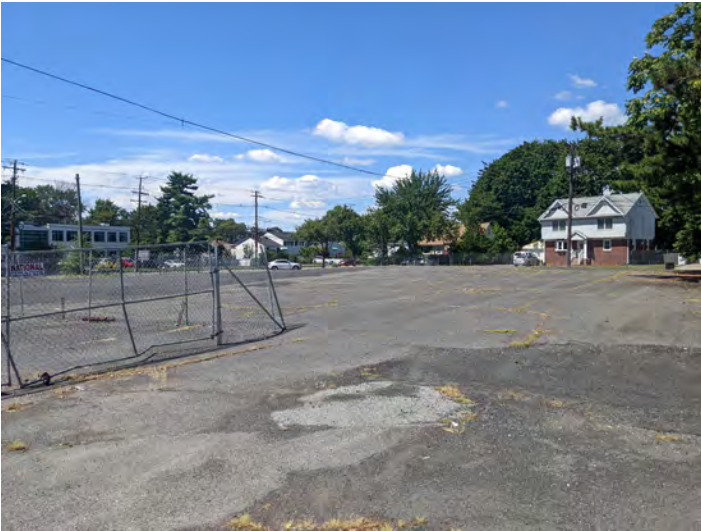
The lot is entirely covered with impervious surface and is surrounded by a chain link fence with some newer portions and some sections in disrepair. Vegetation is growing through the numerous cracks throughout the parking lot. Trash is accumulating in the rear of the lot.

There is no stormwater management infrastructure on the property. A significant portion of the property is in the AE Flood Hazard area with a base flood elevation of 43 feet. The elevation of the property ranges from approximately 40.75 feet in the southwestern corner near the intersection of Fairfield Drive and West Passaic Street to about 44.5 feet in the northern portion near Plaza Way.
