# West Passaic Street Area in Need of Redevelopment Study

Township of Rochelle Park

Bergen County, New Jersey

October 24, 2022

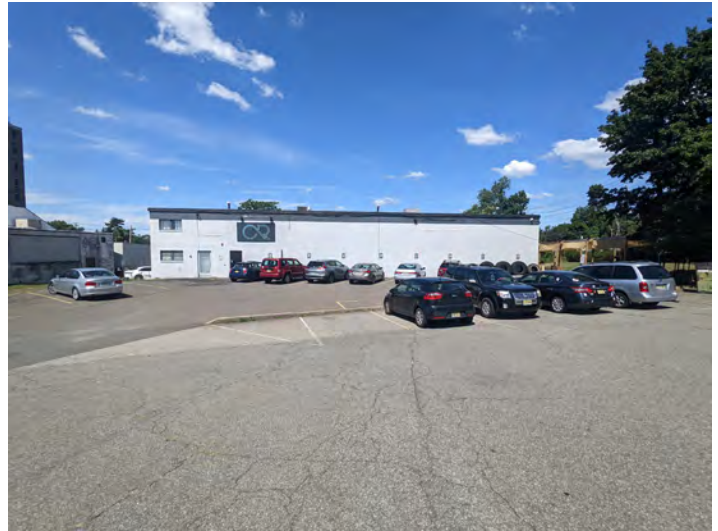
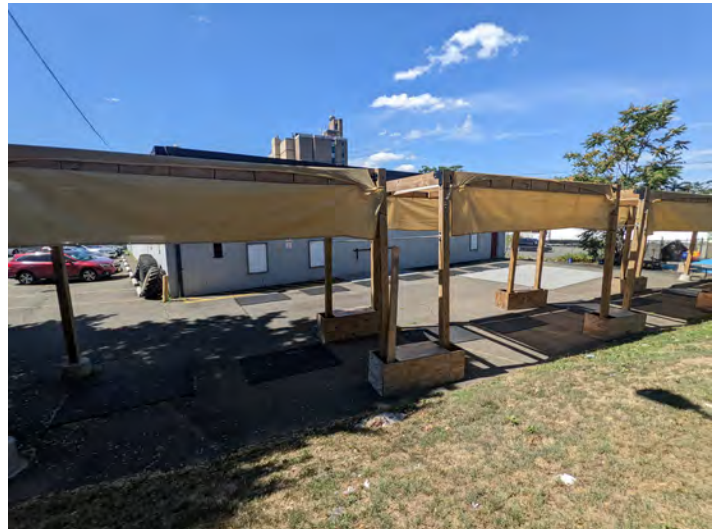
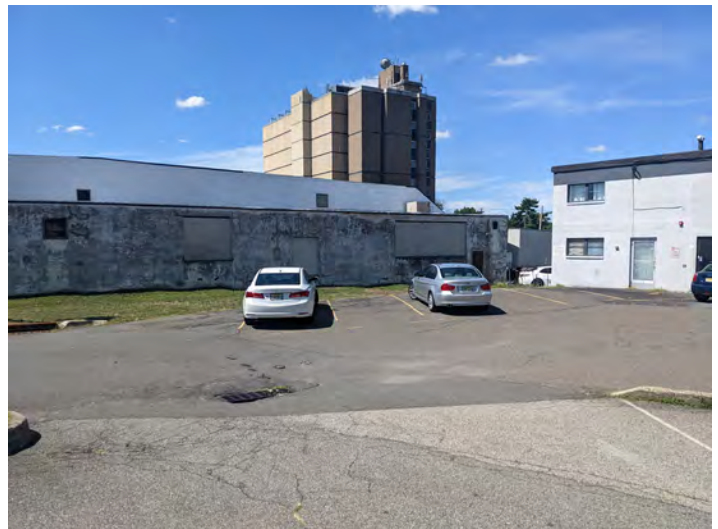
The parking lot wraps around to the northern side of the building, but these spaces are occupied by the facility's workout equipment. At the time of site visit, outdoor storage of gym equipment, including tires, mats, and buckets, was observed.

No stormwater management facilities were observed on the property, which is nearly entirely covered in impervious surfaces.

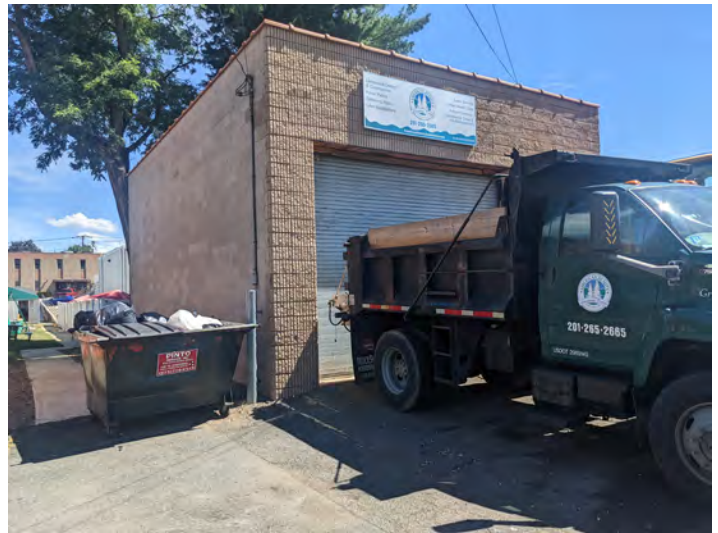
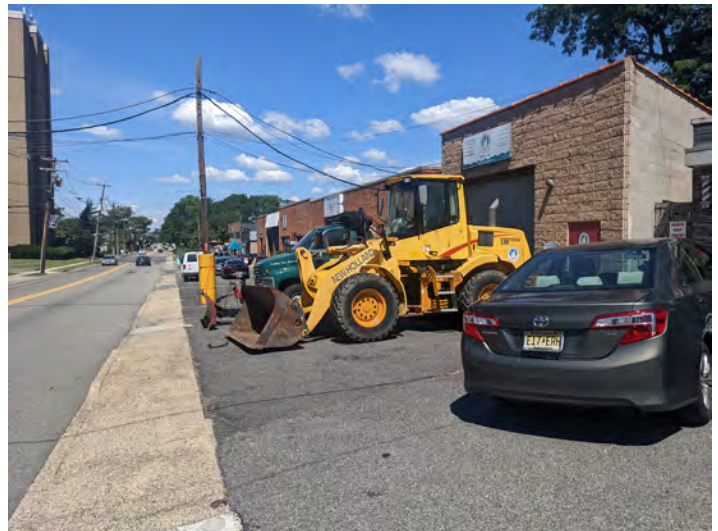
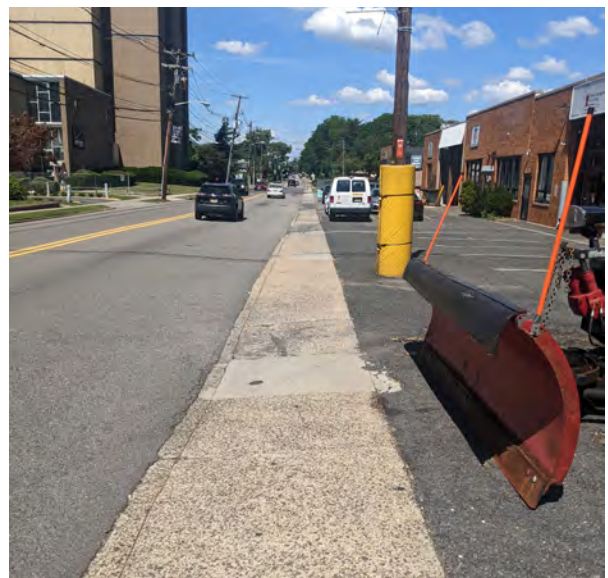
During the site visit, construction equipment and heavy trucks were parked in the front yard along West Passaic Street. The vehicles were just off the sidewalk and within the potential 10 foot widening area. The property lacks on-site parking and circulation area, particularly for heavy equipment. The narrow space in front of the garage door is the only parking or loading space on-site. If machinery like the front end loader observed on-site needs to be loaded onto a trailer, it appears that the loading would have to take place within the right-of-way.

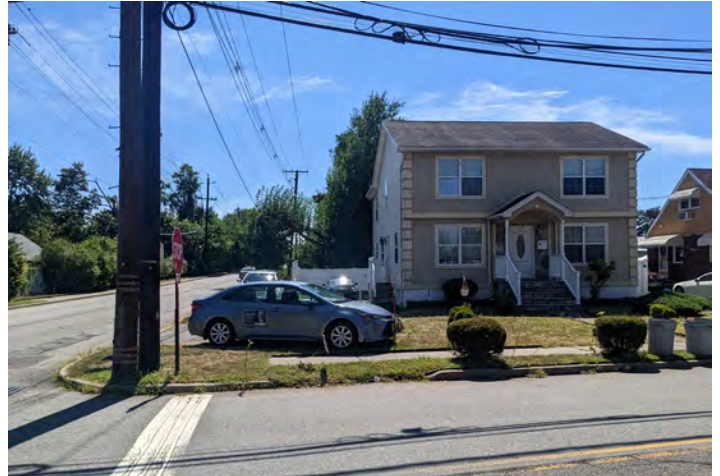
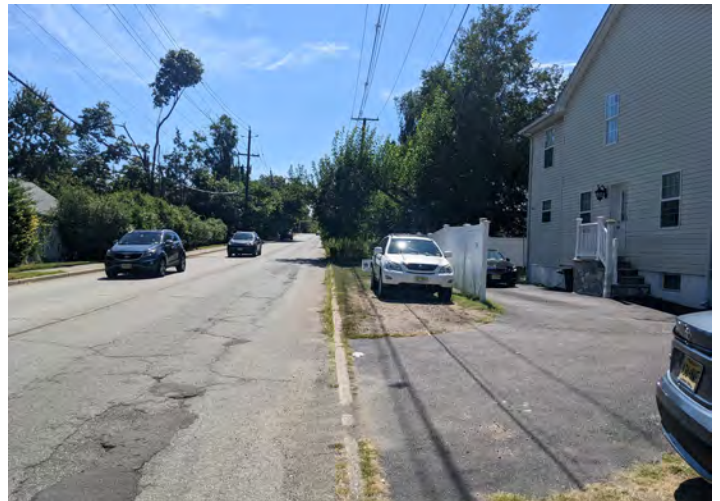
The driveway is located on Plaza Way a few feet from the intersection. The configuration and size of the driveway results in vehicles parked on the side and front lawn of the property, almost obstructing the sidewalk. The ground beneath the parked cars shows signs of erosion. There are seven police calls associated with the property since January of 2015 for a motor vehicle crash with no injuries (1), open door/window (4), suspicious person (1), and downed wire (1).

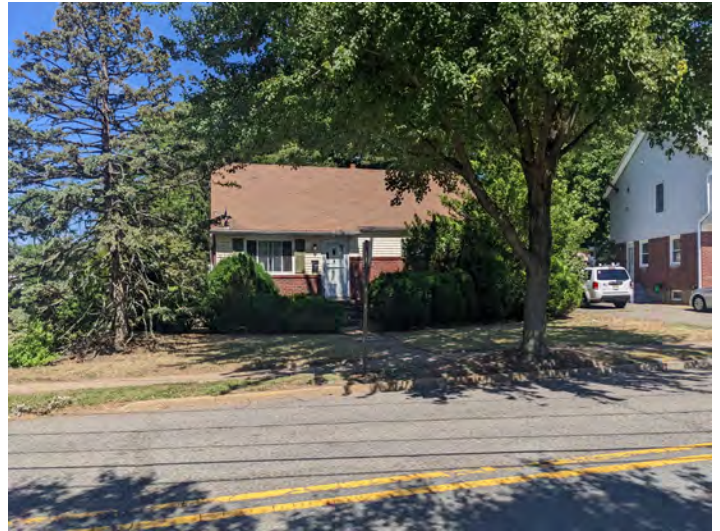
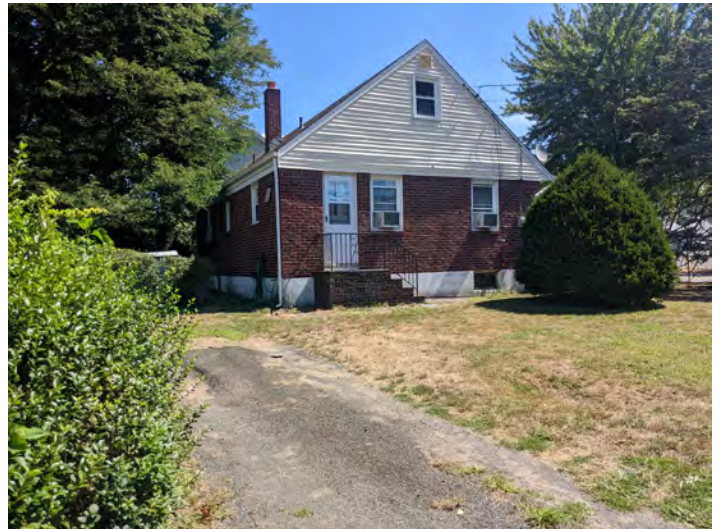
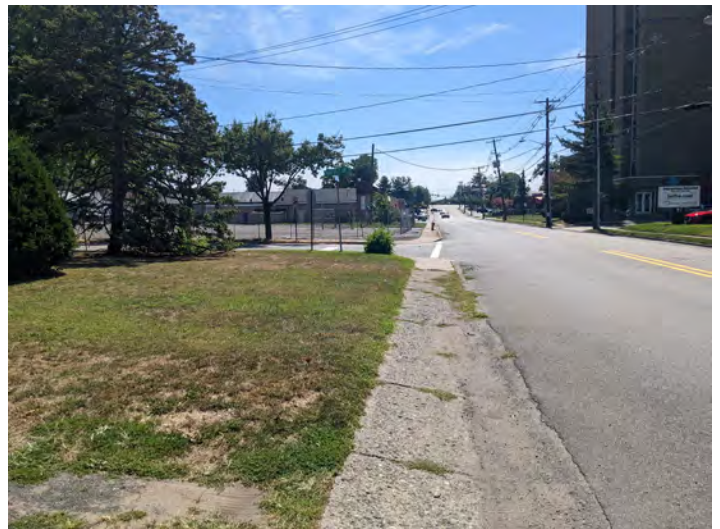
Block 91.02 Lot 1 is a 0.13-acre lot corner lot at the intersection of Fairfield Drive and West Passaic Street in Rochelle Park's Residential District. The property is undersized for the Residential District with a lot depth of only 67.96 feet. The 1.5-story, single-family home was built in 1950 and has four bedrooms and two bathrooms. The building exterior appears to be in good condition. The front entrance for the home is on Fairfield Drive. The driveway for the property is accessed on West Passaic Street. The driveway shows signs of wear with uneven parts and vegetation growing through cracks. The sidewalk along West Passaic Street is in poor condition.

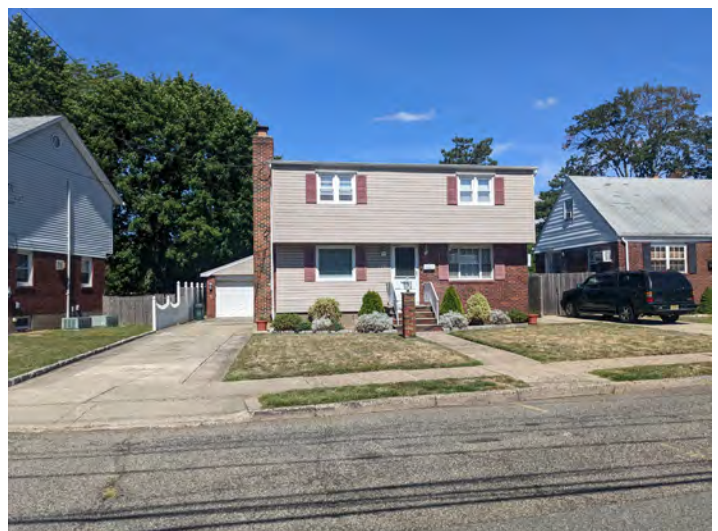
Block 91.02 Lot 3 is a 0.12-acre lot in Rochelle Park's Residential District. The lot is currently developed with a two-story, single-family home and two-car garage built in 1950. The dwelling has four bedrooms and three baths. A vinyl fence surrounds the rear yard of the property and is slightly discolored. The eave of the garage shows some damage as it appears to be pulling apart from the roof.

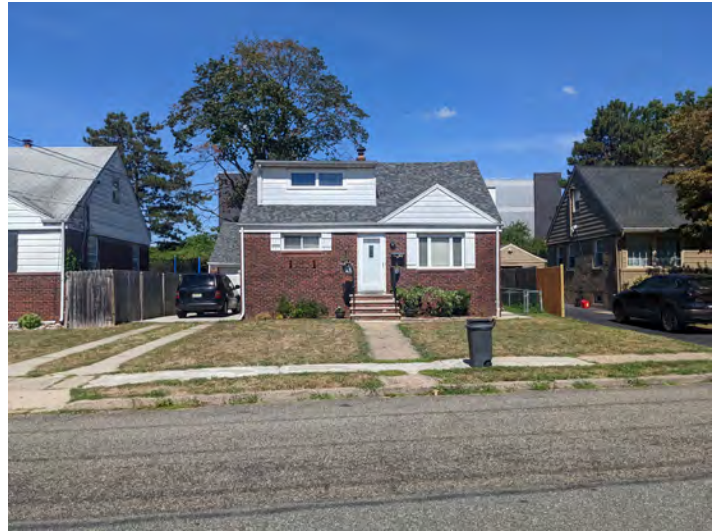
There is some discoloration on the building façade on the rear side of the building. This discoloration may be indicative of mold or algae growth from excessive moisture.

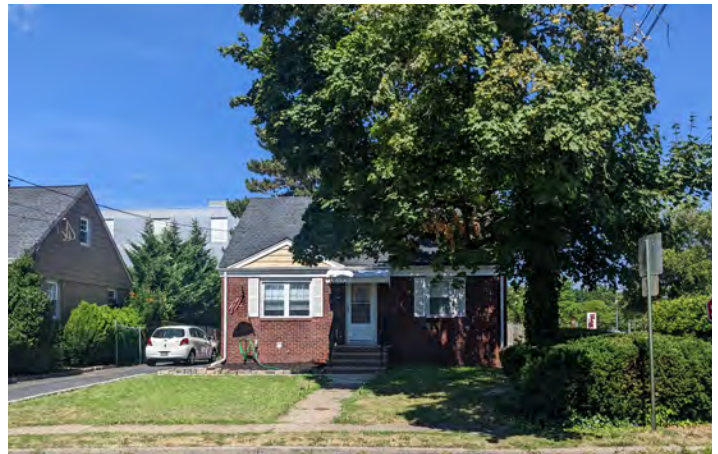
There is some discoloration on the building façade facing Plaza Way. The tan paint appears chipped near the lower window, and the foundation is stained black in areas.
