# Main Inspections Pipe Run

| <b>10/21/21 KEYPORT 3RD ST STORM</b> | <b>KEYPORT 3RD ST CB T11 TO ST T10</b> | <b>KEYPOT NJ</b> | <b>3RD ST</b> |

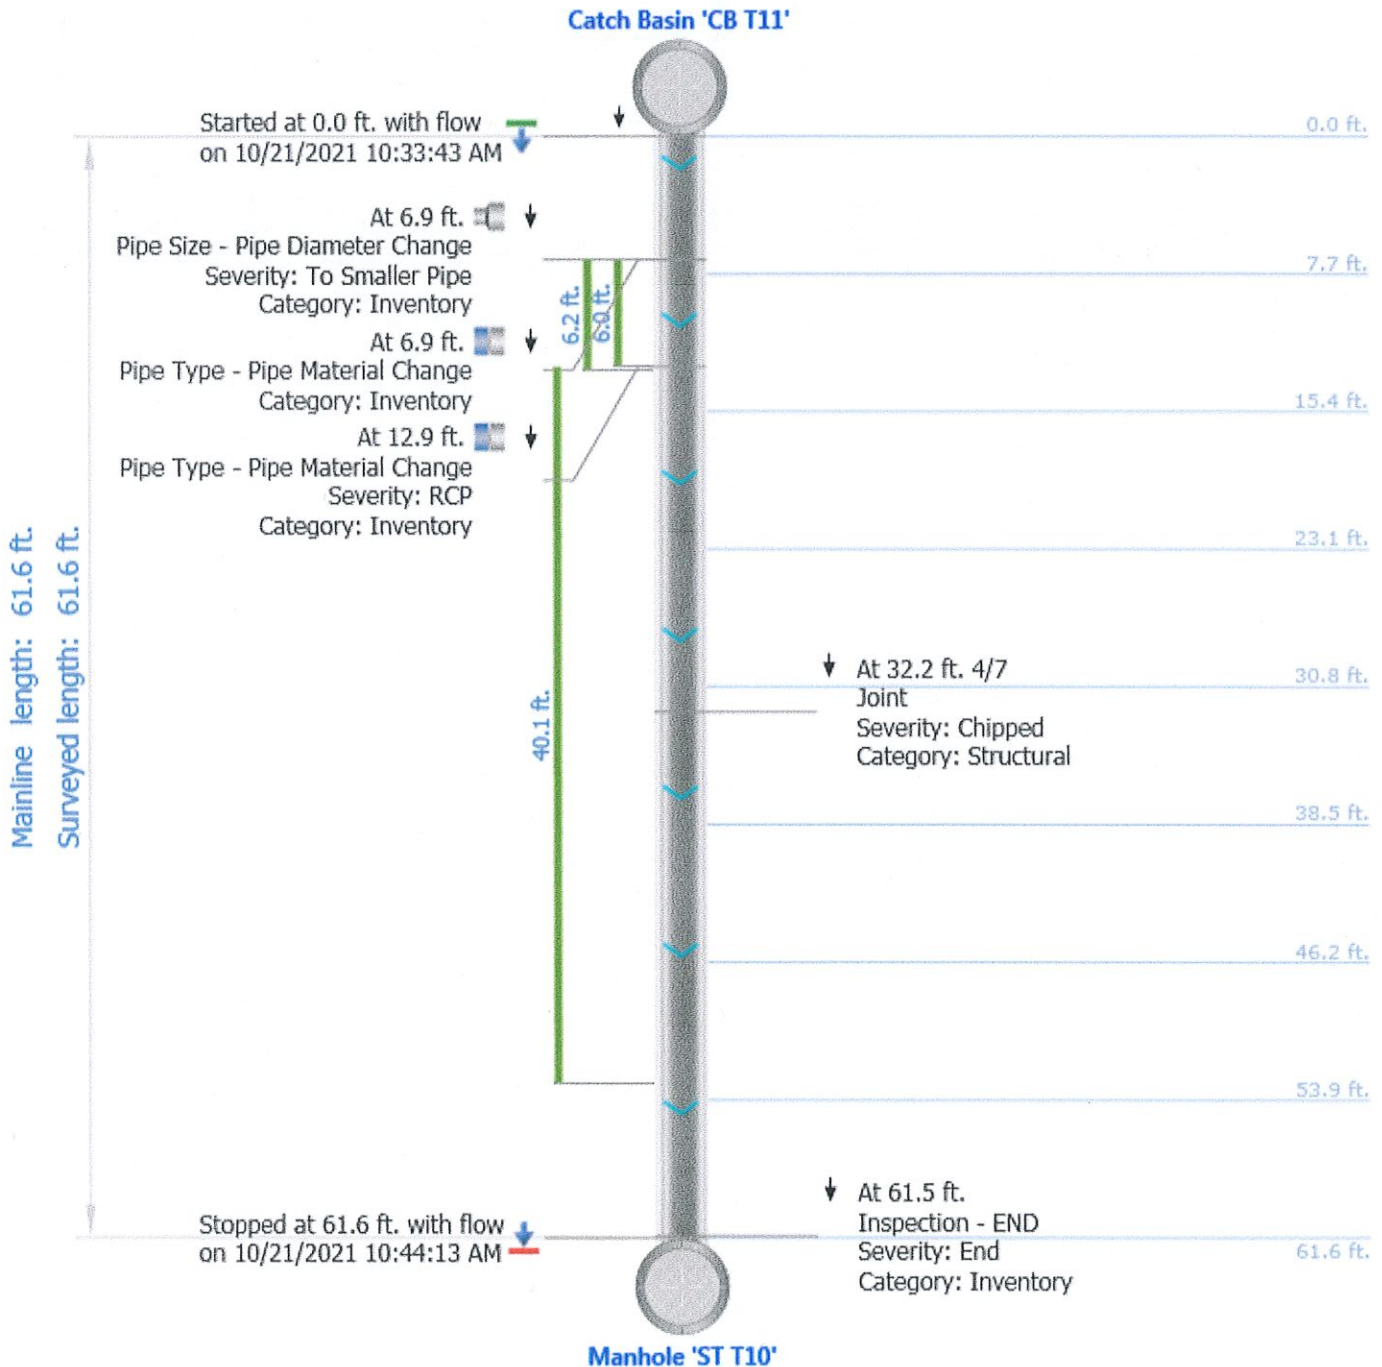
| Distance | Dir. | Length | From/To | Code | Modifier/Severity | Rating | Comments |
|---|---|---|---|---|---|---|---|
| 32.2 ft. | D | | 4 / 7 | Joint | Chipped | | |

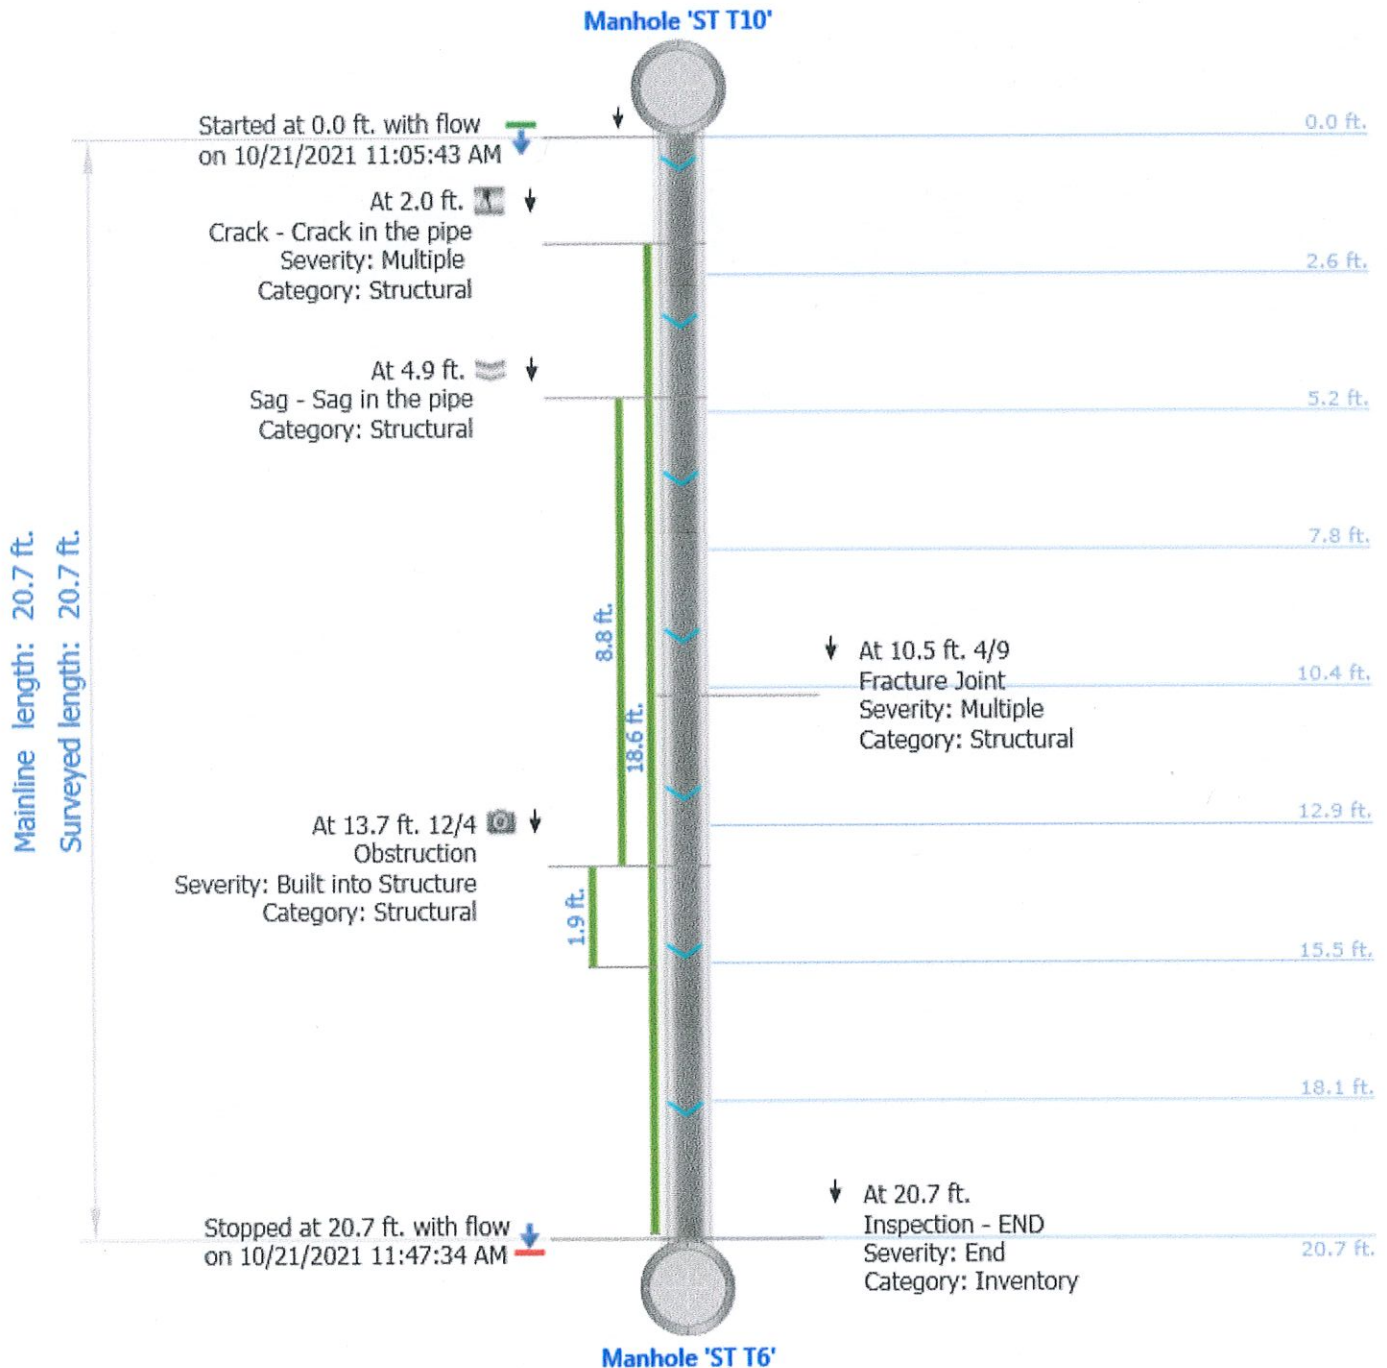
| 10/21/21 KEYPORT 3RD ST STORM | KEYPORT 3RD ST ST T10 TO ST T6 | KEYPOT NJ | 3RD ST |

| Distance | Dir. | Length | From/To | Code | Modifier/Severity | Rating | Comments |
|---|---|---|---|---|---|---|---|
| 2.0 ft. | D | 18.6 ft. | / | Crack | Multiple | | |
| 4.9 ft. | D | 8.8 ft. | / | Sag | | | |
| 10.5 ft. | D | | 4 / 9 | Fracture Joint | Multiple | | |
| 13.7 ft. | D | 1.9 ft. | 12 / 4 | Obstruction | Built into Structure | | |

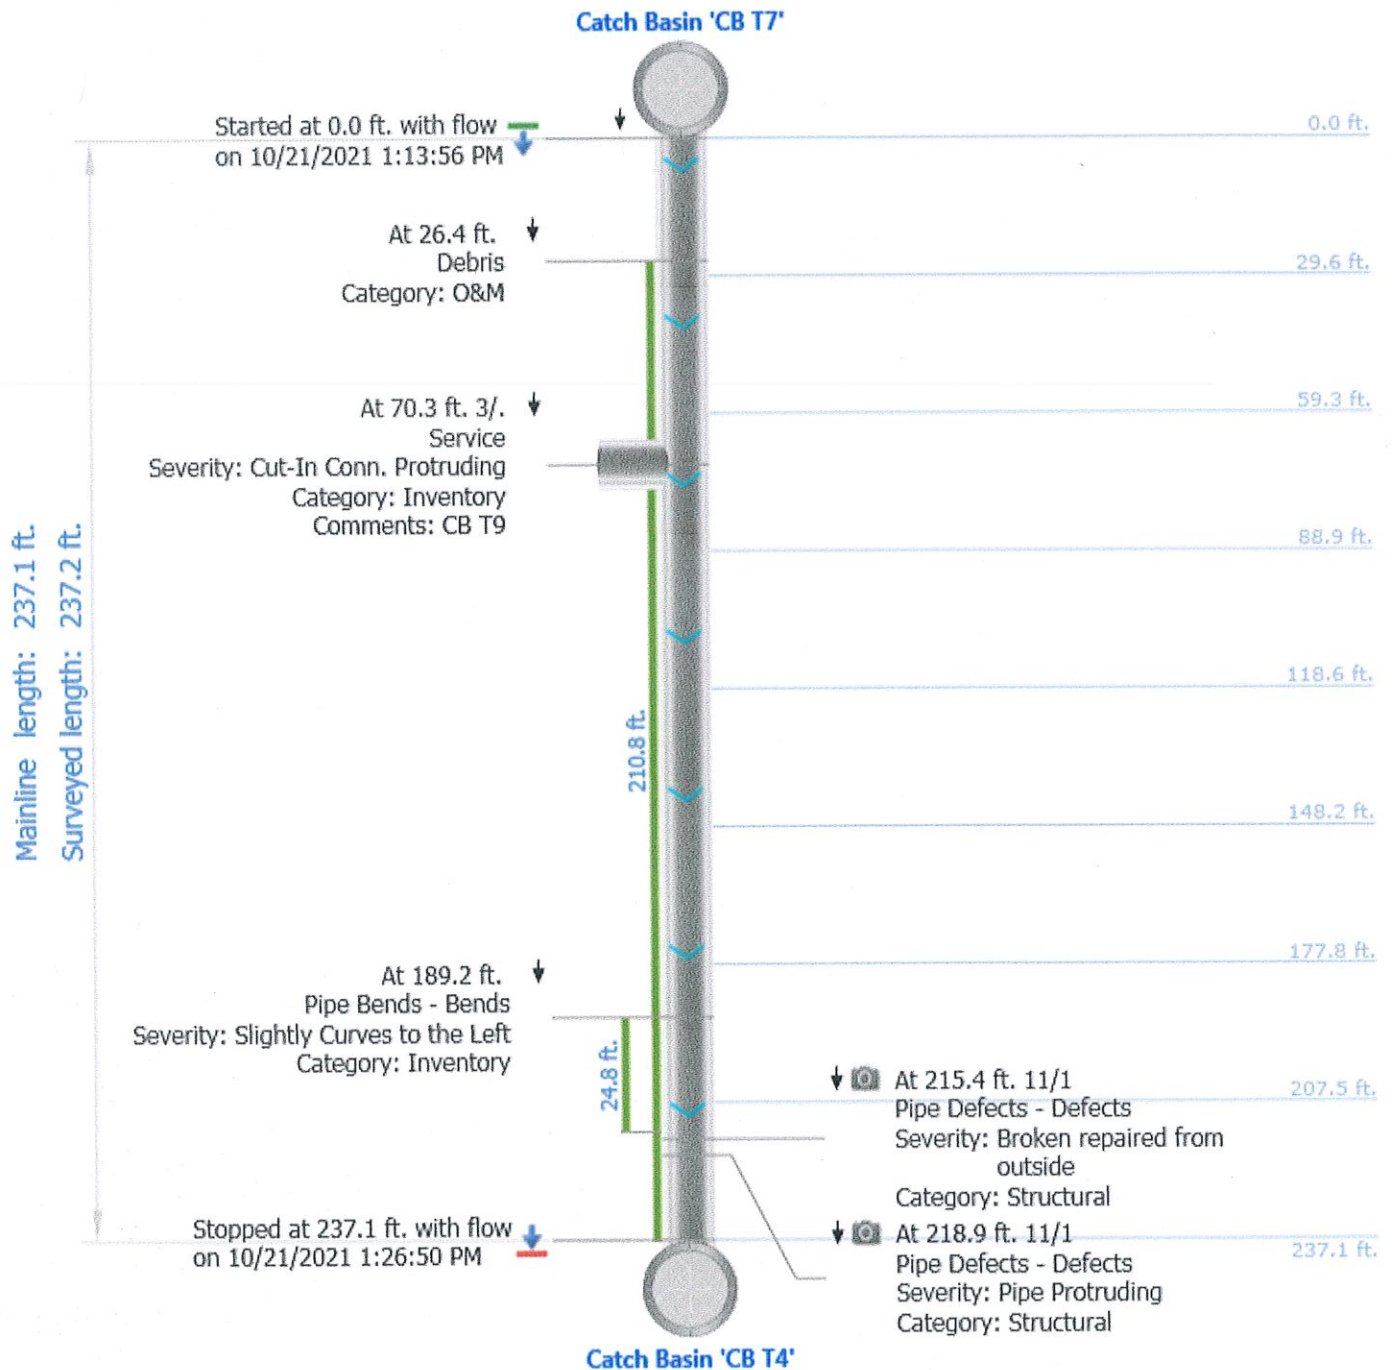
| 10/21/21 KEYPORT 3RD ST STORM | KEYPORT 3RD ST CB T7 TO CB T4 | KEYPOT NJ | 3RD ST |

| Distance | Dir. | Length | From/To | Code | Modifier/Severity | Rating | Comments |
|---|---|---|---|---|---|---|---|
| 26.4 ft. | D | 210.8 ft. | / | Debris | | | |
| 70.3 ft. | D | | 3 / | Service | Cut-In Conn.<br>Protruding | | CB T9 |
| 215.4 ft. | D | | 11 / 1 | Pipe Defects | Broken repaired from<br>outside | | |

| Distance | Dir. | Length | From/To | Code | Modifier/Severity | Rating | Comments |
|---|---|---|---|---|---|---|---|
| 218.9 ft. | D | | 11 / 1 | Pipe Defects | Pipe Protruding | | |

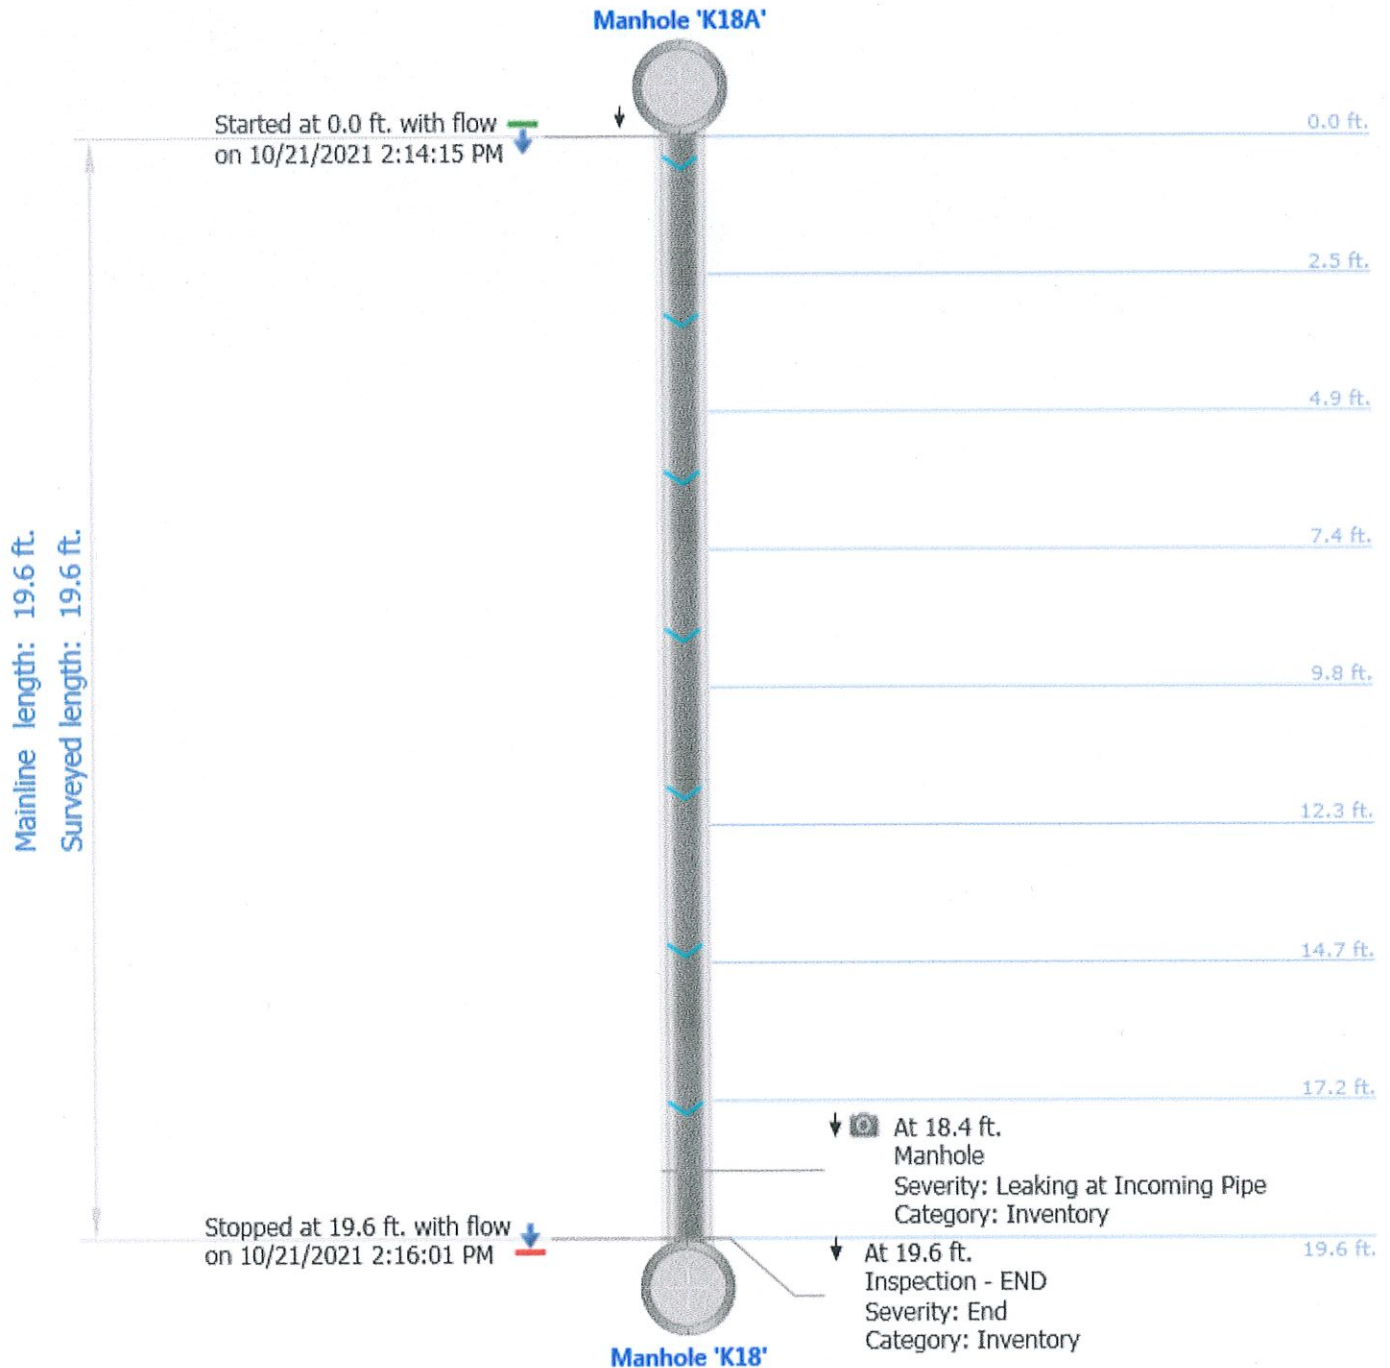
| Mainline ID:<br><b>KEYPORT HAVEN WAY<br/>K18A TO K18</b> | City:<br><b>KEYPOT NJ</b> | Address:<br><b>HAVEN WAY</b> | Project name:<br><b>10/21/21 KEYPORT 3RD ST<br/>STORM</b> |

| Distance | Dir. | Length | From/To | Code | Modifier/Severity | Rating | Comments |
|---|---|---|---|---|---|---|---|
| 18.4 ft. | D | | / | Manhole | Leaking at Incoming<br>Pipe | | |
