Draft Report  
Building Inspections  
NJ Division of Fish & Wildlife  
Tuckahoe Non Game Office  
Winslow Southern Regional Office  
December 5, 2017

**Lammey + Giorgio /** Architects  
215 Highland Avenue, #B  
Haddon Twp., NJ 08108

Re: Building Assessments  
Division of Fish & Wildlife

- Tuckahoe Non-Game Office
- Winslow Southern Regional Office

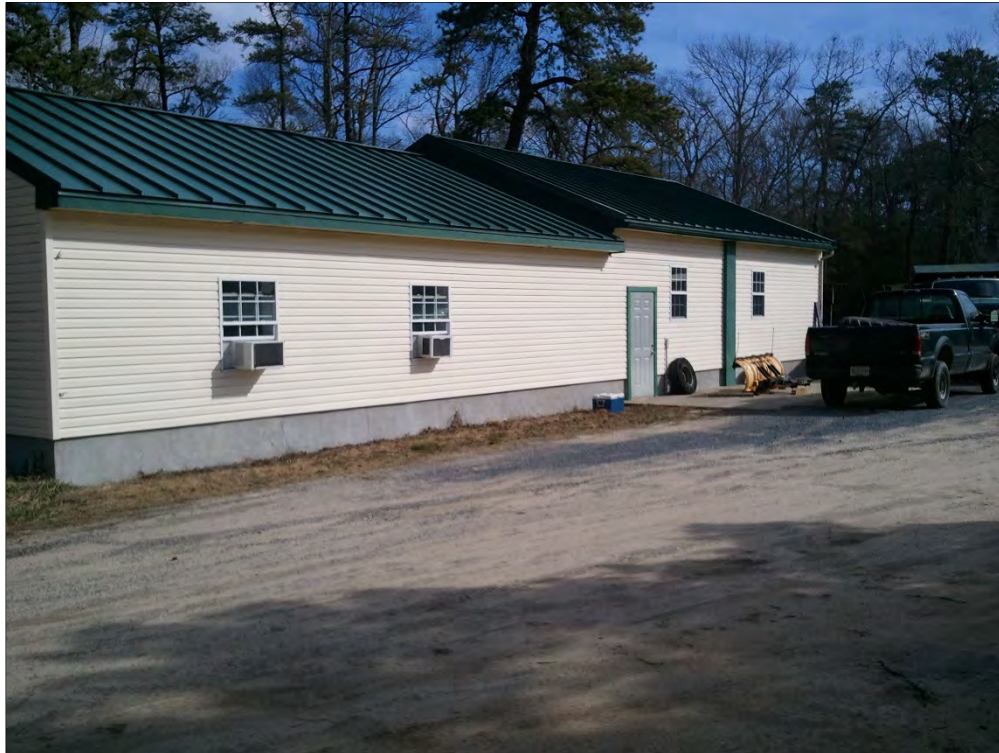
**Building Description:** Masonry, slab on grade building with vinyl siding and standing seam metal roof.

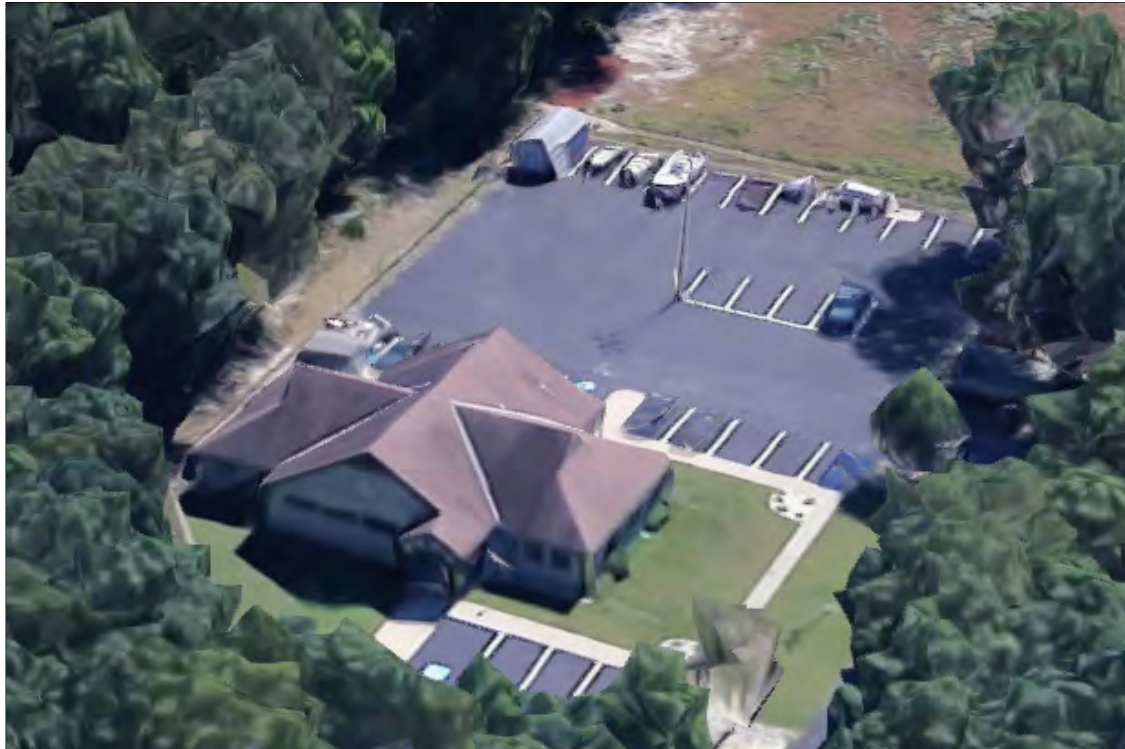
**Building Description:** Slab on grade building with wood siding, wood trim and shingled roof  
**(Wildlife Management Area):** Southern Region
