| New Jersey Police<br>Crash Investigation Report | | | | | | | | | | | Case Number<br><b>20006131</b> | | | | Page <u>2</u> of <u>3</u> | |

New Jersey Police Crash Investigation Report  
Motor Vehicle Crash Diagram

Police Dept: NORTH BRUNSWICK Code: 01  
Station: - Case No: 20006131

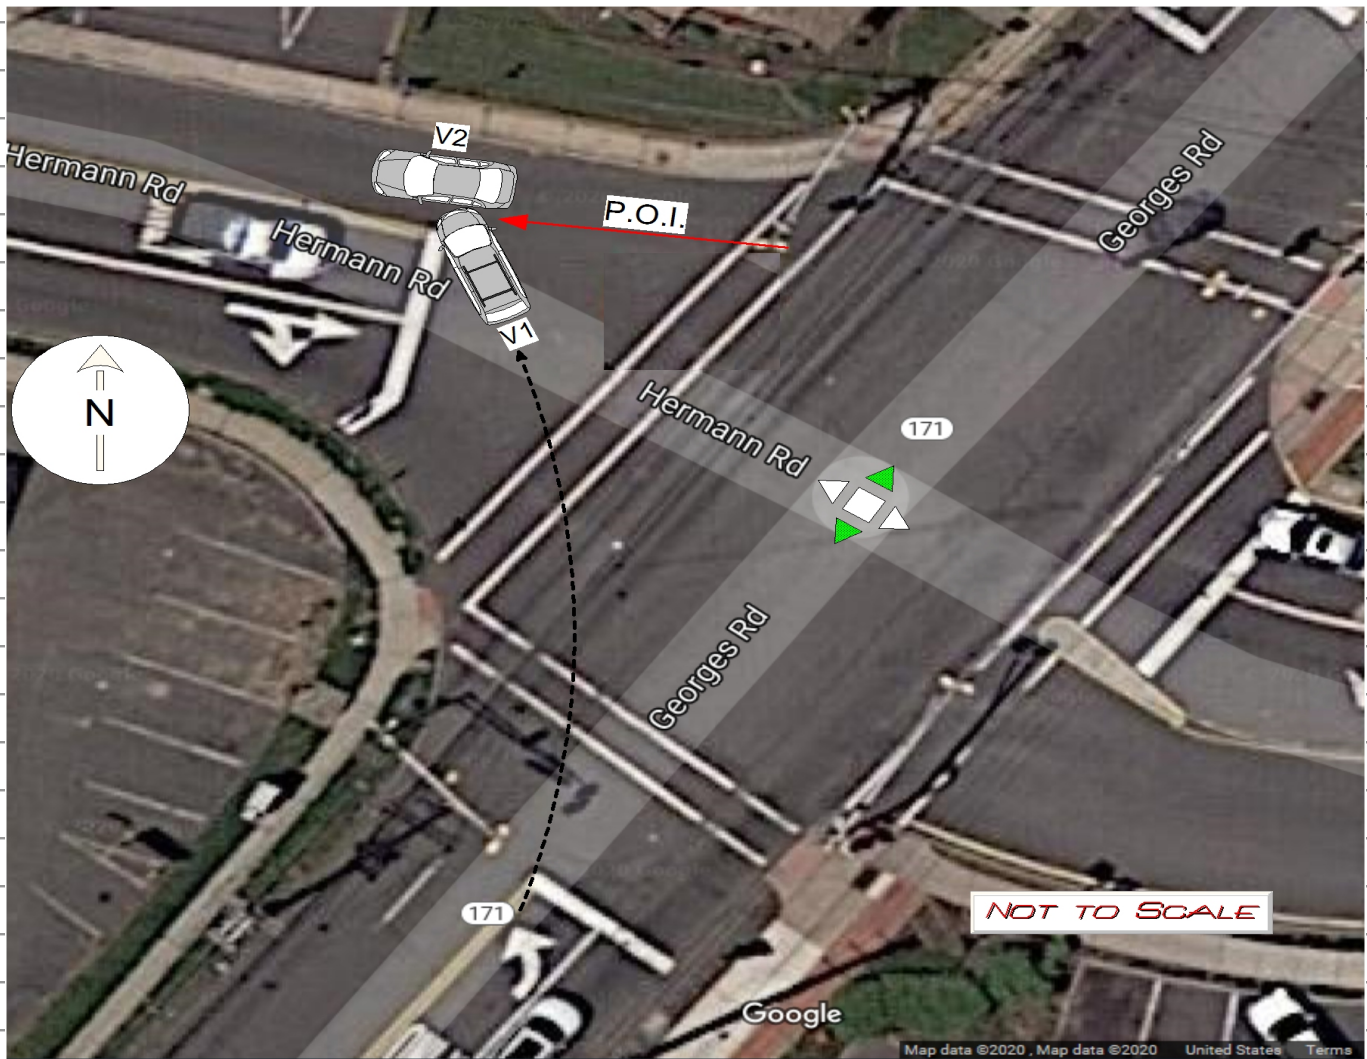
144 Crash Diagram (NOT TO SCALE)

Vehicle 1 was making a left turn from Georges Road onto Hermann Road. Vehicle 2 was making a right turn from Georges Road to Hermann Road.

Driver 1 stated that vehicle 2 made a right turn very fast and hit his vehicle as he was turning left. Driver 2 stated that his light was green and he was making a right turn from Georges Road onto Hermann Road. Vehicle 1 tried to cut his turn early to get in front of him but ended up striking vehicle 2.

I observed debris in the roadway that would indicate vehicle 1 would have had to have make an improper turn. I also observed dash cam footage from vehicle 2.

Investigation reveals driver 1 turned improperly by cutting of the angle of his turn short and also did not yield the right of way to vehicle 2.
