| New Jersey Police<br>Crash Investigation Report | | | | | | | | | | | | Case Number<br>2018-00003729 | | | Page 2 of 4 | |

New Jersey Police Crash Investigation Report  
Motor Vehicle Crash Description

New Jersey Police Crash Investigation Report  
Motor Vehicle Crash Diagram

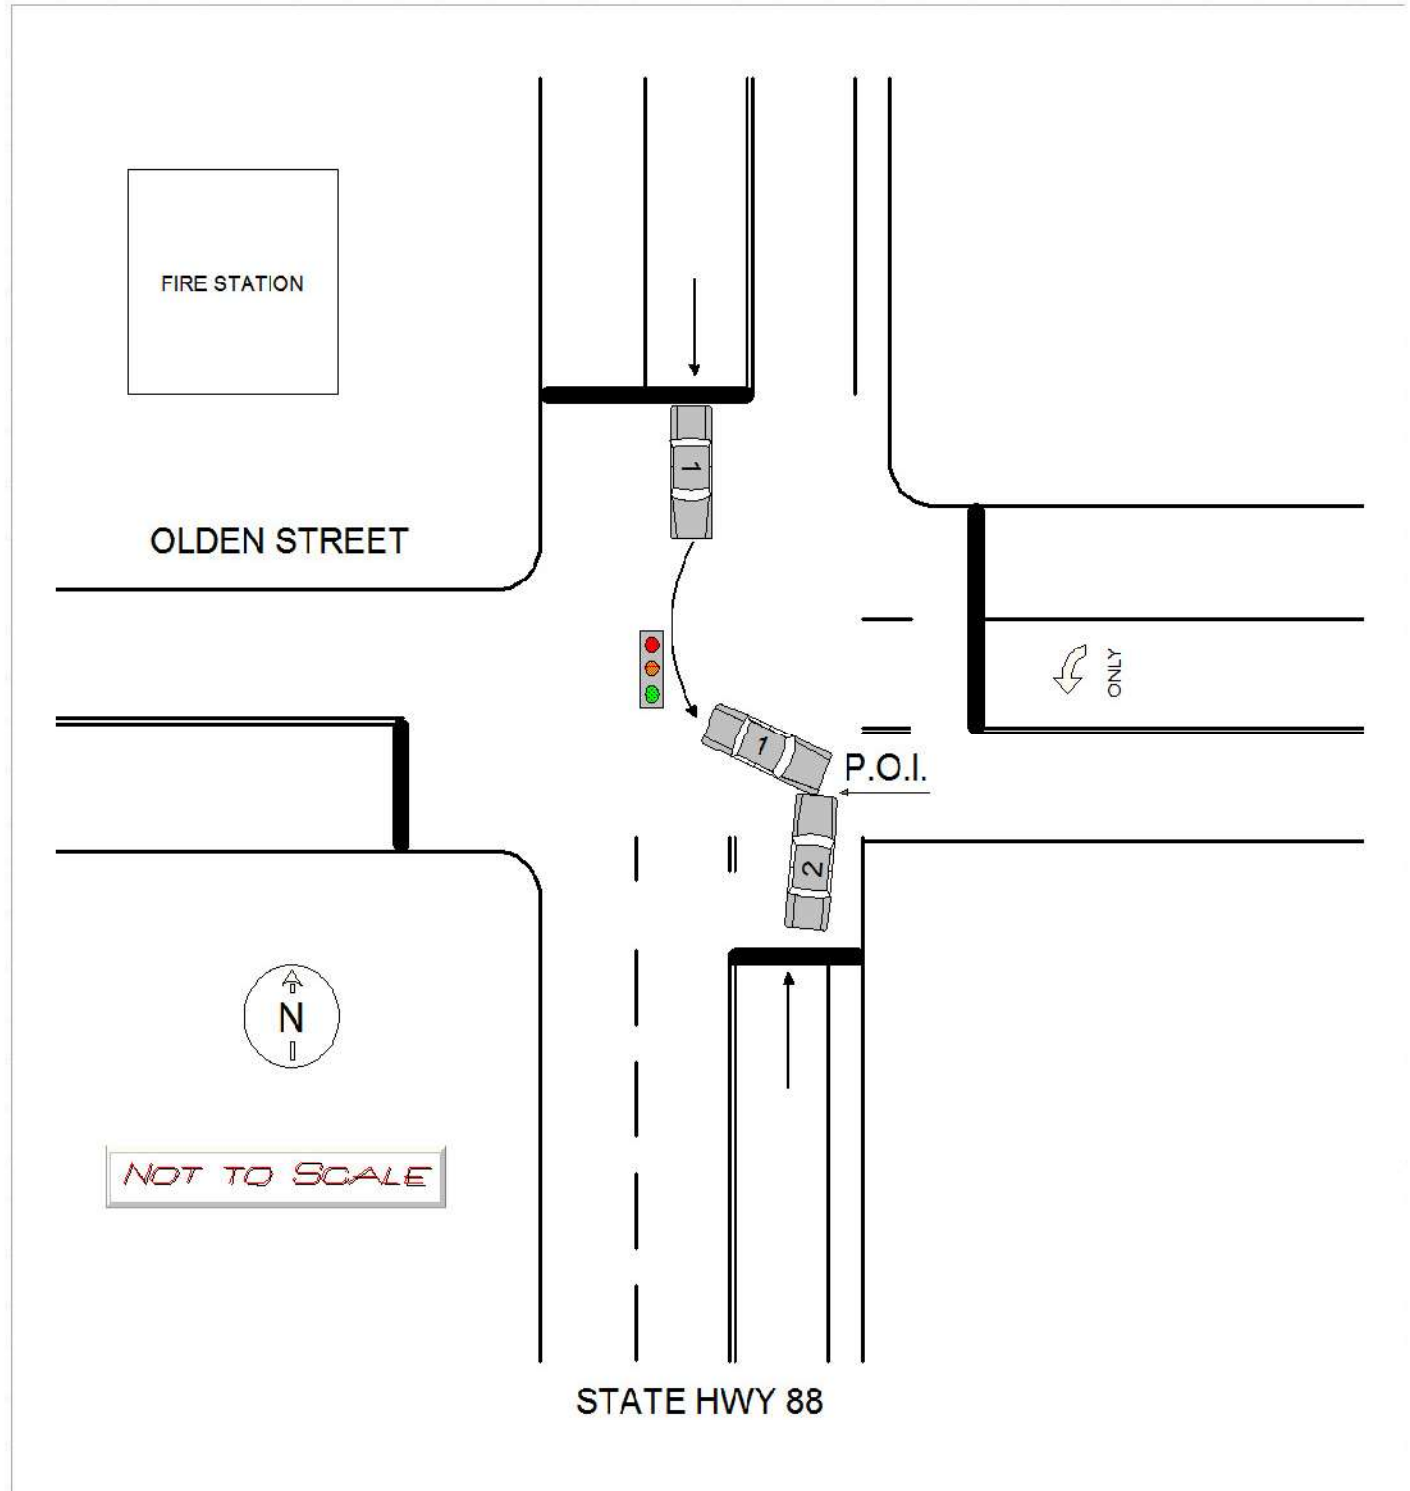
144 Crash Diagram (NOT TO SCALE)

Vehicle 1 was traveling on Route 88 east attempting to make a left onto Olden Street. Vehicle 2 was traveling on Route 88 west going straight through the intersection at Olden Street. Vehicle 1 turned in front of vehicle 2 and both vehicles subsequently collided within the intersection.

Driver 1 stated she was traveling on Route 88 east attempting to make a left turn onto Olden Street. She observed vehicle 2 traveling towards her on Route 88 west and believed she had enough time to turn in front of vehicle 2.

Driver 1 stated that while she was making her turn she was struck by vehicle 2.

Driver 2 stated she was traveling on Route 88 west approaching the intersection at Olden Street. Driver 2 stated she observed vehicle 1 start to turn in front of her and she attempted to avoid a collision by swerving towards the right but was unable to avoid it. Driver 2 stated vehicle 1 struck her vehicle as she was traveling straight through the intersection.

Investigation revealed that the cause of the crash was driver 1 making an improper left turn and failing to yield to vehicle 2 which was driving straight through the intersection.
