## New Jersey Police Crash Investigation Report

## Motor Vehicle Crash Description

Station: **Brick Police** Case No: **2016-00063293**

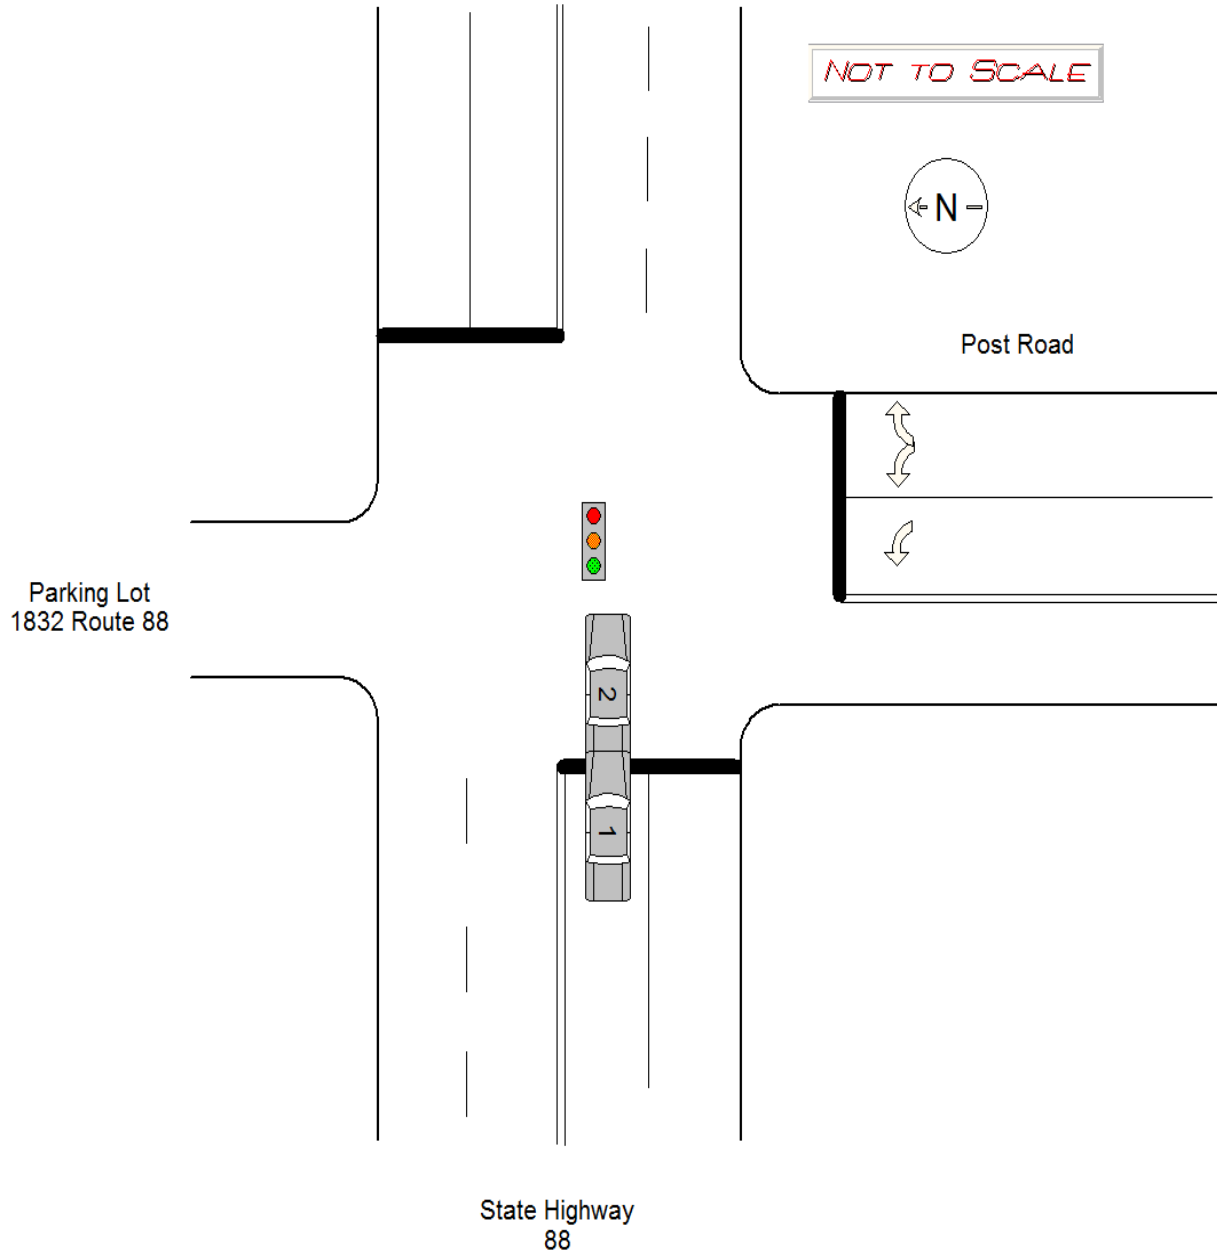
Motor Vehicle Crash Diagram

Vehicle 2 stopped in traffic on Route 88 eastbound at intersection with Post Rd waiting to make a left turn into parking lot of 1832 Route 88. Vehicle 1 traveling directly behind Vehicle 2 on Route 88 eastbound.

Driver of Vehicle 1 stated they were unable to stop in time prior to Vehicle 2's position due to the wet road conditions. Vehicle 1 crashed into rear of Vehicle 2.

Driver of Vehicle 2 stated they were at a complete stop when Vehicle 1 crashed into them from behind.

Based on my investigation and observations on scene I determined Vehicle 1 to be at fault for the motor vehicle crash.
