## New Jersey Police Crash Investigation Report

Station: **Brick Police** Case No: **2016-00059516**

Motor Vehicle Crash Diagram

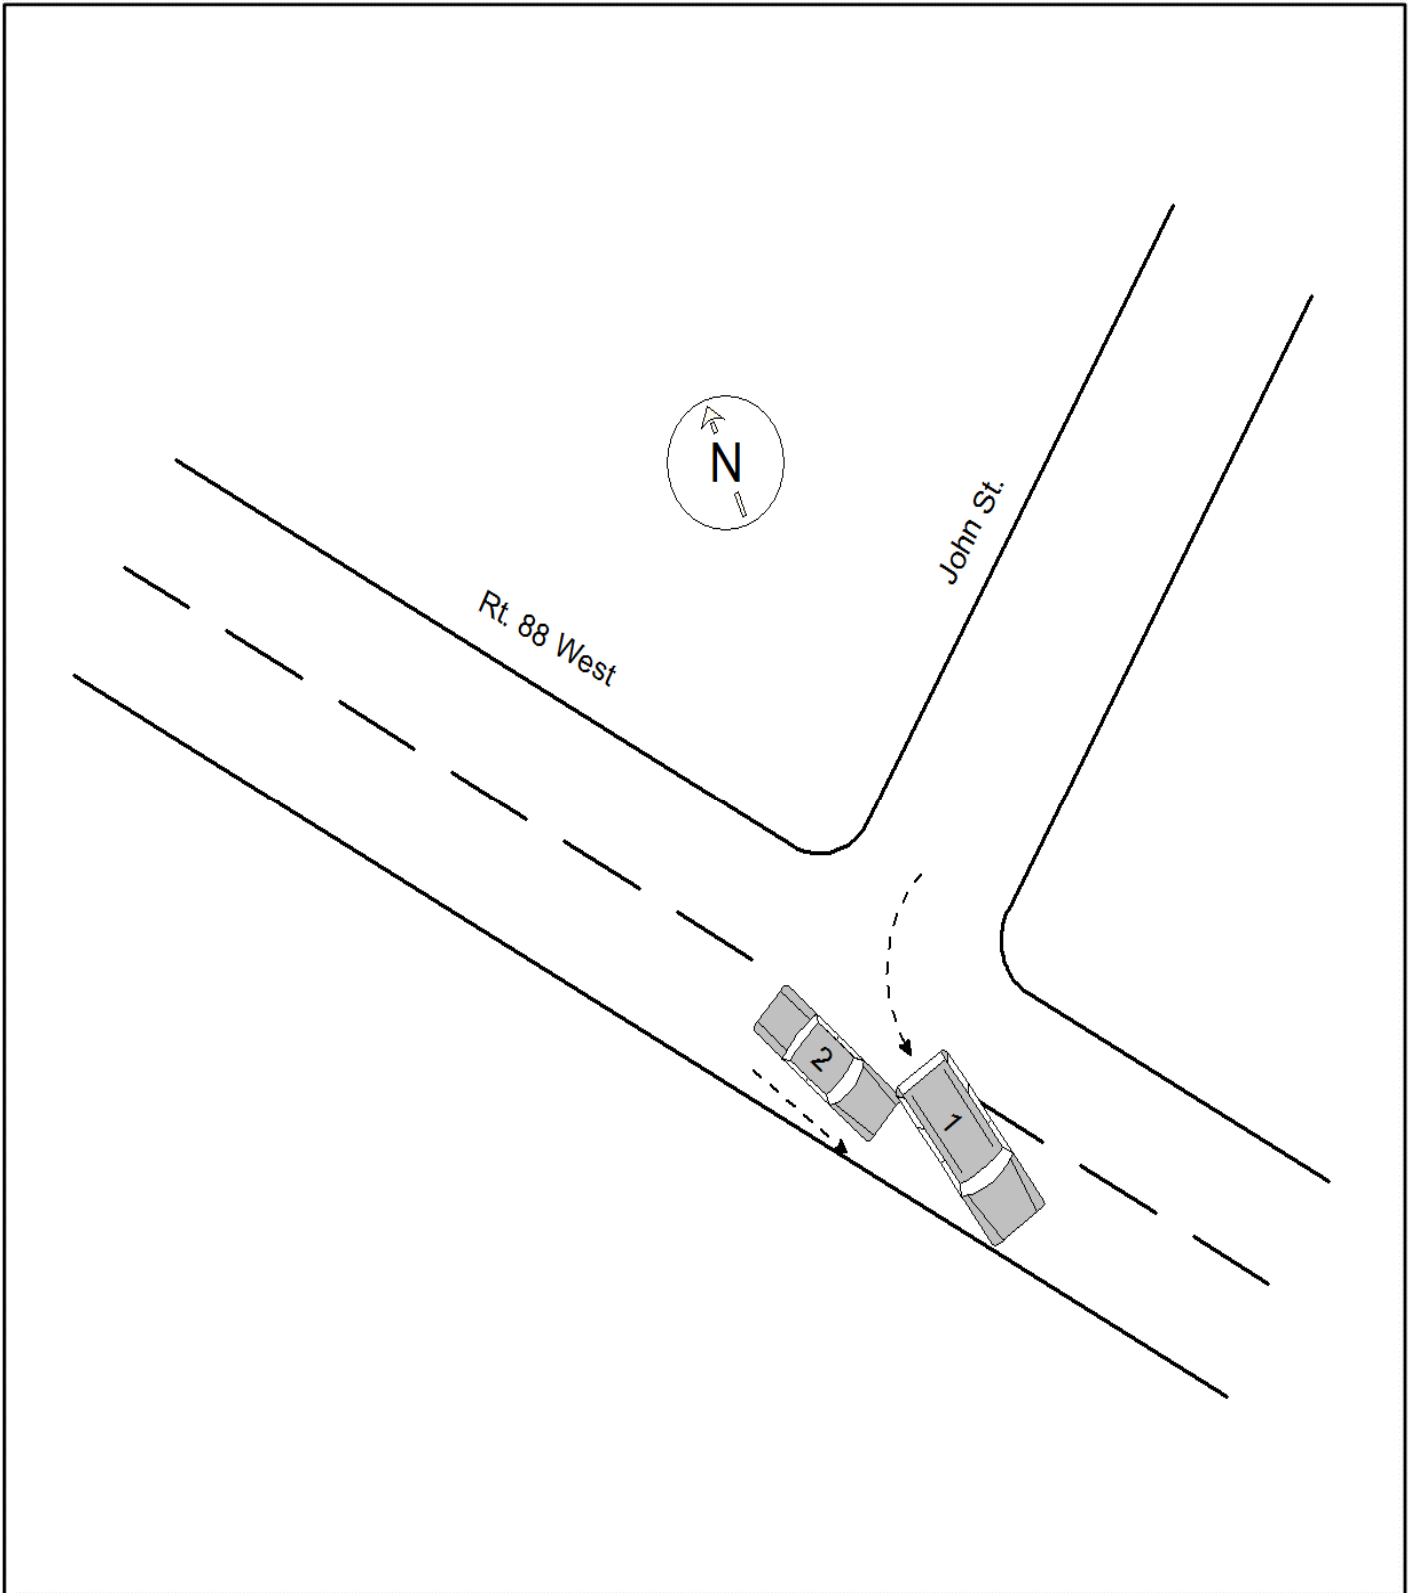
Vehicle #2 was traveling eastbound on Rt. 88 West approaching the intersection of John St. Vehicle #1 was traveling southbound on John St. approaching the intersection of Rt. 88.

Vehicle #1 proceeded to make a left turn onto Rt. 88, failing to yield to oncoming traffic.

Driver #2 stated she attempted to avoid Vehicle #1 which had pulled out in front of her by swerving slightly to the right, but was unable to.

Vehicle #2 struck the right lower rear of Vehicle #1.
