## New Jersey Police Crash Investigation Report

## Motor Vehicle Crash Description

Station: **Brick Police**Case No: **2016-00016957**

## 135 Crash Description

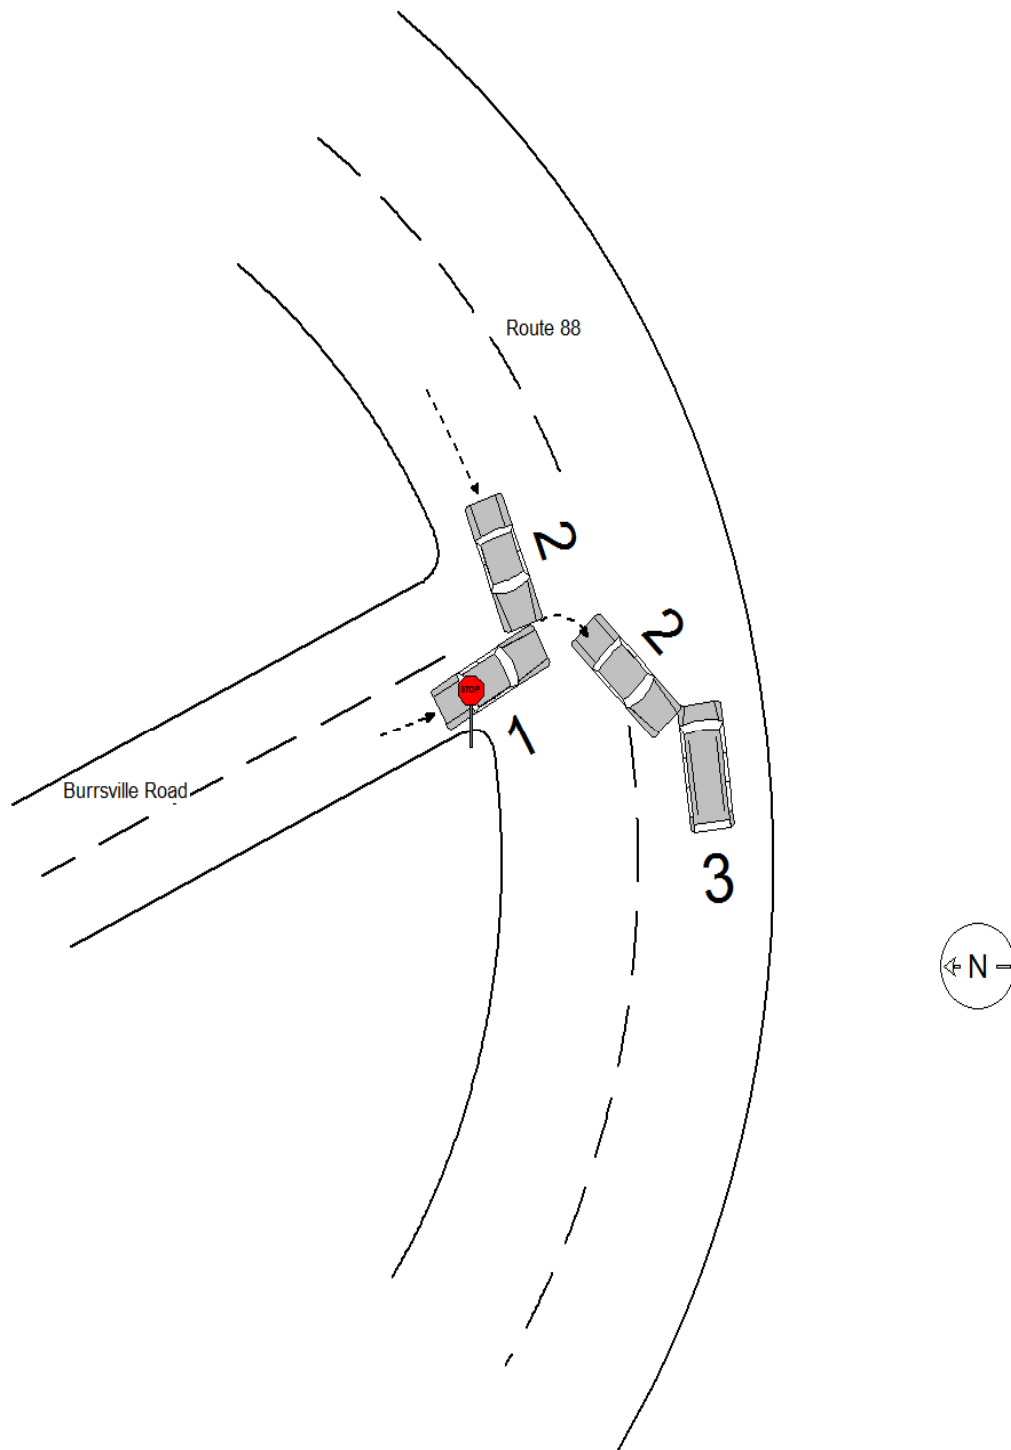
Motor Vehicle Crash Diagram

A motor vehicle crash occurred on Route 88 at the intersection of Burrsville Road.

Driver of Vehicle #1 advised he was attempting to turn left onto Route 88 from Burrsville Road. Driver #1 advised he did not observe Vehicle #2 travel west on Route 88.

Driver of Vehicle #2 stated she was traveling west on Route 88. Driver #2 advised Vehicle #1 pulled out from Burrsville Road. Driver #2 stated the vehicles collided at the intersection of Route 88 and Burrsville Road.

Driver of Vehicle #3 advised he observed the collision between Vehicle #1 and Vehicle #2. Driver #3 stated he braked and came to a full stop when Vehicle #2 struck him on the front driver side bumper.

Vehicle #1 failed to observe Vehicle #2 traveling west on Route 88 prior to turning onto Route 88 from Burrsville Road, causing a collision. Vehicle #1 and #2 collided and Vehicle #2 traveled west on Route 88 striking Vehicle #3 on the front driver side front bumper.

Driver #1 is the at fault driver for driver inattention and failure to yield right of way. Driver #1 was issued the following summons: 1506 T 152152 for 39:4-97, Careless driving.
