| <b>New Jersey Police Crash Investigation Report</b><br><br><b>Motor Vehicle Crash Description</b> | Police Dept: <b>Brick PD</b> Code: <b>01-Municipal Police</b><br>Station: <b>---</b> Case No: <b>2012-00025390</b> |

## 135 Crash Description

New Jersey Police Crash Investigation Report

Motor Vehicle Crash Diagram

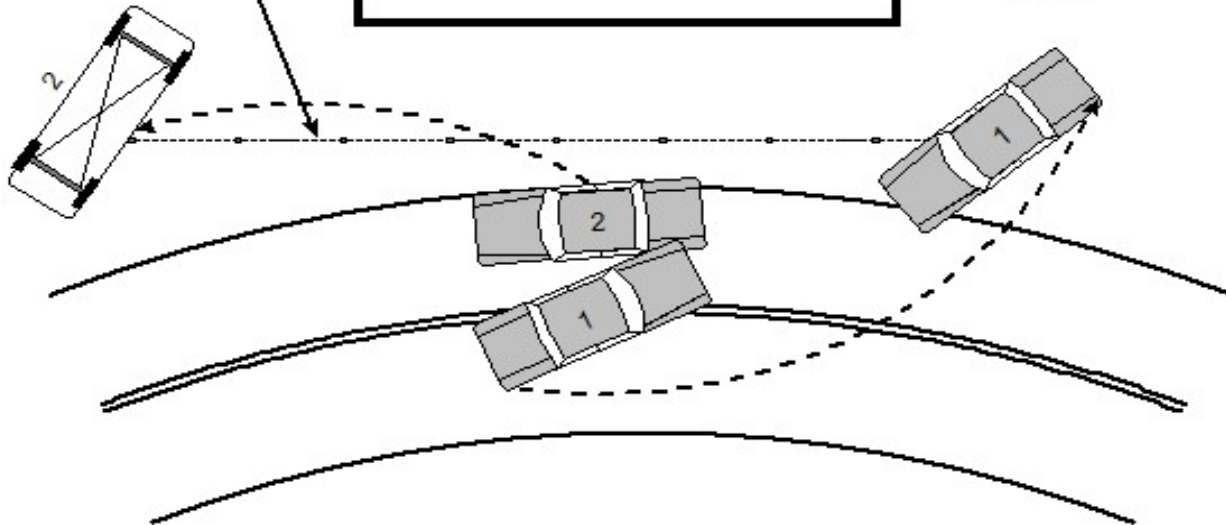
134 Crash Diagram (NOT TO SCALE)

Landscape Retaining Wall/Concrete

Tuscany Restaurant  
1490 Rt.88

Vehicle #1 was traveling east on Rt. 88 and vehicle #2 was traveling west on Rt. 88. As both vehicles approached a curve in the roadway, vehicle #1 continued straight and crossed into the on coming traffic lane. Vehicle #1 collided into the left rear side of vehicle #2 causing vehicle #2 to leave the roadway striking a concrete retaining wall. After colliding into the concrete wall, vehicle #2 became airborne, spinning through the air and landing in the parking lot entrance of The Tuscany Restaurant upside down. Vehicle #1 spun an unknown amount of times and collided into the same concrete retaining wall at The Tuscany Restaurant.

The debris from both vehicles were in the westbound lane, north side shoulder and on the front property of the Tuscany Restaurant. There was little to no debris in the east bound lane. Driver #1 stated that she thought vehicle #2 had pulled out in front of her vehicle and that the collision occurred in her lane of travel.

Driver #2 stated that he observed the vehicle in front of him, also traveling west, swerve as vehicle #1 started to cross over the double yellow center lane marker into his lane. Driver #2 attempted to move to the right but was struck by vehicle #1. Numerous witnesses had the same account of the collision as driver #2 (see witness statement forms).
