| <b>New Jersey Police Crash Investigation Report</b><br><br><b>Motor Vehicle Crash Description</b> | Police Dept: <b>Brick PD</b> Code: <b>01-Municipal Police</b><br>Station: <b>---</b> Case No: <b>2011-00022620</b> |

New Jersey Police Crash Investigation Report

Motor Vehicle Crash Diagram

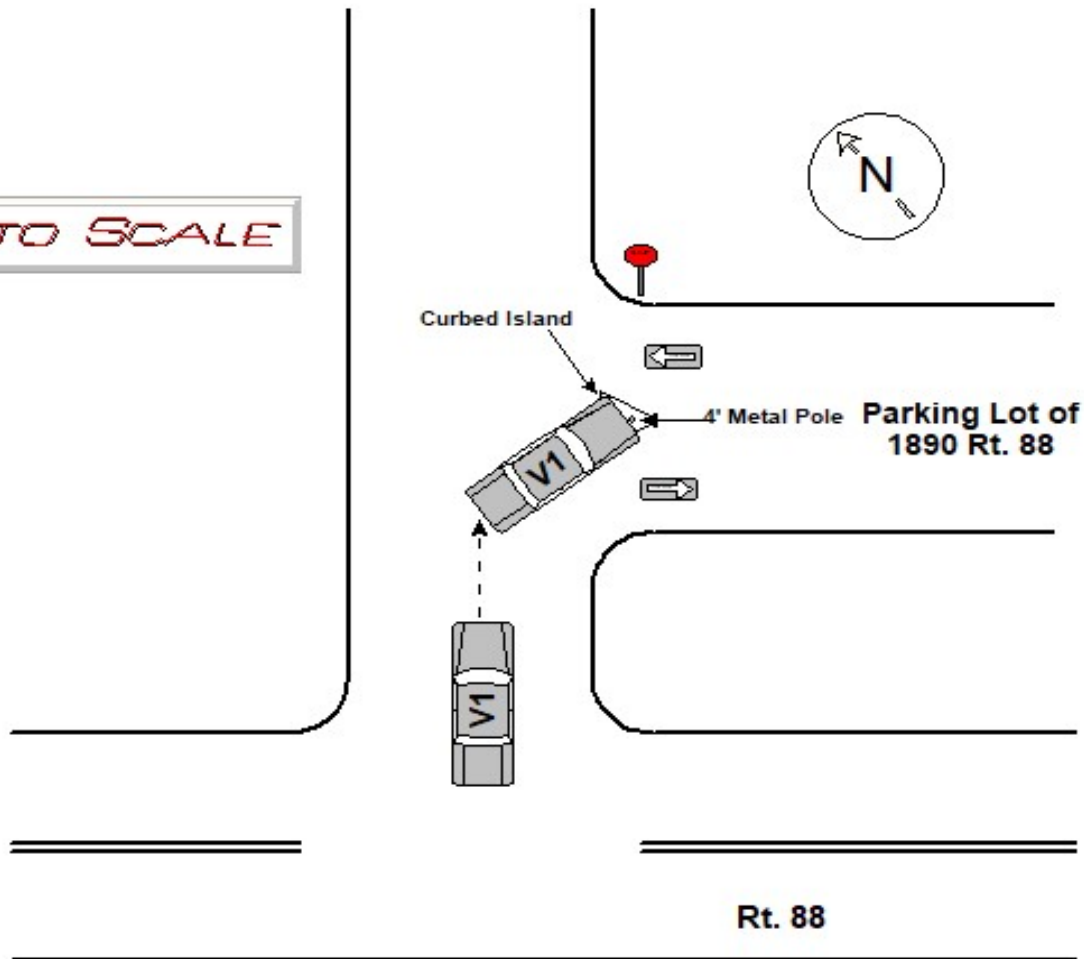
134 Crash Diagram (NOT TO SCALE)

As Vehicle 1 was entering the parking lot of 1890 Rt. 88, it struck a curbed island. The vehicle continued across the island where it struck a yellow 4 foot high metal pole that was located in the middle of the island. Driver 1 stated that as she was entering the parking lot, she did not see the curbed island or the metal pole until exiting the vehicle after the impact. Driver 1 had a complaint of facial and back pain but refused medical aid from responding EMS units.

It should be noted that during the hours of darkness, the curbed island and metal pole are difficult to observe while attempting to make the sharp turn into the parking lot.
