| New Jersey Police<br>Crash Investigation Report | | | | | | | | | | | | Case Number<br>2020-00059897 | | | Page 2 of 4 | |

New Jersey Police Crash Investigation Report  
Motor Vehicle Crash DescriptionPolice Dept: Brick Police Code: 01Station: — Case No: 2020-00059897

New Jersey Police Crash Investigation Report  
Motor Vehicle Crash Diagram

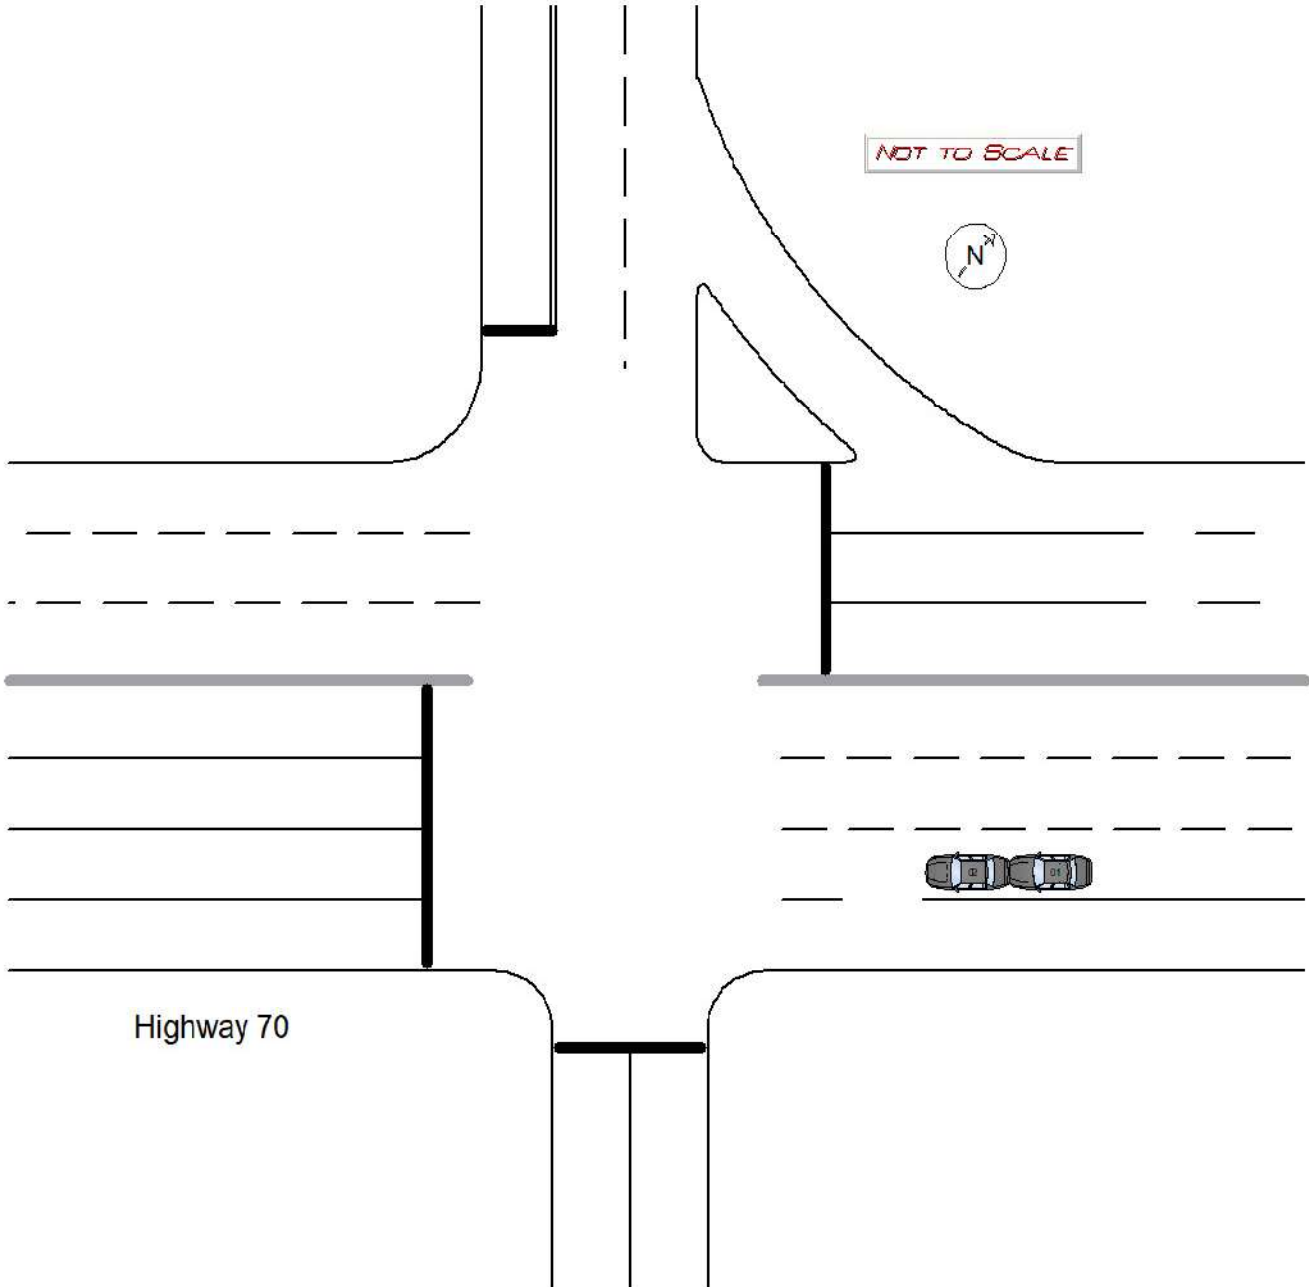
144 Crash Diagram (NOT TO SCALE)

Prior to arrival both vehicles were moved from Route 70 west bound approximately 100 feet east of the intersection with Olden Ave to a near by parking lot.

Driver #2 stated he was stopped in the left lane of travel of Route 70 westbound waiting for the traffic signal to turn green. He said while he was stopped, vehicle #1 collided into the rear bumper of vehicle #2 causing damage to the entire rear bumper.

Driver #1 said she was traveling directly behind vehicle #2 and was also stopped waiting for the traffic signal to change from red to green. She said when the traffic signal turned green she took her foot off the brake and started to roll forward anticipating vehicle #2 to proceed forward as well. Driver #1 said when vehicle #2 did not move, the front bumper of vehicle #1 tapped into the rear bumper of vehicle #2.
