| New Jersey Police<br>Crash Investigation Report | | | | | | | | | | | Case Number<br>2018-00063744 | | | | Page 2 of 4 | |

# New Jersey Police Crash Investigation Report Motor Vehicle Crash Description

New Jersey Police Crash Investigation Report  
Motor Vehicle Crash Diagram

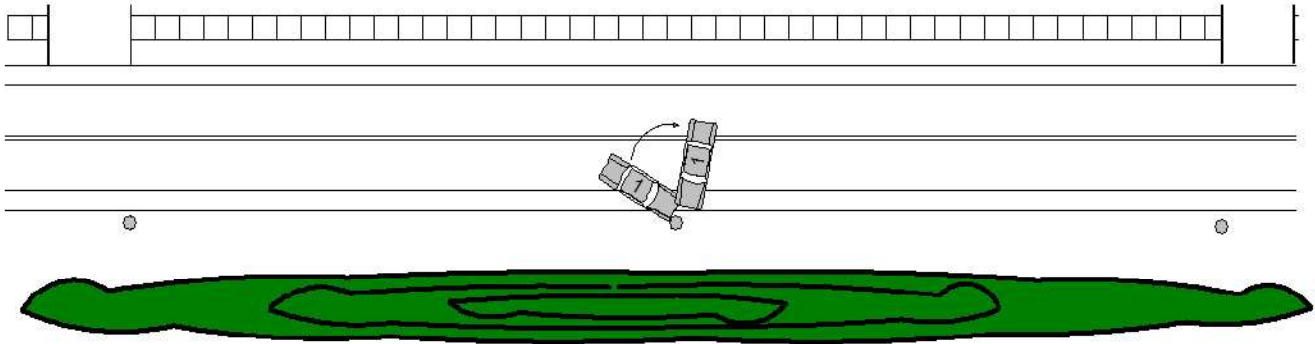
144 Crash Diagram (NOT TO SCALE)

Colonial Funeral Home  
2170 Route 88

For illustration purposes only

Vehicle #01 was traveling east on State Highway 88 between Sullivan Road and Burnt Bridge Avenue. As vehicle #01 was passing by the Colonial Funeral Home, it left the road to the right and struck a large utility pole. #JC283BK, with the right front bumper / fender area of vehicle #01, causing significant damage to vehicle #01 and a crack in the utility pole.

The impact caused vehicle #01 to rotate around the utility pole to the left and come to rest blocking the eastbound lane and partially blocking the westbound lane.
