New Jersey Police Crash Investigation Report NJTR-1 (Rev. 01/22)

Police Dept: Franklin Township Police Department/Somerset Co. Code: 01

Station: FTPD Case No: 23054169

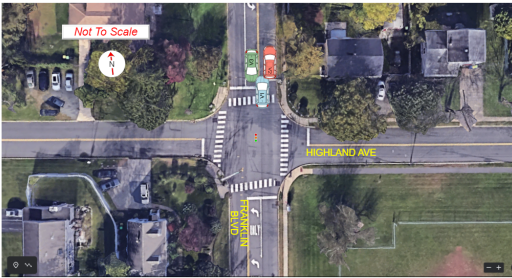
144. Crash Diagram

Invest: V2 was traveling north on Franklin Blvd, slowed for traffic. V3 was traveling south on Franklin Blvd and was stopped at the intersection of Franklin Blvd and Highland Ave attempting to make a left turn. V1 was traveling north on Franklin Blvd, struck V2 from the rear, crossed the center line and struck V3.

D1 stated the following; as he went through the intersection he did not realize V2 was stopped, D1 relayed he attempted to go around V2 by pulling to the left, however, he rear-ended V2 and sideswiped V3.

Investigation revealed D1 caused the crash due to driver inattention. D1 was issued a summons for careless driving.
